Stop Use & Return Notice

Dyna-Lock[®] Self-Retracting Lanyard - 22m (70ft) and 30m (95ft) Types and Dynevac[®], Dynevac II, and Lynx[®] Rescuers - 30m (95ft) Types Manufactured between January 1, 2001 and October 8, 2004

October 28, 2004

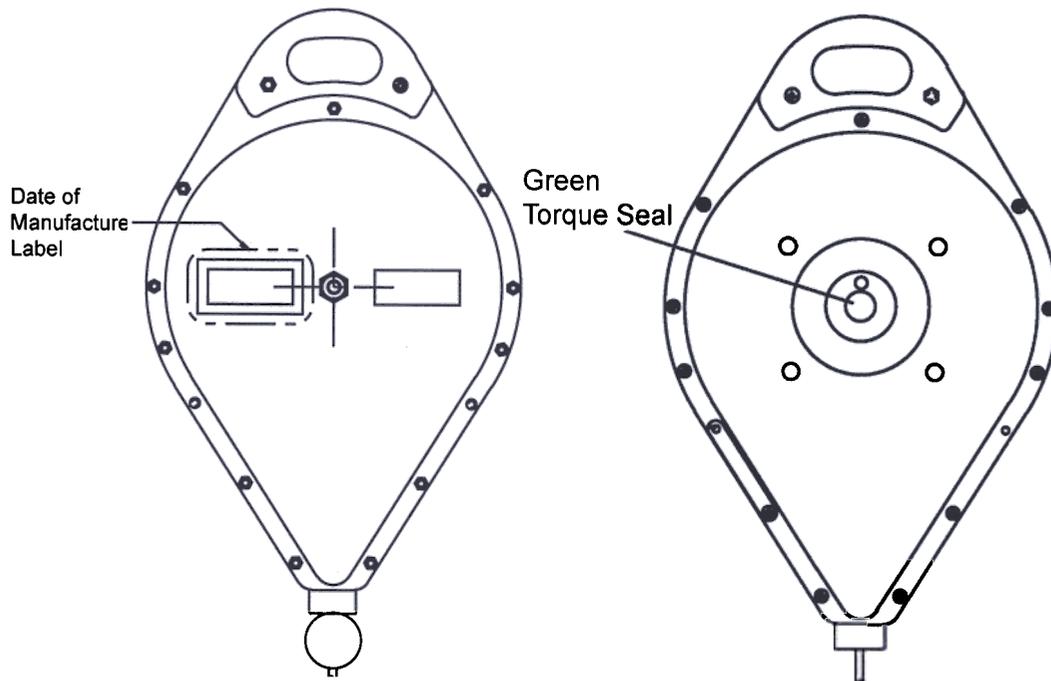
As indicated above, this notice affects only those MSA SRLs and Rescuers manufactured between January 1, 2001 and October 8, 2004. SRLs and Rescuers manufactured outside the specified time period as well as products manufactured with green torque seal on the torque nut (located on the face of the unit - see diagram below) do not have this condition and may continue to be used.

Inspect all products to determine the date of manufacture and if green torque seal is present. The date of manufacture is located on the label affixed to back of the housing and the green torque seal is located in the center of the face of the housing. (see diagram below). If the date of manufacture is within the affected range or if the date cannot be determined, the product is subject to this notice and must be removed from service, with the following exception. If green torque seal is present, the unit is not subject to this notice, even on units with a date of manufacture within the affected range.

The returned product will be inspected for this condition and repaired as needed. We will use a green torque seal on the torque nut located in the center of the face of the housing and enter a new date under the "last factory service" field on the label shown above. The original or replacement products will be express shipped to you within four working days of our receipt of your product.
