Pop the Tires, Light the Fires

By Ltjg. John Nelson

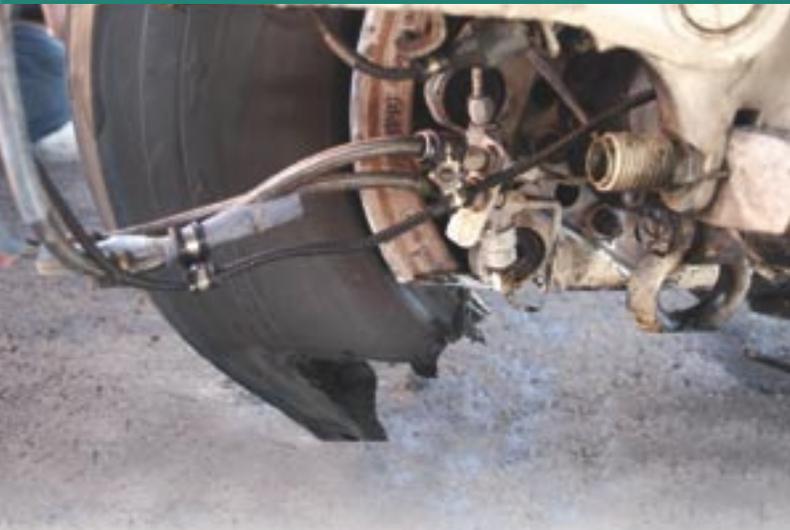
Although we couldn’t hear it in our jet, the rest of NAS North Island was treated to a spectacular “boom, boom!” Both main landing-gear tires had popped in quick succession. The jet began to swerve, and I feverishly worked to maintain centerline.

Passing the 5 board, tower came over the radio with, “503. Your right wheel is on fire.”

The post-incident safety investigation revealed a failed anti-skid system. Because of a confluence of events (landing with a crosswind, failed anti-skid, negative flaperon popups, and pilot-landing technique), the old Swiss-cheese holes lined up perfectly for us.

We discuss ORM every flight, and we need to take time to discuss the critical phases of flight. The CQ environment poses great inherent risks, even without the added jets with fuel concerns coming back to the beach. With plenty of gas remaining, I needed to fight off the urge to get on deck as soon as possible and, instead, land on the runway with the most favorable winds. I also should have used my past experience of landing in crosswinds to put the jet firmly on the deck and dissipate energy, rather than using a min-rate-of-descent landing.
