Diving Safety Lines

Spring Edition

2005

Diving Safety Lines is a semi-annual release by the Afloat Safety Directorate of the Naval Safety Center. The information contained herein is a summary of research from selected reports of diving hazards to assist you in your mishap prevention program. *Diving Safety Lines* is intended to give advance coverage of safety-related information while reducing individual reading time. This bulletin does not, in itself, constitute authority but will cite authoritative references when available. It is recommended that this bulletin be made available to all hands.

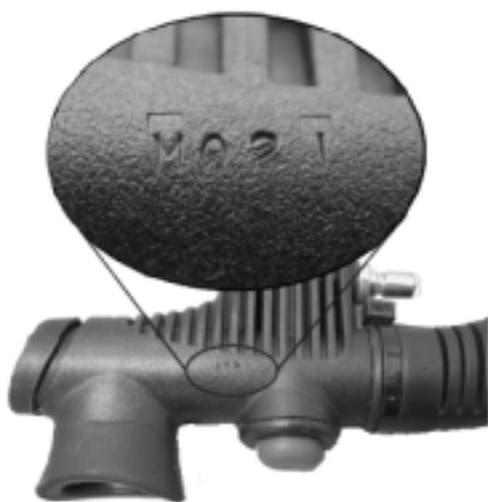
Fig. 2 - Serial number stamp

Aqua Lung has received reports that some of the ribbed hoses on the Powerline Airway have been tearing at the top near the dual exhaust valve. The problem has been traced to an error in the molding process from their supplier that occurred over a three-month period between 2001 and 2002. The best way to confirm whether or not you have one of the questionable hoses is to look at the serial number on the lower unit of the Powerline. If the serial number falls within the range of M48H to

M52H (M48H, M49H...M52H), or M01I to M08I (M01I, M02L...M08I) and is the original hose, then it should get replaced. This affects both SeaQuest and Aqua Lung BCs utilizing the Powerline inflator.

If you have a spiral hose that falls within the serial number range, please have the hose replaced by this authorized Aqua Lung retailer.

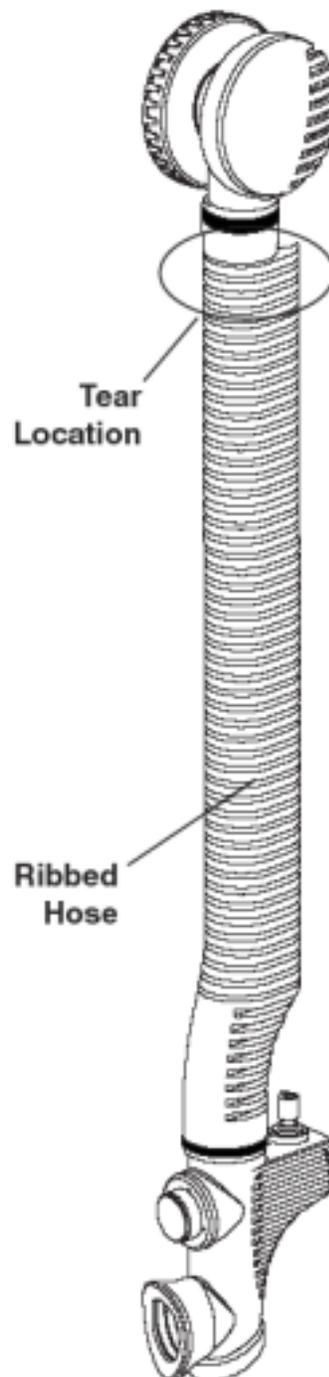
Fig. 1 - Powerline Airway

Aqua Lung has received reports that some of the ribbed hoses (Fig. 1) on the Powerline Airway have been tearing at the top near the dual exhaust valve. The problem has been traced to an error in the molding process from our supplier that occurred over a three-month period between 2001 and 2002. The best way to confirm whether or not you have one of the questionable hoses is to look at the serial number on the lower unit of the Powerline (fig. 2). If the serial number falls within the range of **M48H to M52H** (*M48H, M49H...M52H*), or **M01I to M08I** (*M01I, M02I...M08I*) and is the original hose, then it should get replaced. This affects both SeaQuest and Aqua Lung BCs utilizing the Powerline inflator.

If the ribbed hose were to tear near the top, the BC would not be able to hold air and a loss of buoyancy would occur. This could result in the need for the diver to ditch their weight pockets or rely on their buddy for assistance. In extreme cases it could result in result in panic, injury or death.

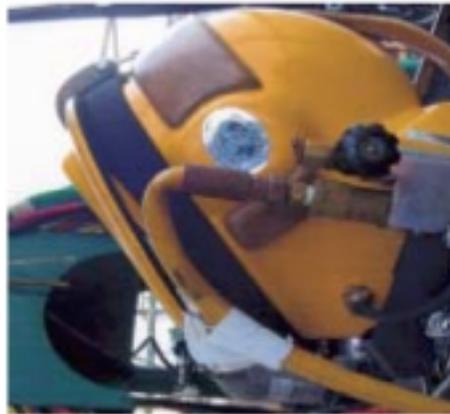
On 23 September 2004, Mobile Diving and Salvage Unit Two (MDSU TWO) Divers were tasked with assisting SIMA Norfolk Dive Locker during the removal of USS HARRY S. TRUMAN (CVN 75) #1 propeller off the shaft taper. MDSU TWO Divers splashed to apply and initiate detonating cord (high explosives) to the forward end of #1 propeller hub. MDSU TWO Divers utilized MK 21 deployed from Charlie Team dive boat. While at depth on the project, Red Diver reported loss of air and immediately initiated EPs. Diving Supervisor asked Green Diver how he was breathing and Green Diver reported he was okay with no air supply problems, Console/Bank pressures were satisfactory. Red Diver reported that his air had been restored almost immediately after reporting the loss. The dive was aborted and both Divers returned safely to the surface. Once topside, the Divers were unhatted and it was immediately determined that Red Diver's umbilical had kinked at the hat connection (non-return valve).

Root Cause: The root cause of umbilical failure at the hat connection was primarily due to the frequency of removing the MK 21 helmet without sufficient support of umbilical weight in conjunction with setting the helmet on faceplate.

MK 21 kinked umbilical.

Corrective Action: Inspect umbilical shackle points on dive benches to ensure there is sufficient support to relieve the strain experienced from umbilical weight and assume the practice of resting the MK 21 helmet on the neckdam area vice the faceplate. Routinely inspect umbilical end fittings during pre-dive setup.
