LEARNING A FLIGHT-DECK LESSON

By JO3 Megan Moline

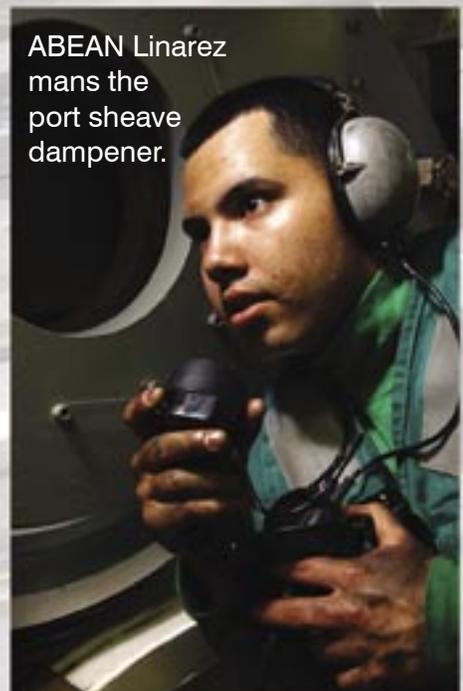
ABEAN Linarez mans the port sheave dampener.
