# The “A” Panel That Didn’t Stay Forgotten

By AD1 Aaron G. Beckman, VP-26

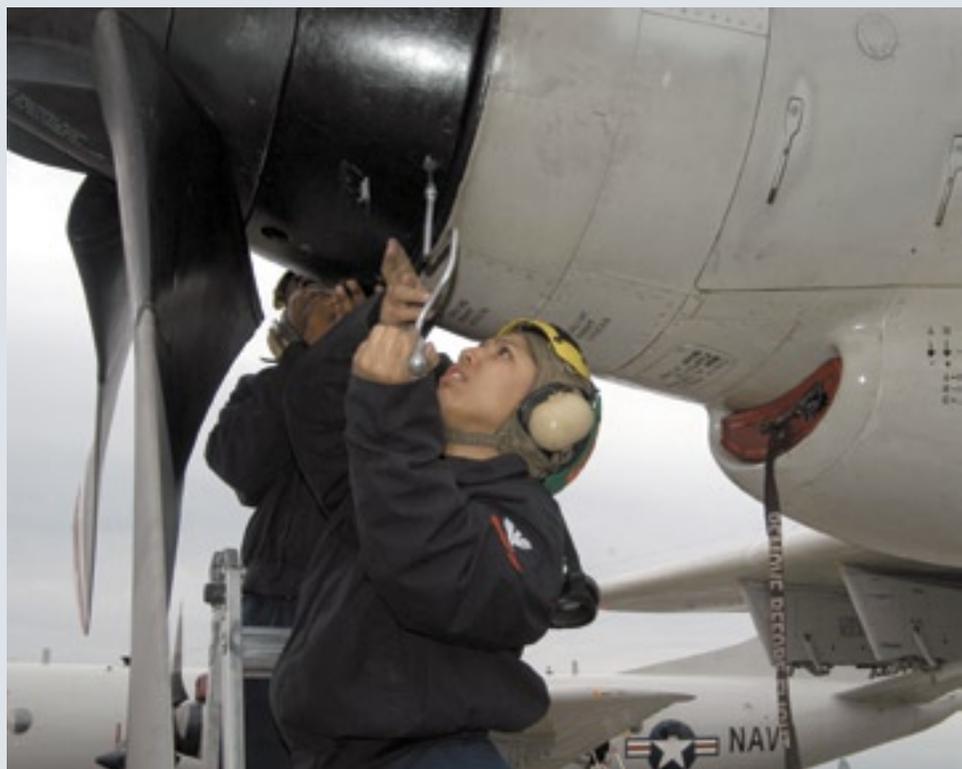
The “A” panel I had set on top of the wing took flight when the FE shifted down the No. 3 engine into low RPM, which had launched it about 50 feet aft of the wing. Sparks flew as it slid another 20 feet. After a

close inspection by one of the airframe CDIs, we determined the panel hadn’t been damaged significantly, but I couldn’t say the same for my self-esteem.

The maintenance manual contains no cautions against setting panels on the wing during preflight; however, there is an instruction to inspect upper wing surfaces for FOD hazards before performing turns. A qualified pilot, QA representative, flight engineer, CDI, and a yellowshirt all had overlooked the panel I left on top of the wing; each of us failed to use our checklist.

The “Man on the Stand” engine turn is one of the most dangerous maintenance tasks we perform. Adhering to the checklist is imperative for the safety of all involved and for personnel in the vicinity. The rain during our work had caused several stoppages, which induced dangerous gaps in our process and opened the door wide for human error. If we only had said, “Let’s start a new checklist from the beginning,” this incident might have been avoided. 🦋
