My Kingdom for an Assist MAF

By AME2(AW) Scott Cutler

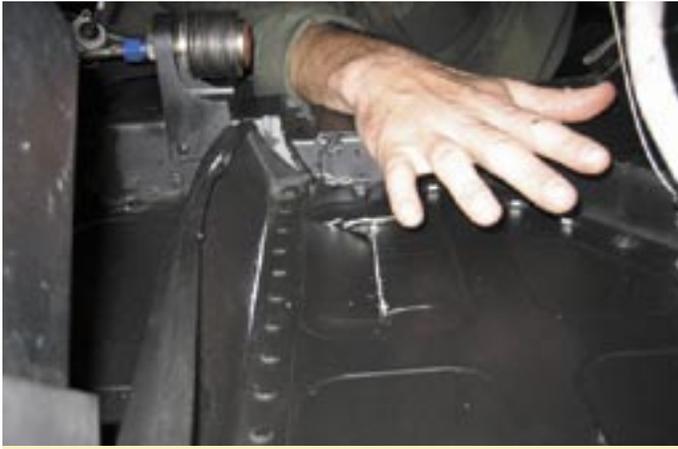
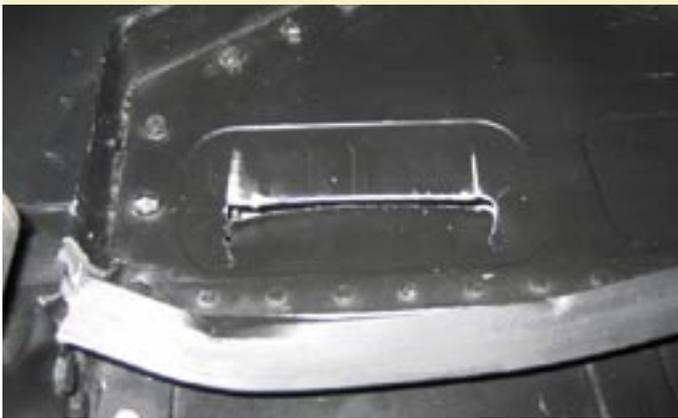
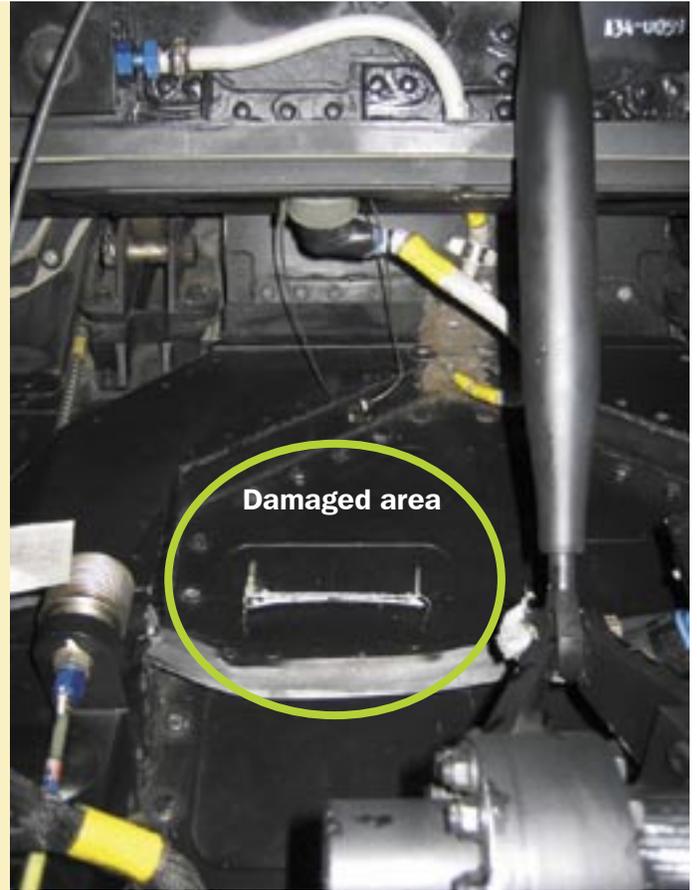
The canopy rail and areas around the canopy need to be free of objects. This damage shows why.

I rushed to the hangar bay, climbed on top of the aircraft and looked at the spot where I had placed the recorder. The No. 1 fuel-cell access panel had a gash in it the same length of the CVRS box, and the support rib running across it was bent out of shape. The CDI had overlooked the recorder I placed on the access panel behind the aft seat and had closed the canopy on it. When the canopy was closed, it pinched the CVRS box between the canopy glass and the No. 1 fuel-cell access panel.

small the job seems. I should have cut an assist MAF and had the appropriate work center remove its piece of gear. Effective communication is key, and I should have told the other AMEs about the recorder. Had I told them, someone might have reminded me to reinstall it after the seat removal was done.
