Sailors and Marines Preventing Mishaps

BRAVO Zulu

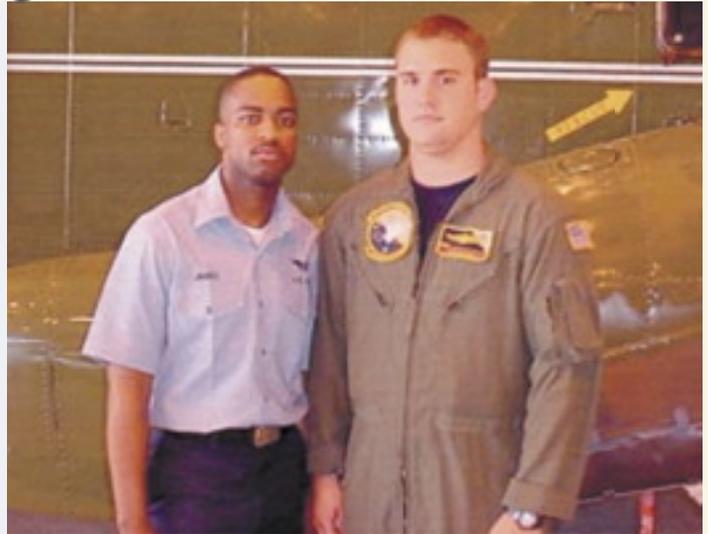
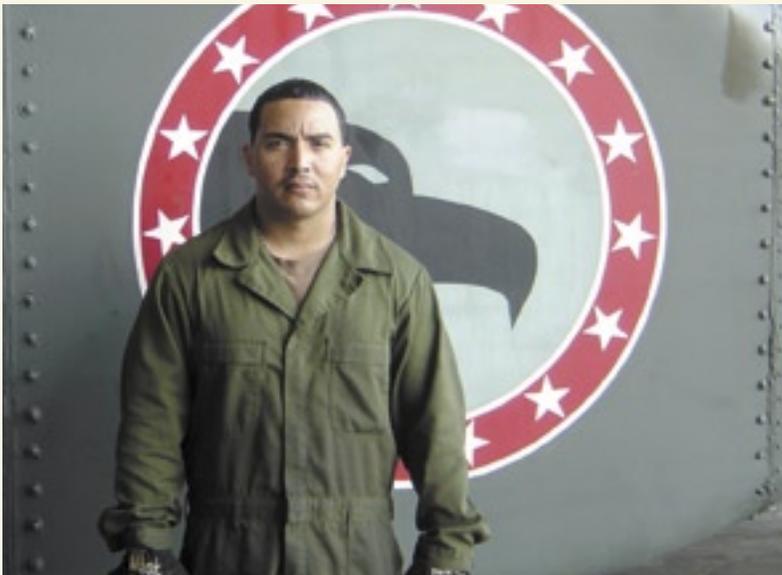
AD3 Jacoby and AD2 Jarvis HSC-2

Petty Officer Jacoby was flying as the crew chief on Redhawk 732. While in straight and level flight, he heard a strange noise coming from the transmission area. He immediately investigated the noise and called for a check of the gauges. No one else heard the noise, and no other indications were noted. After 732 safely landed, Petty Officer Jacoby inspected the transmission and tail drive-shaft areas, discussed what he had heard with maintenance control, and convinced them to investigate further.

With little information to help, Petty Officer Jarvis meticulously inspected the transmission and tail drive-shaft areas. He found the transmission oil cooler had rotated, the belts were loose, and an oil line was rubbing on the airframe.

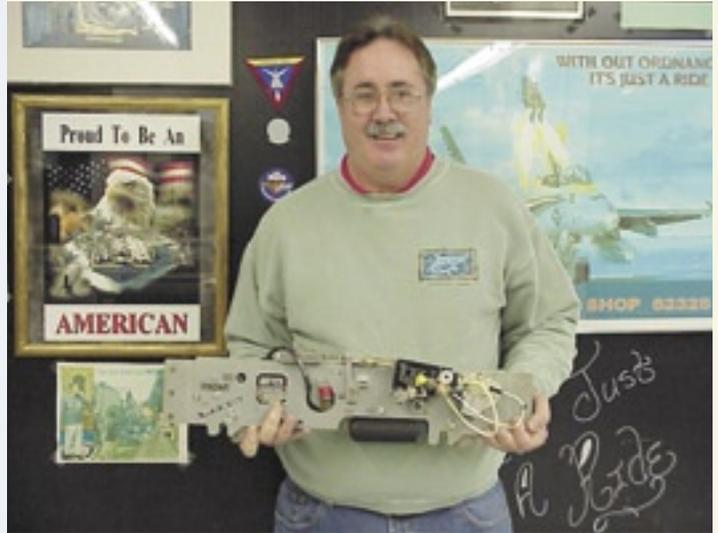
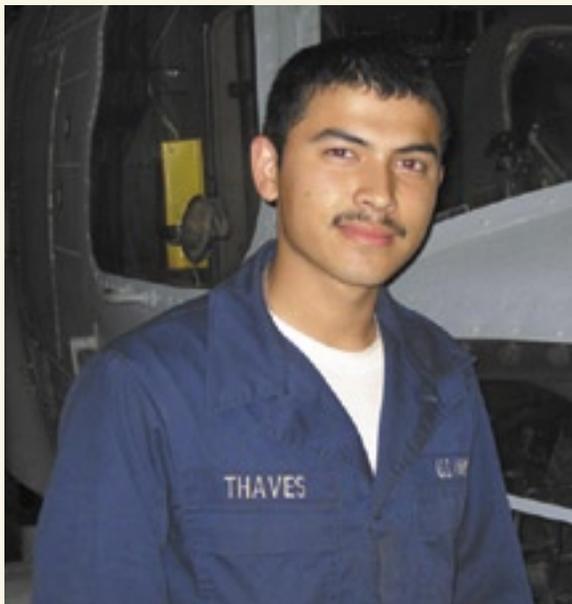
**Ordnance Mechanic-Artisan John Collandra
Naval Air Depot, Jacksonville**

While inspecting and overhauling a BRU-14A, Mr. Collandra had to replace an auxiliary-unlock-switch assembly. After removing the replacement part from the shipping package, he did a pre-installation inspection of the component, even though that step was not part of written procedures. Looking inside the threaded M55 CAD hole for the unlock spring, he didn't see it.

The part was disassembled, uncovering a factory defect. Because the assembly uses a shear wire, no mechanical check of the unlock assembly is done once the BRU is assembled. Had this discrepancy gone unnoticed, the spring position would have locked the store to the rack, preventing release of a loaded weapon. His actions led to Aviation Armament Bulletin (AAB) No. 709.

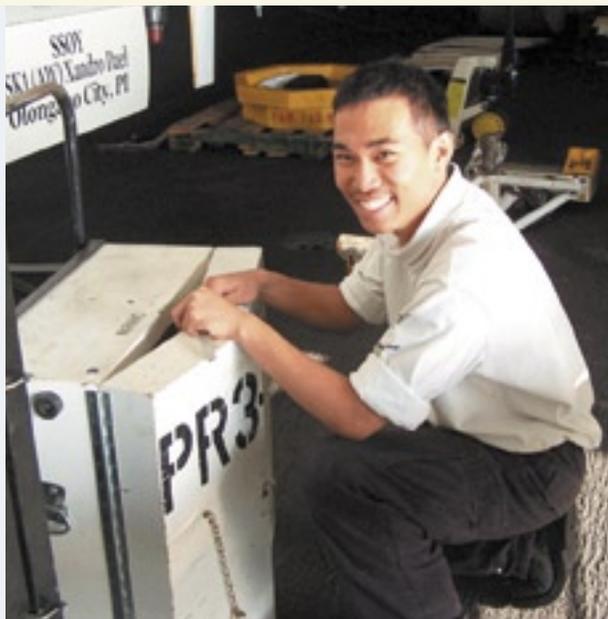
**AD3 Mark Fronda
VAW-113**

Petty Officer Fronda found a crack on the propeller of Black Eagle 600 that, if left undetected, could have led to the loss of the aircraft.

He discovered the problem while doing a corrosion inspection on the No. 3 blade of the port propeller assembly. He first noticed what appeared to be a hairline crack in the fiberglass on the camber-side inspection window. But a closer look revealed that the crack ran beyond the length of the front propeller inspection window and along the spar line.

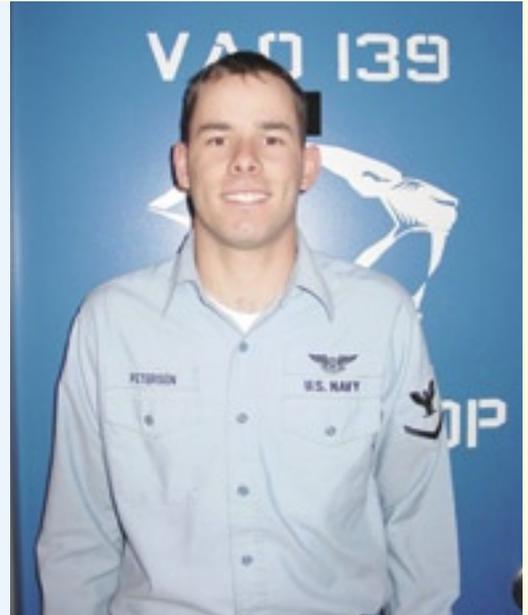
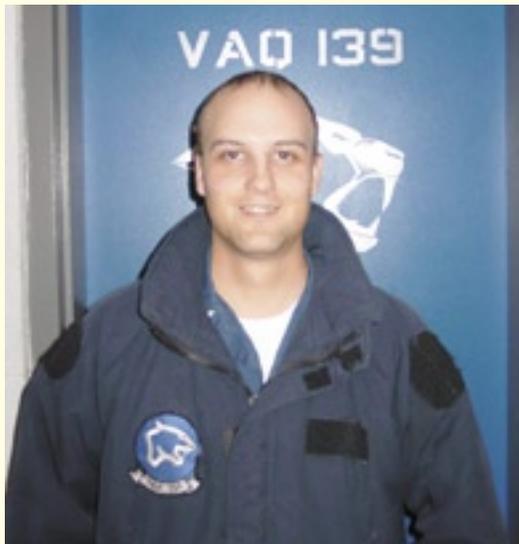
**AME3 Chad Petersen
VAQ-139**

During a pre-launch inspection of aircraft 501, Petty Officer Petersen noticed an anomaly with the main landing-gear doors. Despite being well beyond his normal area of responsibility and training, he discovered a broken aft lock-attachment lug on the port, forward main-gear door.

Had this discrepancy gone undiscovered, it could have caused catastrophic failure of aircraft 501's landing gear.

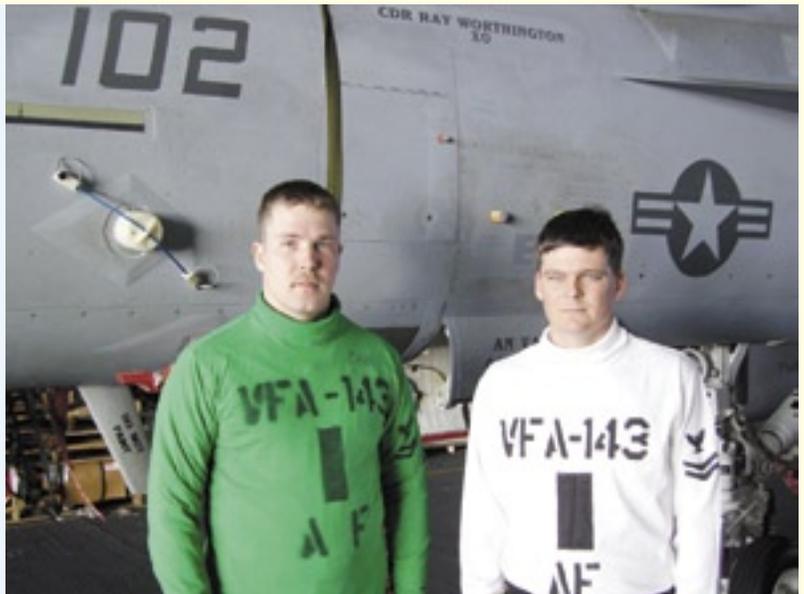
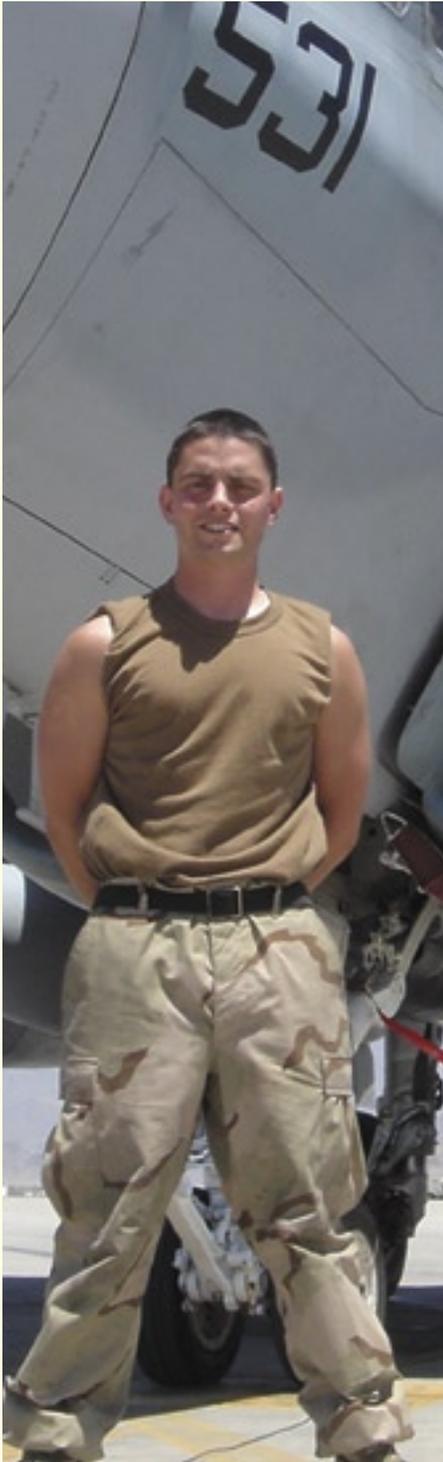
**AE2(AW) Larry Lowry & AM2(AW) Jamie Cain
VFA-143**

Petty Officers Lowery and Cain were troubleshooting a rudder-pedal binding discrepancy on Dog 105. During the inspection of the cockpit, Petty Officer Lowery saw something sticking out of the bulkhead in the port rudder-pedal area.

As he moved the pedals, he immediately noticed that there was only about one-eighth-inch of movement. Upon further inspection, they noticed that an avionics cooling-fan filter caused the binding situation on the port rudder pedal. Petty Officer Cain also found one of the mounting tabs on the filter housing was bent because of excessive contact with the rudder pedal, causing extensive wear marks.
