Under PRESSURE

By AME3 Daniel Kennedy, VFA-86

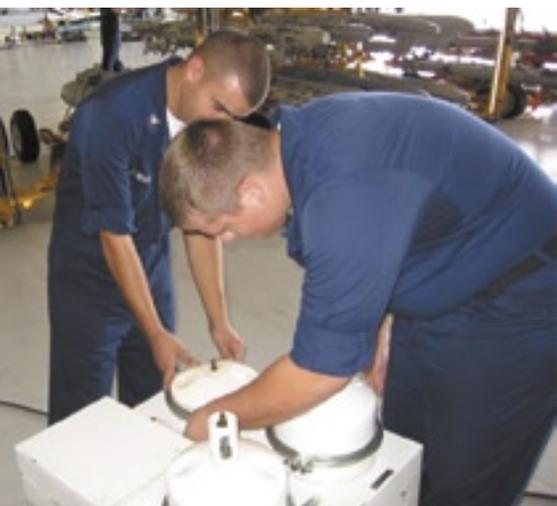
Lid with stenciling added by VFA-86 to warn personnel before servicing is performed.

to undo the back bolt, everything went wrong. We had missed one of the first steps in the technical manual that says, “Open LCFU make-up reservoir bleed valve to release any built up pressure.”

A thunderous boom resounded in the hangar bay as the lid flew off and hit AME3 Tillman in the face. I immediately turned to assess the situation and saw AME3 Tillman cupping his face in his hands, with torrents of bright-red blood gushing from behind his hands. The blood was collecting at his feet. I immediately ran to the shop for clean, lint-free rags to stop the bleeding. While in the shop, I informed the LPO and day-check supervisor that AME3 Tillman was hurt and needed medical attention.

In the future, I will heed the hazards presented during pass downs, safety training, and within hazreps. They are published so personnel can apply the ORM process. We missed a step because controls were implemented in the form of checklists, and we failed to follow them. It does no good to have a publication if it isn't the correct one for the job, if steps are skipped, or if the manual is in a work center while you perform maintenance tasks. We also have a recommendation for the fleet: Stencil the lid of the LCFU with a red-letter warning to release the pressure before loosening the lid. We believe some external marking or warning might help prevent future incidents with the LCFU.
