The Safety Corner

From the Marine Corps Center for Lessons Learned

October 26, 2007

Tire Safety

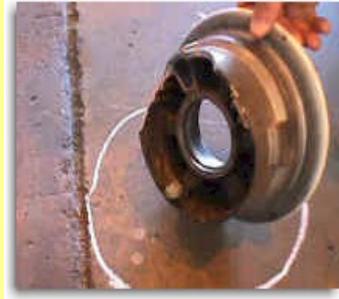
A Real Story About a Wheel Job by Capt. Scott Clifton, USMC

It was a small workspace, but large enough to use an illegal procedure to change a set of bearings on the wheels. Our mech used a hammer to hit the socket extension against the old bearings. The results were quite spectacular when the wheel's split rim cracked, and the tire exploded. Two amazing events occurred: Our mech survived massive head trauma, and the tire could have won a high-jump contest.

The tire departed the workbench area, flew over the top of the cage, and landed approximately 30 feet away. Pieces of the split rim and hammer, not to be outdone by the tire, also were blown outside--remember, the cage is 10 feet high. The socket extension was the overall winner in the distance-flown contest. It flew over another cage (one of equal size and adjacent to the GHW cage) and finally landed on a set of shelves 33 feet away from the mishap site.

The hammer and one-half of the split rim cleared the fence and landed 10 feet from a workbench. What happened to the Marine? Well, he didn't travel too far from the workbench, not as far as the tire or the socket extension. One of the tools hit our mech between the eyes, causing a closed-skull fracture and severe bleeding. He remained conscious and staggered out of the cage, where the first Marines on the scene made him lie down.

How could this have happened to a trained 6072, ground-support-equipment mechanic? First, he was working on the tire while it was still inflated. The force of the explosion showed that the tire was inflated well above its storage inflation pressure of 15 psi (a requirement in a local Marine Aviation Logistics Squadron guideline). The squadron suspects the tire pressure was closer to its normal operating range of 40 to 60 psi. Secondly, he was not using the right tools or safety gear for the job. A socket extension and a hammer are not the correct tools to change wheel bearings.
