FOUL-DECK LANDING

By Lt. Nicholas Wyzewski

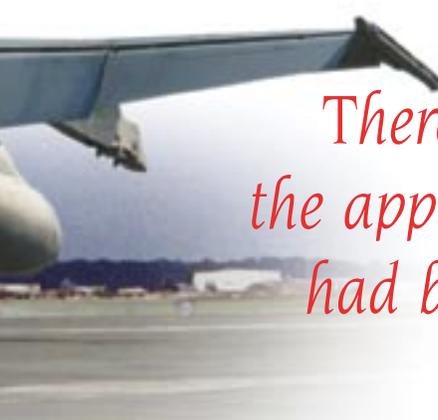
There was tension in the air as they said the approach-end, arresting-gear cable on 32R had been out-of-battery when I landed.
