## ***Moment of Inattention***

By AD3 Claudia Martinez

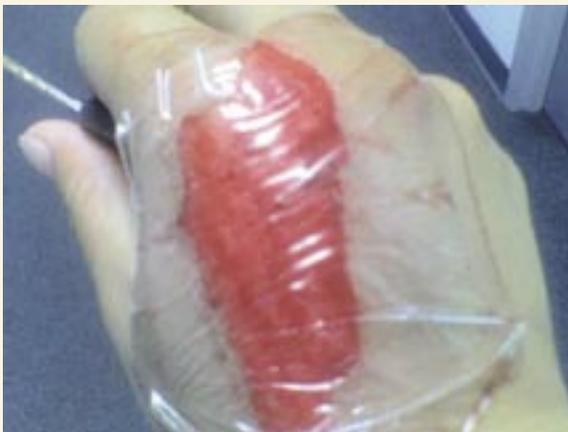
The power transmission shaft (PTS), which turns at 30,000 rpm, was roughly 5 to 6 inches from the vent tube. I knew the PTS was there but decided that I had enough room to do my job. However, I misjudged the distance, and the cheesecloth I was using to wipe down the vent tube got caught in the PTS. My right hand vio-

lently was yanked up and pulled toward the spinning PTS.

As the cheesecloth was grabbed, it shredded, throwing white cloth everywhere. As soon as the plane captain noticed that something was wrong, he gave the

My hand is healing and everything looks good except for the scar that I always will have. It will remind me of that day. From this experience I learned that we must be more aware of our surroundings and that no matter how routine or easy a job may appear to be, attention to detail is always a part of the process. I never will forget that the jobs we do everyday have the potential to injure or kill in a split second. ✦
