PON-6 Confusion

By Lt. Darrin Mullins

Canopy Capers

By Lt. Justin Hendrickson

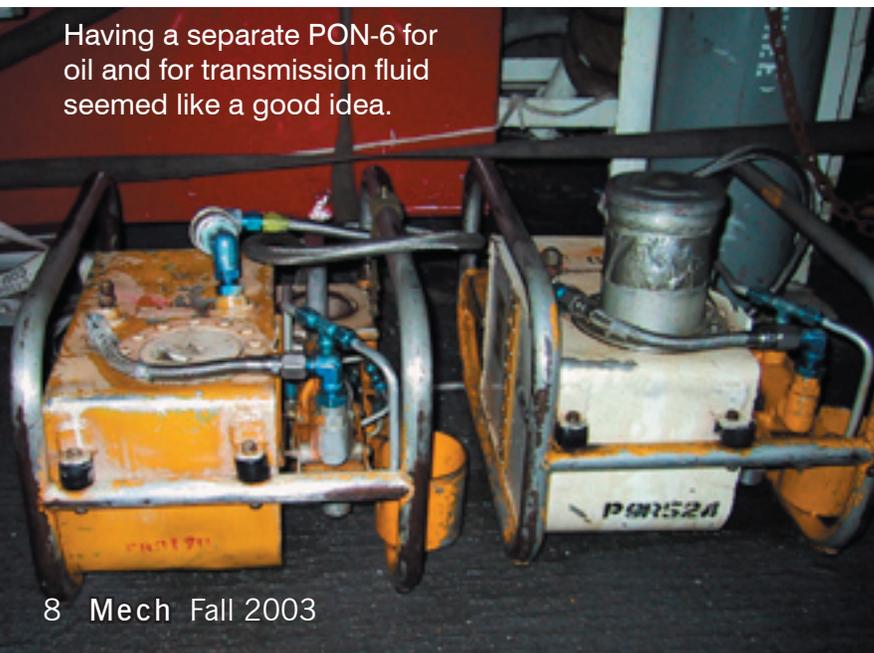
The problem occurred at sea when the ship had set darkened ship. The yellow-light configuration in the hangar during darkened ship led to an aircraft engine being serviced with DOD-L-85734 transmission fluid! It was an honest mistake, caused by a lack of attention to detail and a color scheme that did not take into account different shipboard lighting schemes.

Our junior night-check mech needed to service the No. 1 engine. He went to the PON-6 storage area and grabbed the one that looked white under the yellow hangar lighting. Unfortunately, he grabbed the wrong one. He serviced an engine with transmission fluid and downed our aircraft, which had been tasked to fly a mission six hours later.

Having a separate PON-6 for oil and for transmission fluid seemed like a good idea.

We woke up our senior AD, and he supervised the drain and flush and did training on engine servicing with the proper PON-6. I am sure this servicing error never will happen again on my detachment, but we came close to a possible mishap. Change isn't bad, but it may have serious consequences in different environments. We need to be prepared to adjust. A simple two-inch tape strip placed horizontally along the PON-6 labeled “NOT FOR ENGINE SERVICING” would have helped identify the proper PON-6 servicing unit. We need to hedge our bets to make sure we are giving our maintainers the greatest chance for success. Our safety chain caught this error—this time—and prevented a possible catastrophic event.

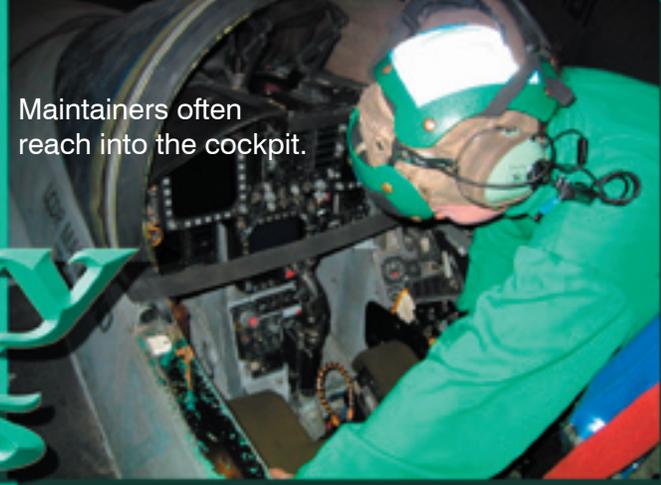
The airframer was working around the starboard side of the cockpit area with her body halfway in the cockpit. The canopy suddenly came down on her lower back, pinning and subjecting her to excruciating pain. A plane captain heard her screams and quickly raised the canopy off the airframer before any permanent damage was done. She was lucky to escape the incident with only a sore back and a few days of light duty.

a little housekeeping, another maintainer got "the squeeze" put on him. The victim was an AME who just had finished installing a kick panel. The canopy came down on him, and, this time, the person lowering the canopy did not hear the AME's screams.

Maintainers often reach into the cockpit.

Rushing the job is the common theme in these two near-disasters. Closing a canopy is a simple job, but steps still must be followed. The simple act of clearing both canopy rails of personnel and equipment before moving the switch can prevent a grave injury. Maintainers can take personal and material safety into their own hands: Disconnect the cannon plug for canopy power or pull the battery circuit breaker before doing maintenance around the cockpit area.

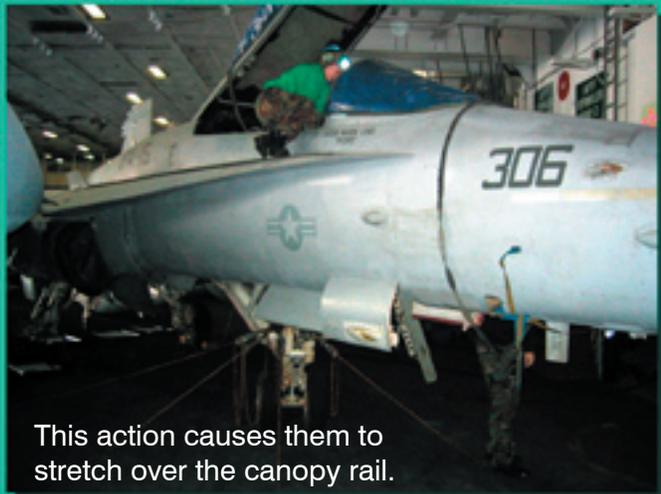
This action causes them to stretch over the canopy rail.

People are not the only items endangered. By not taking time to check the canopy railing, you can damage the ejection-seat SEAWARS Koch fittings and the canopies. This careless attitude wastes maintenance time and money.
