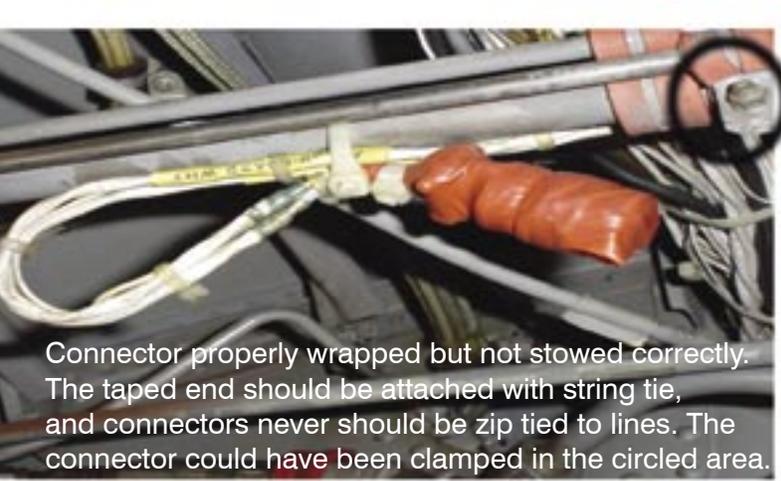
Connector properly wrapped but not stowed correctly. The taped end should be attached with string tie, and connectors never should be zip tied to lines. The connector could have been clamped in the circled area.
