A New Look at Wiring Problems

By Ed Taylor

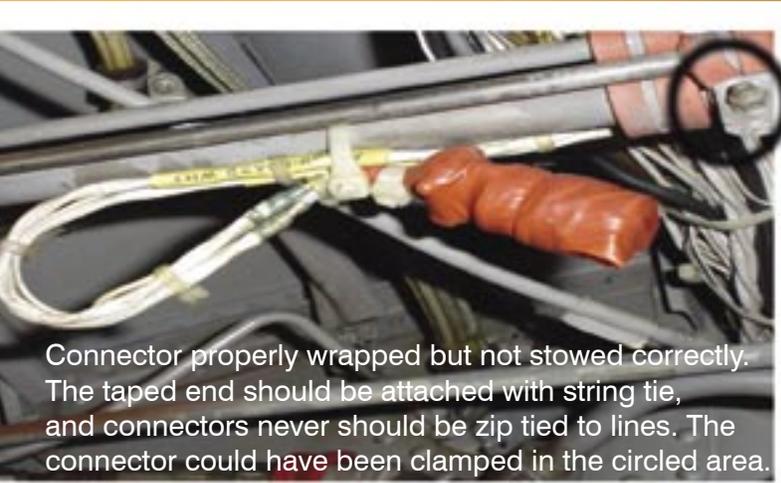
Connector properly wrapped but not stowed correctly. The taped end should be attached with string tie, and connectors never should be zip tied to lines. The connector could have been clamped in the circled area.

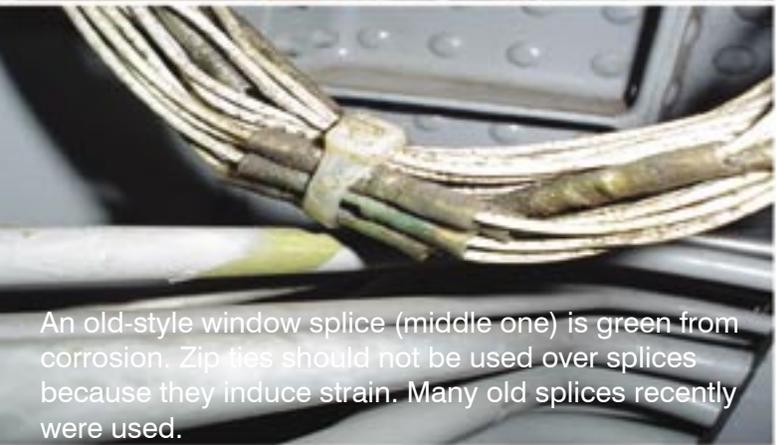
An old-style window splice (middle one) is green from corrosion. Zip ties should not be used over splices because they induce strain. Many old splices recently were used.

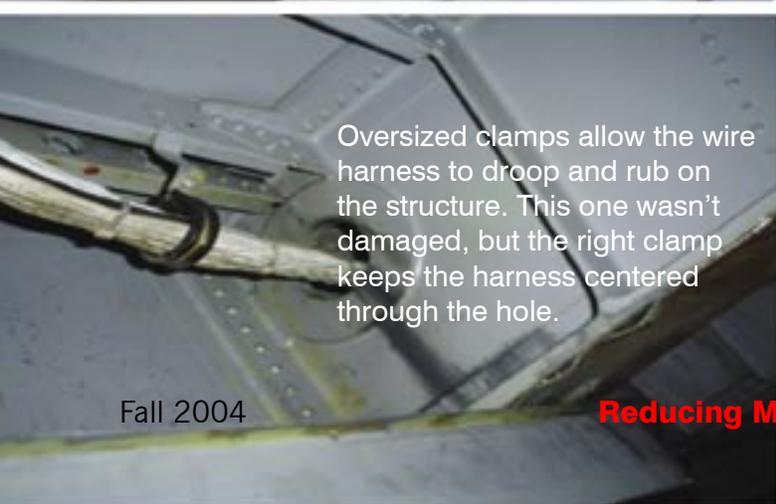
Oversized clamps allow the wire harness to droop and rub on the structure. This one wasn't damaged, but the right clamp keeps the harness centered through the hole.
