Sailors and Marines reducing mishaps

BRAVO Zulu

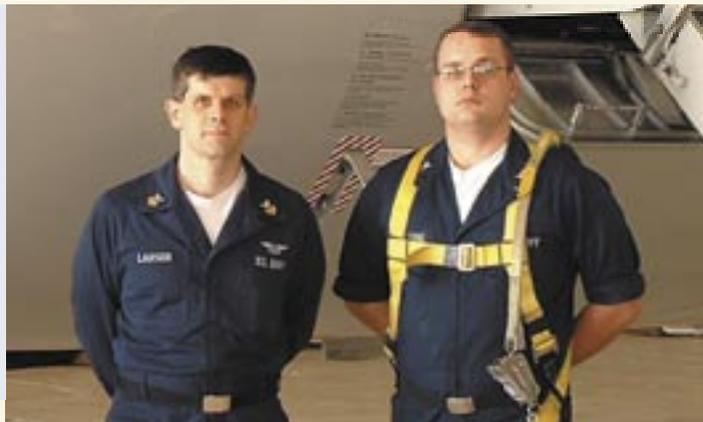
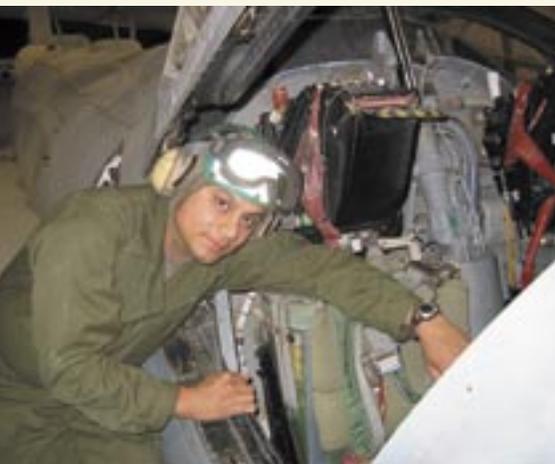
AT1(AW) Larsen and AM2 Whetstone VR-52

During a routine inspection on a squadron aircraft, AT1(AW) Larsen and AM2 Whetstone went beyond the 18-inch rule and inspected the entire open area in the tail section. They noticed a cable-guard pin was worn on the elevator-cable sector.

This area is not on an inspection cycle, and the worn pin could have separated and led to jammed elevator flight controls. Their decision to look beyond the immediate area being inspected prevented a potential flight-control malfunction and possible loss of aircraft and aircrew.

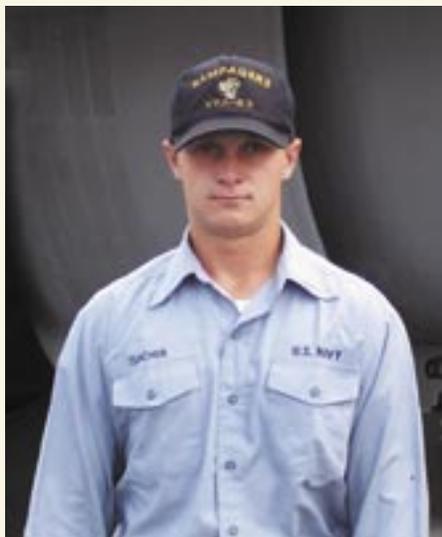
AMEAN Gary A. Baguio, Jr. VAQ-133

During a daily inspection on aircraft 532, AMEAN Baguio discovered the bolt-nut combination attaching the drogue shackle to the scissor shackle assembly on ECMO-1 seat drogue parachute was installed improperly. Had this gone unnoticed, it could have led to a malfunction of the ejection seat's drogue parachute preventing activation in an emergency situation.

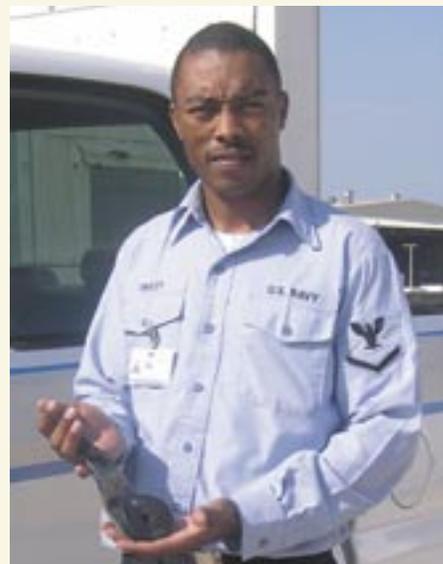
AMAN Ishchuk VFA-83

While picking up cleaning gear following a 14-day special inspection, AMAN Ishchuk noticed the forward attaching nut on the starboard-main landing-gear planing-link assembly was in an abnormal position. Further investigation revealed the forward planing-link bolt had been sheared.

If gone unnoticed, this problem could have resulted in catastrophic failure of the starboard landing gear, serious damage to aircraft, and possible loss of aircrew.

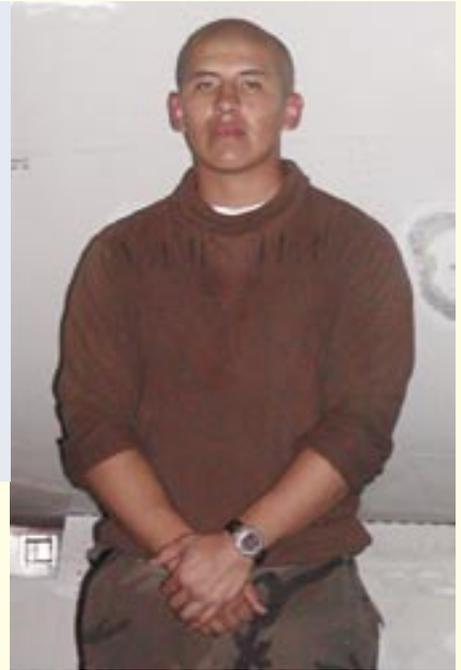
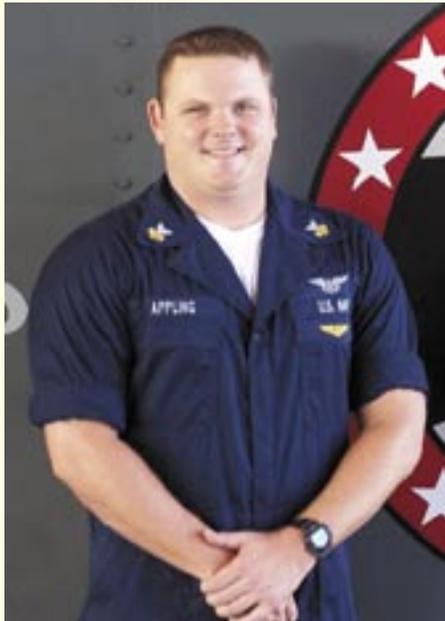
AN Adalberto Ramirez
VAW-113

AN Ramirez discovered a sheared bolt on the port main landing-gear strut while performing his plane captain preflight walk-around inspection. Further inspection revealed that the drag brace hard-point on the port, main landing-gear strut had departed during its last flight. AN Ramirez immediately notified his flight deck coordinator and downed the aircraft.

His decision prompted the launch crew to prepare another aircraft, allowing the squadron to meet its scheduled sortie. This particular discrepancy was almost undetectable in that it escaped the attention of the assigned qualified plane captain, airframes collateral duty inspector and Black Eagle troubleshooters. Had this discrepancy gone undetected, the potential existed for a catastrophic failure of the landing gear during take-off or landing. AN Ramirez's keen attention to detail saved the Navy potential loss of an aircraft, as well as the lives of the aircrew and shipmates on the flight deck.

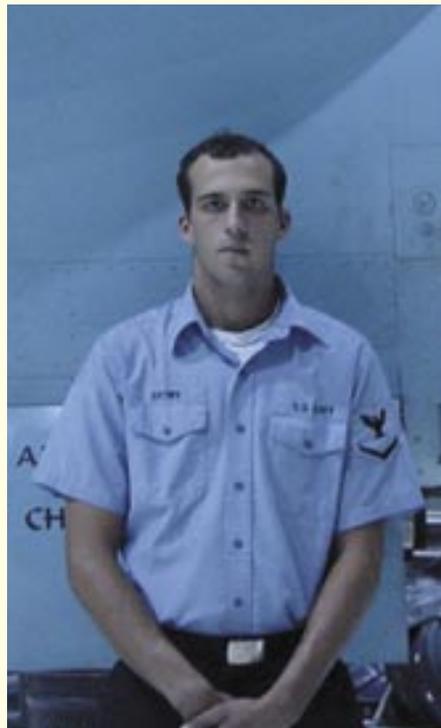
AM1 Christopher C. Appling
HM-15

During a routine inspection of an MH-53E attached to HM-15 Det 2 in Bahrain, AM1 Appling noted that "Hurricane 10" had an engine-exhaust nozzle assembly installed on the No. 2 motor but "Hurricane 11" did not. He researched the correct configuration for the engine-exhaust nozzle on the No. 2 motor.

AM1 Appling determined that the nozzle assembly is required only on the No.1 and No. 3 engines, not on the No. 2 engine. In addition to "Hurricane 10," other home-guard aircraft had the same discrepancy, and maintainers corrected it immediately. The exhaust-nozzle assembly could affect proper cooling of the No. 2 engine compartment, which could lead to a possible No. 2 engine compartment fire.

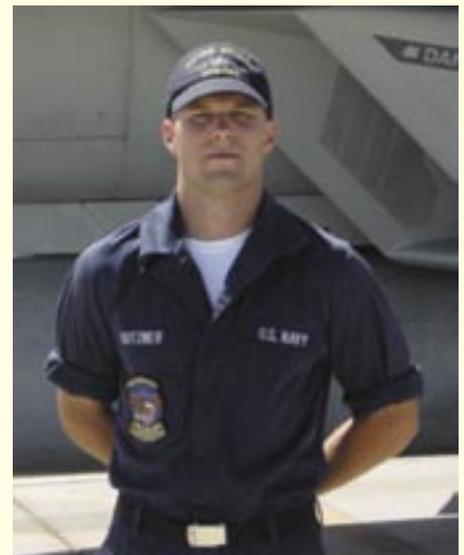
PO3 Brown
VFC-12

While performing a daily and turnaround inspection on a squadron aircraft, Petty Officer Brown discovered a 1-inch long hairline crack in the port main-landing-gear uplock-support bracket. The crack was so slight that it could have easily been dismissed as a scratch in the paint. Had the crack gone undetected, the bracket most likely would have cracked through or broken off, possibly jamming the uplock mechanism and preventing gear extension.

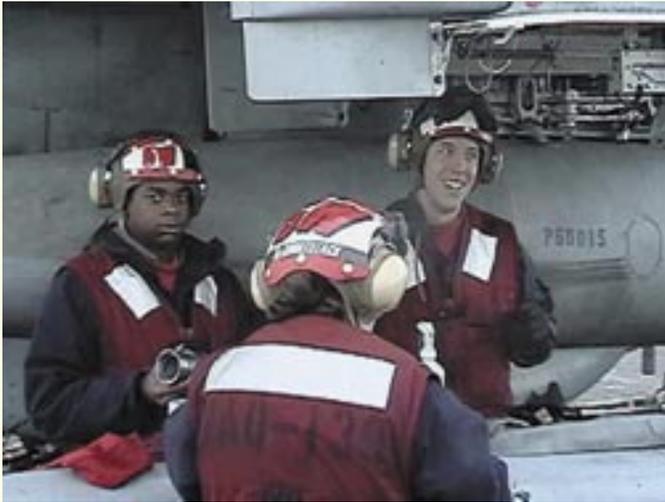
AN Gutzmer
VFA-122

During the final preflight inspection on squadron aircraft AN Gutzmer discovered a missing cotter pin and loose trailing edge flap-shroud bolt on the outboard aileron. He notified airframes personnel, who fixed the discrepancy.

AN Gutzmer also was doing a preflight inspection on another aircraft when the master brake servo-cable caught his attention. Closer review showed the cable was rubbing and misrouted.

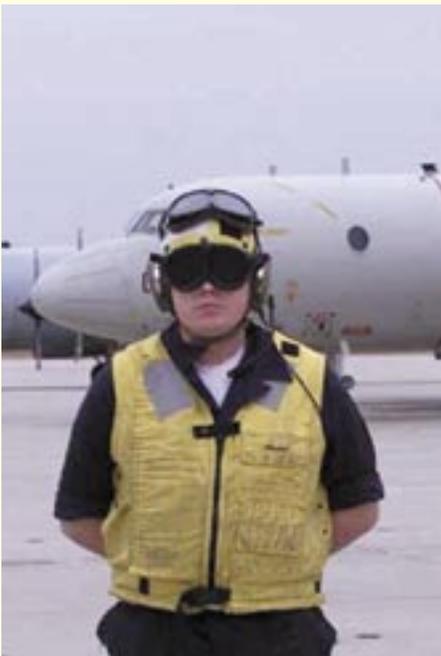
**AO2 (AW) John Vincent and AN Ronald Spears
VAQ-139**

AO2 Vincent and AN Spears were assisting a sister squadron's beach detachment launch a newly accepted aircraft when they discovered two station pylons were extremely loose and unsafe for flight. They immediately notified the squadron's detachment maintenance CPO, who grounded the aircraft possibly preventing the catastrophic failure of both store stations and a Class-A mishap.

Not finished with the task at hand, AO2 Vincent and AN Spears organized a working party and expeditiously unloaded the pod and drop tank, properly torqued both pylons to specifications, and launched the aircraft to Navy Fallon less than two hours after its scheduled launch.
