Wing-Tip Crunch Teaches Communication Lesson

By AD1 Zamir Alvarez and AM1 Philip Carter

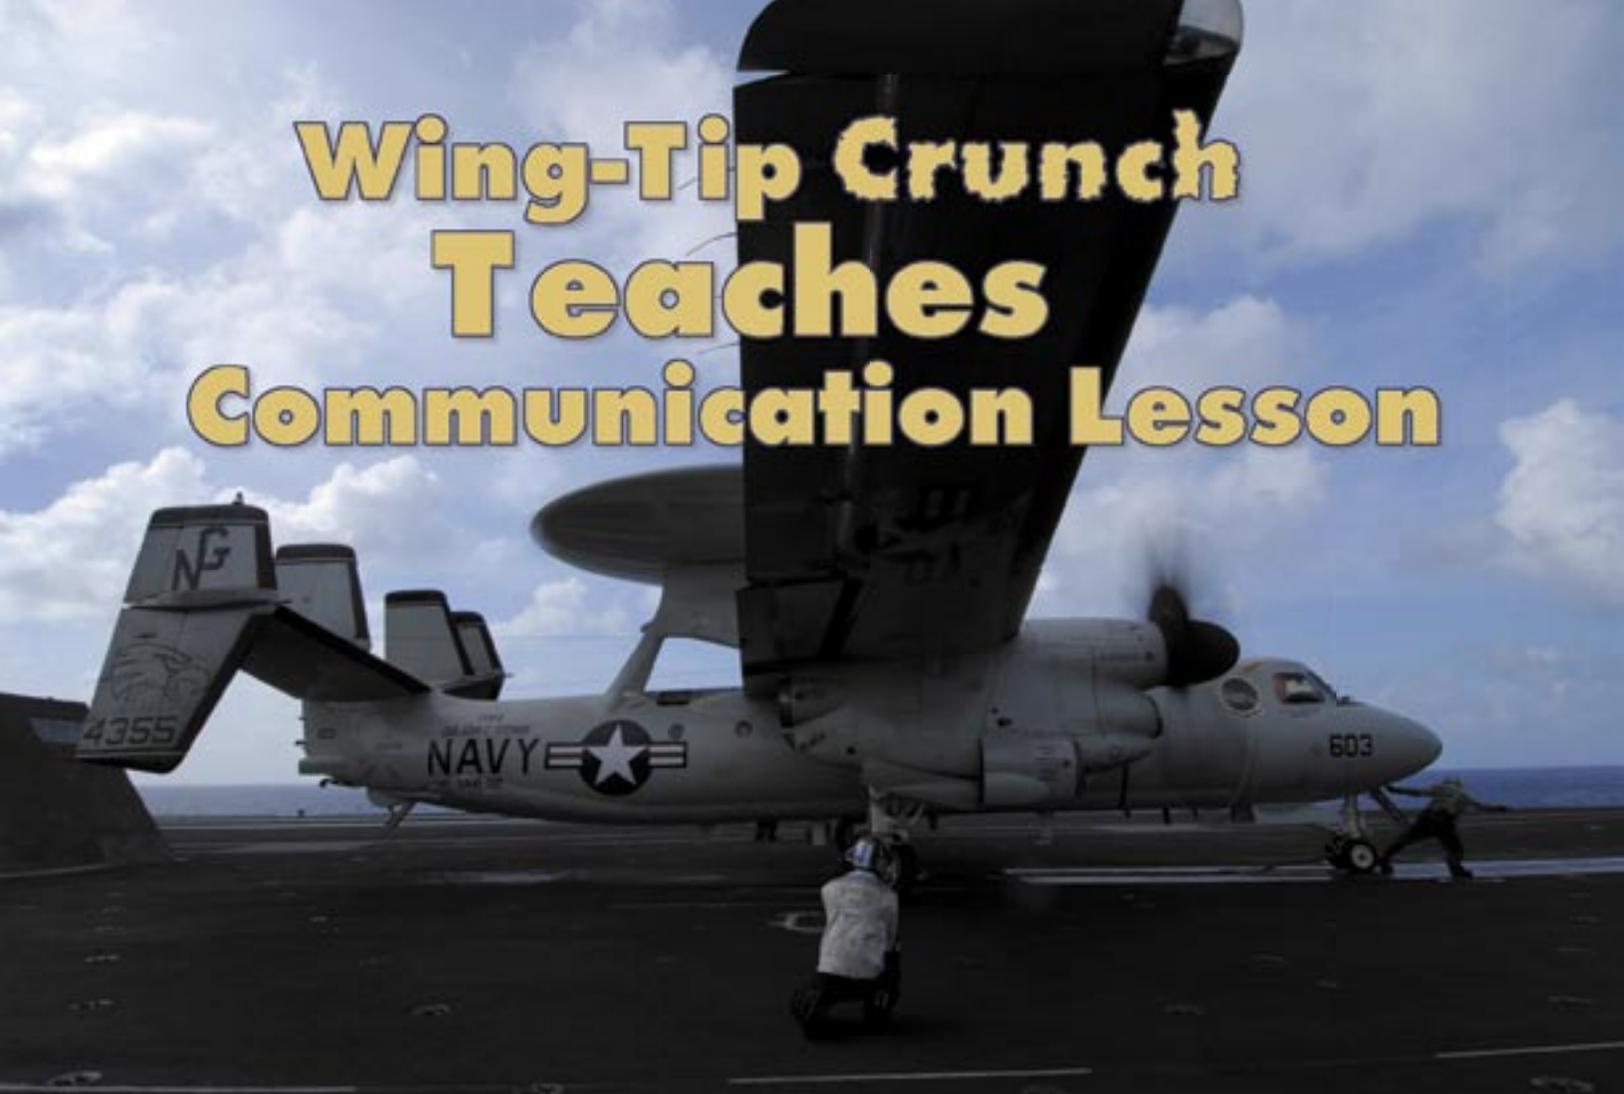
This is where our communication failed. After seeing my signal, the yellowshirt relayed the same signal to the pilots in 601. The pilots saw that signal and, unaware that there was a dangerous situation developing near their left wing, they thought the signal was intended to stop the aircraft, instead of the wing-spread. The pilots continued to hold the brakes, but they did not reverse the wings.

Unbeknownst to the pilots, the port wing clipped the P-25 and lifted the fire truck off the deck a few inches, destroying the outer wingtip. Needless to say, this problem downed the aircraft resulting in a failed launch.

Complacency, error in executing proper flight-deck procedures, and a break down in communication resulted in the damage of an aircraft. Fortunately no one was hurt, but simple communication between airwing personnel and carrier flight-deck personnel could have prevented this crunch from ever happening. 🌸
