Good To Be a Curious George

By AT3 Michael Jacildo

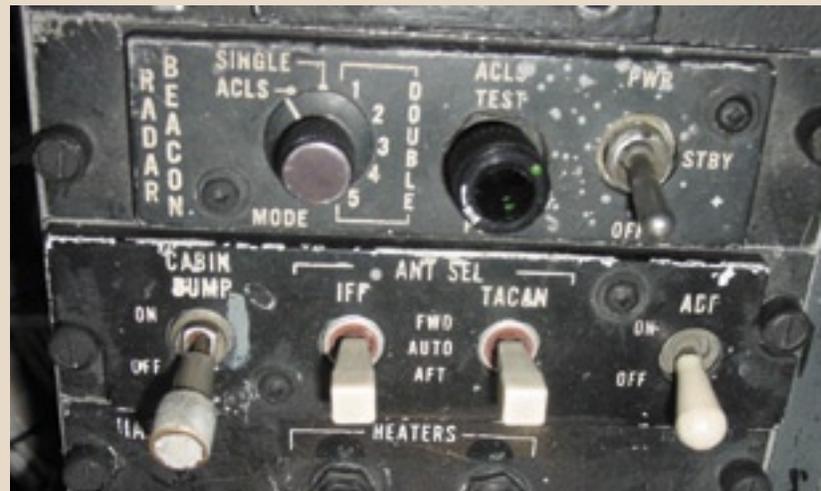
A closer investigation revealed that this panel had the TACAN and IFF antenna-select switches, but it also had the cabin dump switch, making it a downing discrepancy when the box was pulled out of an aircraft—this one had been taken out of aircraft 502. Maintenance control changed the MAF to a “down” discrepancy, and the jet did not go flying. Training was held with the avionics, egress and maintenance-control work centers.

Miscommunication and lack of attention to detail resulted in the part being ordered improperly with a PROJ PRI (project-priority code) of AK7, indicating the aircraft was partial mission capable. It should have been ordered as AK0—not-mission capable. That simple coding would have made the gripe a “downer,” and it would have been flagged in the ADB for aircrew and maintainers to see.

Knowing whether a removed panel is an up or down gripe is critical to aircraft safety.

We were a bit lucky to catch this problem before it was too late. Lack of communication, inattention to detail, and complacency are common factors in most mishaps. We had several “holes in the cheese” lined up but found the problem in time. It really is necessary to train maintainers correctly and do by-the-book maintenance to prevent these types of situations.
