On the Cuff of Failure

By AE1 Cassandra Daniel

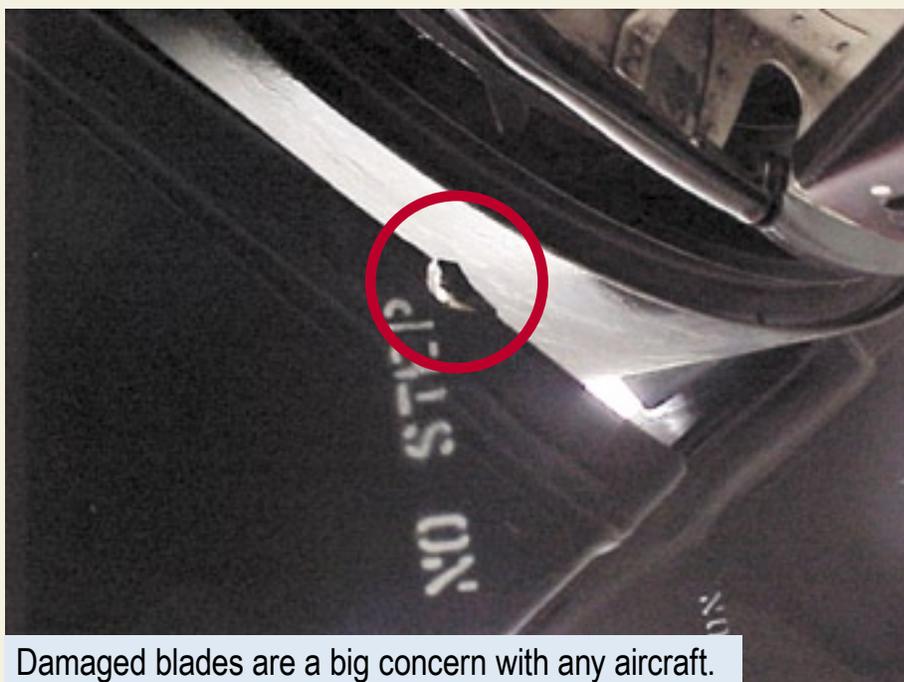
Damaged blades are a big concern with any aircraft.

Extensive damage occurred to the blade cuff on the No. 1 propeller and lesser damage to the No. 2 propeller. The damage took place when the propeller

blades were rotated and came into contact with afterbody bolts left in the wagon-wheel structure of both engines after completing AYB-1055.

The maintenance instruction manual does not state that the afterbody bolts should be removed immediately, but this critical step clearly should have been taken after completing the inspection. The bolts then should have been marked and stored for accountability. As maintenance professionals, we must have total situational awareness, especially at the supervisory level, about concurrent tasks that involve multiple work centers. Maintainers assigned to complete any maintenance action must do an operational risk management (ORM) assessment before beginning any job.

All maintenance personnel received training on the proper steps to incorporate AYB-1055 and

the importance of not leaving afterbody bolts in the wagon wheels after removing the afterbody. Our entire department also reexamined the most important character trait when it comes to maintenance safety and the operation of aircraft: integrity.

QA also submitted a technical-publications deficiency report (TPDR) on NA-01-75PAA-2-4.6. They requested a caution be included to highlight the damage that can occur if the afterbody bolts are left in without the afterbodies being installed. ✈️

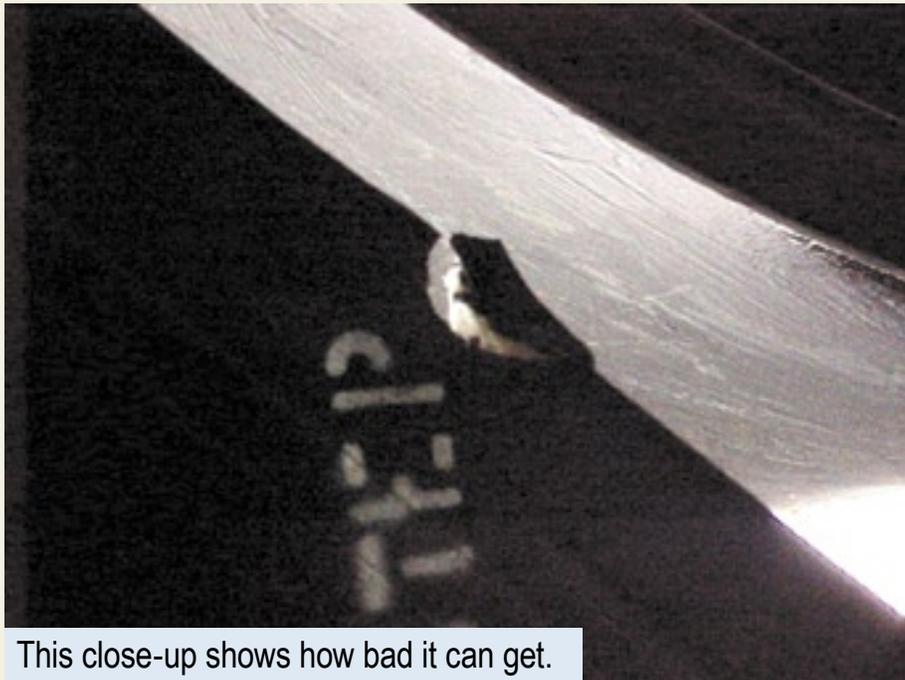
This close-up shows how bad it can get.

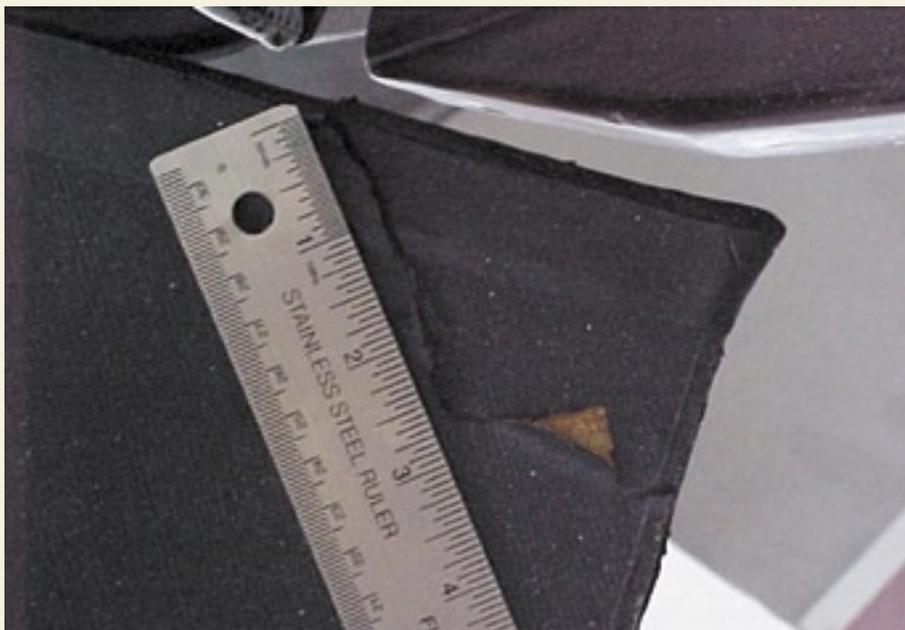
Several people could be at fault, but no one knows who's guilty.
