Never Thought I'd Need a Cranial To Push a Broom

By AOAN David Maryatt, VFA-136

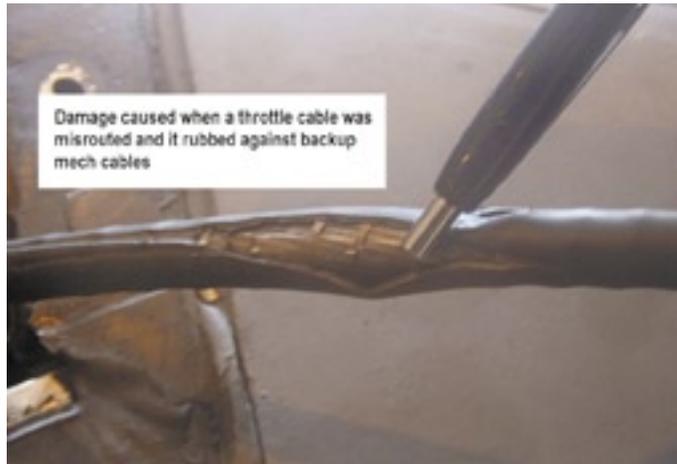
Fortunately, the Boeing representative was able to provide the technical drawings that proved the cable was routed incorrectly. The cable was repaired and re-routed correctly—underneath the horizontal stab cutout, vice through it.

As part of the original maintenance gram, all AD1 Lindsay had to do was inspect the back-up mechanical flight-control cables in panels 41 R/L. He expanded that inspection into all the other open panels and associated cables, identifying a potentially fatal discrepancy. It was reported via the NAMDRP, thereby notifying other squadrons of this

Our quality-assurance division completed a naval aviation maintenance discrepancy report (NAMDRP) on this discovery. As a result, efforts are underway to revise the F18C-D Power Plant and Related Systems Maintenance Publication (A1-F18AC-270-310) to add an illustration showing the correct routing of the middle throttle-cable assembly in panel 34 right.
