Sailors and Marines Preventing Mishaps

BRAVO Zulu

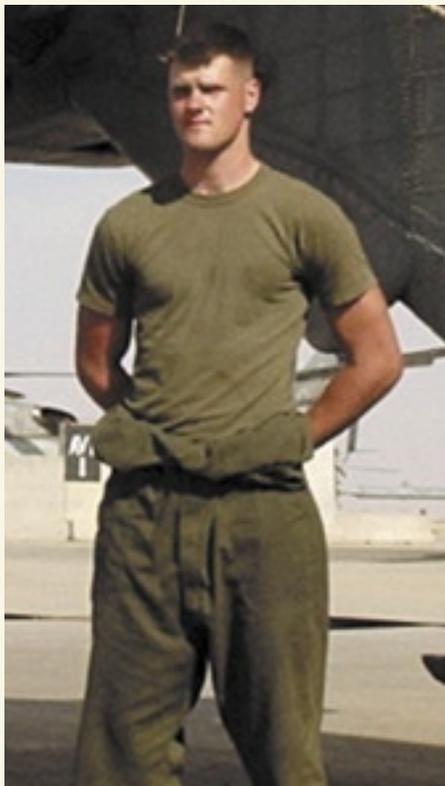
Cpl. Christopher Ruark
HMH-361

While doing a phase inspection of the horizontal stabilizer on a CH-53E helicopter, Cpl. Ruark discovered numerous loose fasteners on the primary structure of the stabilizer, near the mounting point for the stabilizer strut. A closer look showed two hi-loc fasteners in the fitting assembly also were loose. These fittings are essential for attaching the horizontal stabilizer to the fuselage of the aircraft.

Corporal Ruark is a knowledgeable and diligent inspector, and he found a serious problem that could have been overlooked. These items weren't part of a normal phase inspection. The stabilizer was removed and repaired.

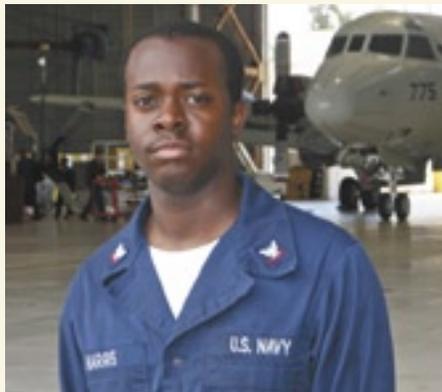
AM3 Christopher Harris
VP-4

Petty Officer Harris and other members of airframes work center were sent to troubleshoot a binding rudder-boost-handle discrepancy on aircraft 163291. While troubleshooting, Harris noticed a "No Hydraulic" placard had fallen inside the power-levers and elevator flight-control-system console. This aluminum placard measured 4 inches by 6 inches. If it had not been discovered, it could have migrated into the elevator flight controls or power-lever cables, causing a total loss of the flight-control system.

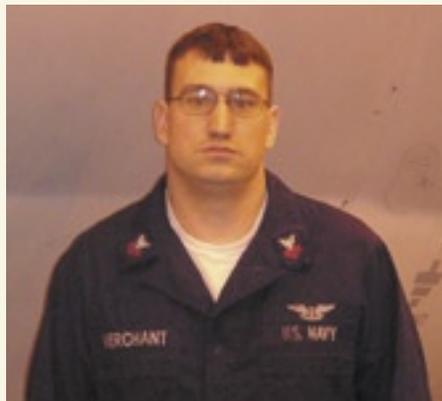
AD1(AW) Wesley Merchant
VR-62

While checking the torque on a C-130T propeller nut, Petty Officer Mer-

chant noticed the amount of effort to set the required torque was much less than previous times. He got another torque wrench and verified the torque setting was lower, so he immediately notified maintenance control of the situation.

Petty Officer Merchant's attention to detail resulted in the discovery of a torque wrench that the calibration lab found was 17 percent low. Not knowing how many propellers had been installed with this wrench since the last known calibration date, the squadron downed their aircraft until all 16 propellers had been retorqued.

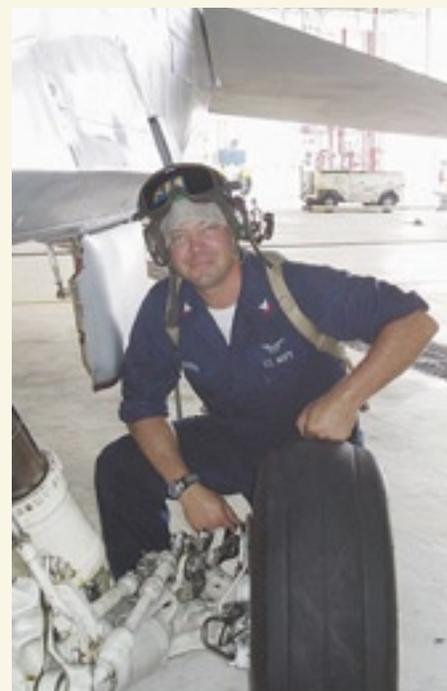
AT2(AW) Joshua Brown
VFA-15

Aircraft 302 was taxiing toward the catapult for final checks when Petty Officer Brown noticed the starboard main-landing-gear wheel wobbling. He immediately gave the signal to the catapult officer to suspend the launch and told the flight-deck chief.

A closer inspection revealed the brace-assembly bearing on the upper side was broken in four places, allowing the starboard MLG to have excessive play during taxi.

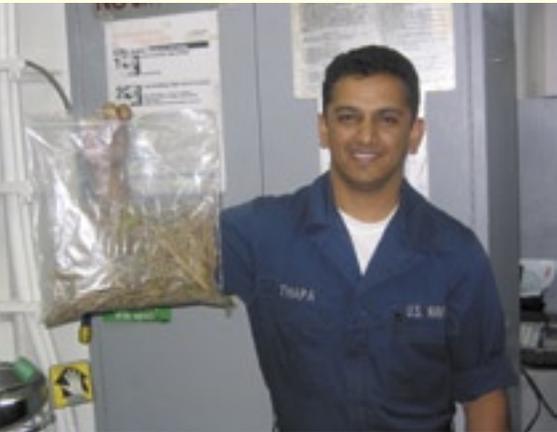
ADAN Ramesh Thapa
HSL-44 Det. 1

While cleaning and treating corrosion on a bolt for the tail rotor servo on Magnum 456, Airman Thapa found a bird's nest. It was difficult to see and an extraordinary find. The nest was in the aft part of the tail-rotor gearbox, inside the tail-rotor gearbox cowling. His attention to detail and extra effort highlighted a serious problem in a critical part of the helicopter, which could have led to a mishap.

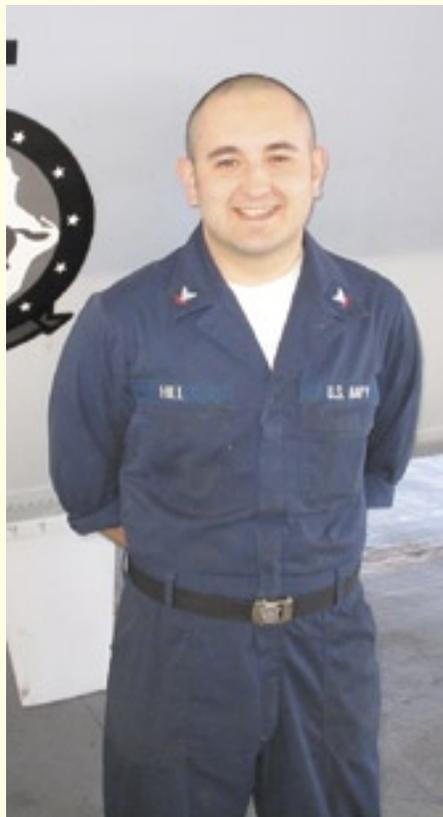
AM3 Wayne Hill
VR-55

Petty Officer Hill was doing a daily inspection on a C-130T during night flight-line operations and discovered two 8-inch cracks on the skin section of the starboard upper wing. The cracks were barely discernible and were a very good find. He immediately notified maintenance control and QA to investigate the damage.

Petty Officer Hill's attention to detail prevented catastrophic failure of the wing section.

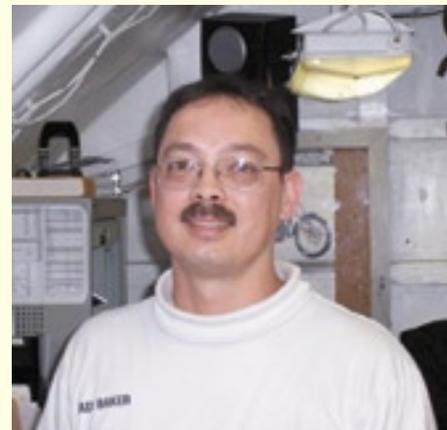
AD1 David Baker
VAW-113

While watching the engine starts on Black Eagle 601, Petty Officer Baker noticed that Stinger 302, an FA-18, had taxied forward next to his aircraft. He also noticed that the pilot had begun spreading the Hornet's wings, as the taxi director directed. Baker immediately determined the wing tip was about to strike the turning starboard propeller on Black Eagle 601. He quickly signaled both the pilot and the taxi director to begin an emergency wingfold, avoiding a serious mishap.

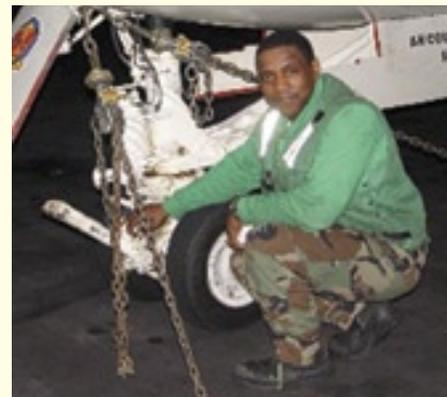
AM2 Yunoir Royes
VAW-121

Petty Officer Royes was observing a recovery on aircraft 600. As it taxied from the landing area to catapult No. 1 for immediate launch, he noticed the port nose tire was not inflated. Without his trained eye, Bluetail 600 could have been launched with a deflated nose tire, resulting in a tire blowout on launch or the next trap. That result could have FODed an engine or caused more severe damage.

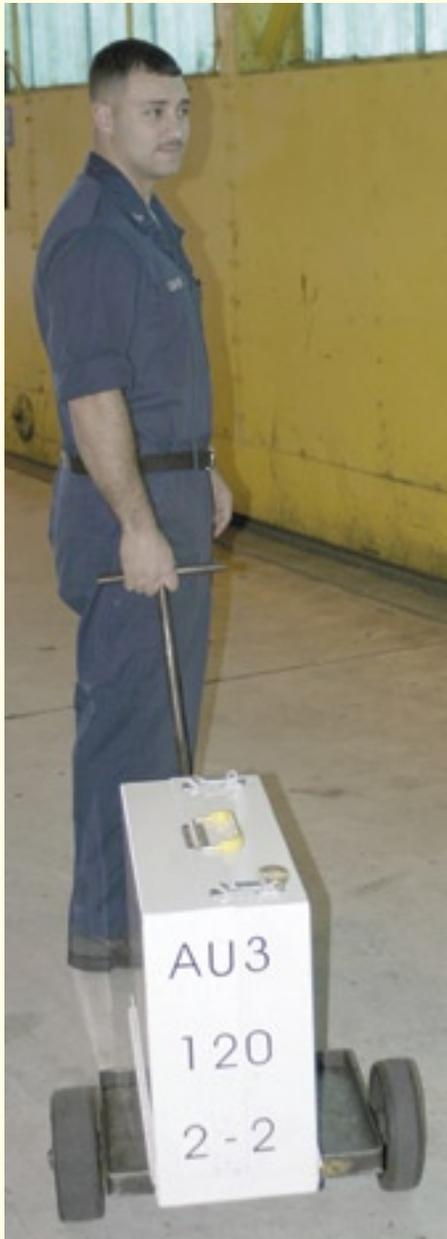
**AM2(AW) Christopher Simon
VP-16**

While assisting the power-plant shop with a discrepancy on a P-3C, Petty Officer Simon noticed a major fuel leak on the aircraft. A closer look revealed that the leak had occurred from a faulty fuel-transfer valve.

Petty Officer Simon's quick response avoided a potentially dangerous situation. Through proper procedures and a take-charge attitude, he was able to stop and contain the leak before any harm came to the environment or aircraft.

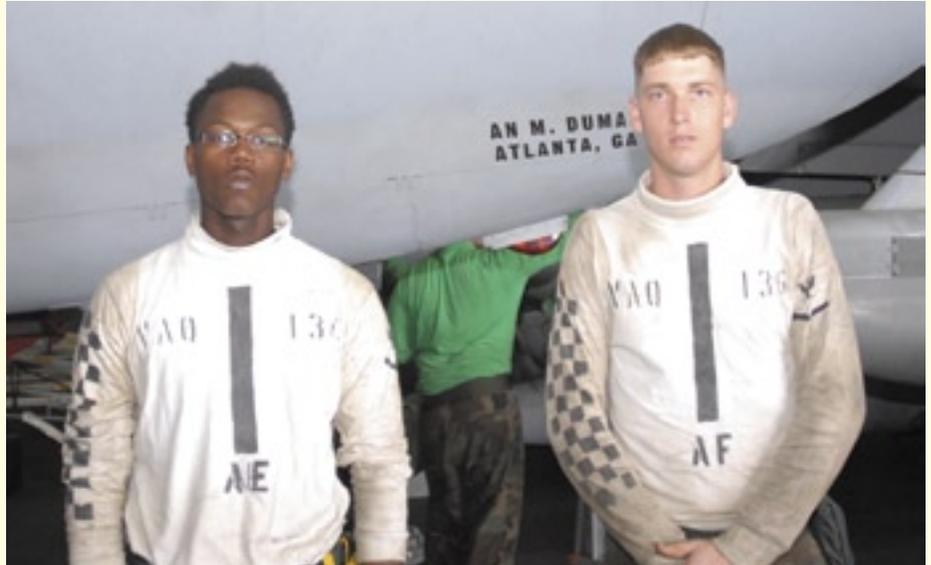
**AE3 Hebert Taylor and AM3 Robert Smith
VAQ-136**

Petty Officer Taylor noticed hydraulic fluid leaking onto an ALQ-99 tactical-jamming-system pod on station No. 3 during a routine night launch of Ironclaw 503. He immediately suspended the launch and signaled for an airframes troubleshooter to verify.

Petty Officer Smith quickly came to the scene, inspected the problem, and found that a nose-wheel-steering line had cracked, releasing hydraulic fluid from the combined hydraulic system.

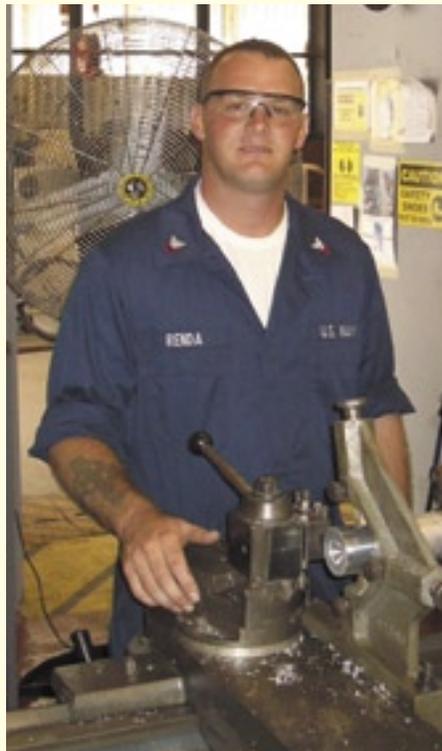
**MR2 Michael Renda
MALS-24**

Petty Officer Renda corrected a safety hazard found in the MALS-24 airframes space, specifically the hydraulic and non-destructive inspection areas. He noticed that the large overhead ventilation system regularly built up condensation, which would drip down onto a heavily trafficked passageway, creating a slip hazard. Renda installed coverings to direct the water away from the passageway and into containers. He raised the safety issue with base facilities and spoke with the controller. The next day, personnel began to replace the insulation on the overhead ventilation system.
