By Cdr. Dave Bean

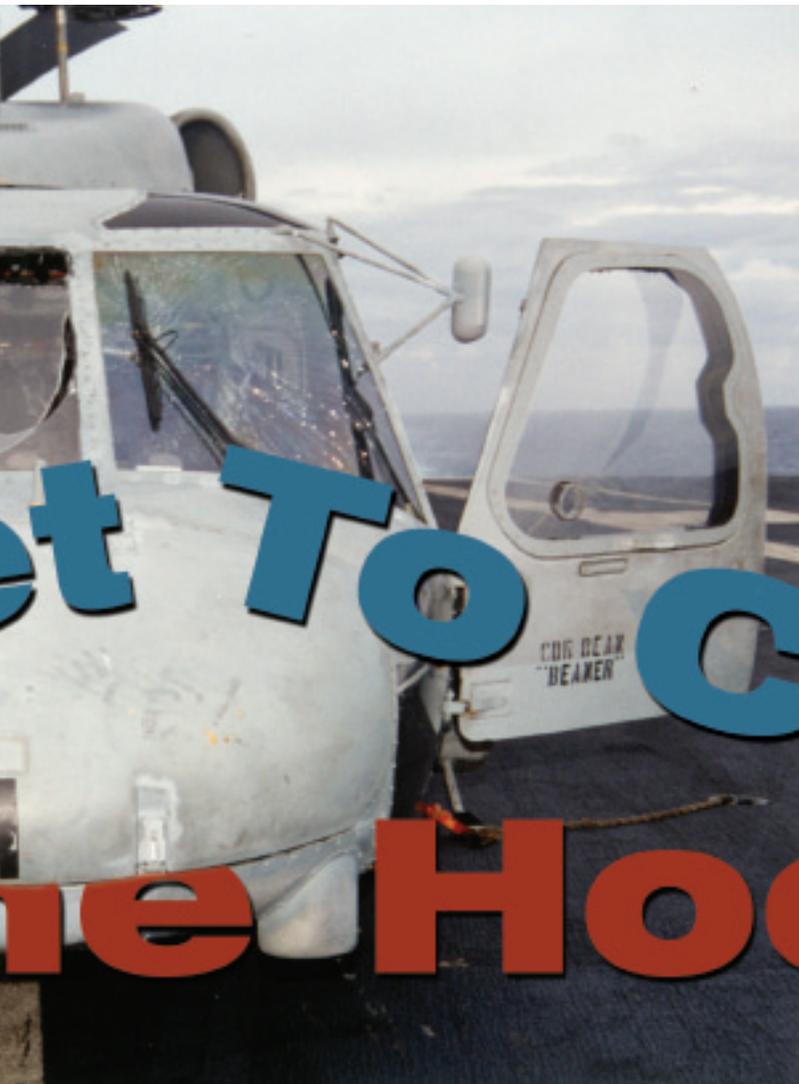
A short time later the crew was airborne and started another maintenance auto. Following their entry into the maneuver, the electronics-compartment door rotated violently up and aft, crashing into the windshield wipers and the OAT gauge located in the center windscreen. Although the two glass screens in front of each pilot were cracked badly, they remained intact. The plexiglass in the center screen, however, broke into pieces, which then became missiles with sharp edges, hurtling aft through the cabin.

...the electronics-compartment door rotated violently up and aft...

What's worth learning from this misadventure? Spend time checking the security of your

aircraft, especially following maintenance. Did the AEAN leave the door open? This crew focused only on the area where the power-plants troubleshooters had been working. There wasn't a standard requirement to touch the door latches to ensure security. A visual check of the aircraft was all that was done. Given the position of the latches, they might have appeared to be closed.
