By Lt. Russell Girty

# No-Brainer

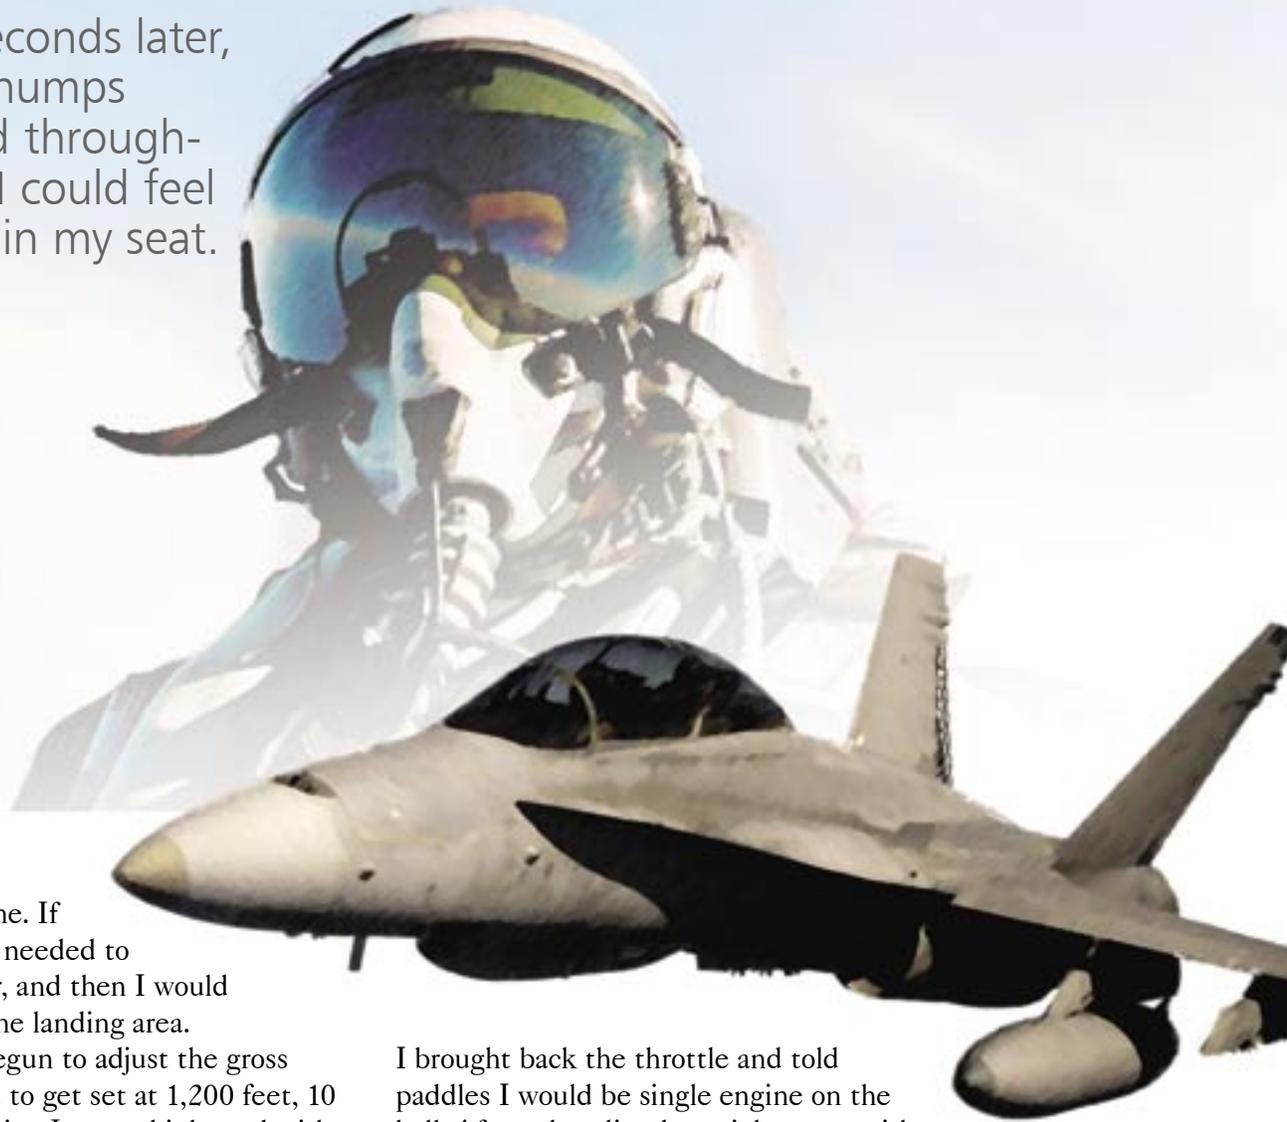
About 10 seconds later, a series of thumps reverberated throughout the jet. I could feel the thumps in my seat.

During the postflight inspection, maintainers found that FOD had damaged the starboard motor. Every first stage blade was nicked or bent. Our best guess was the motor ingested the FOD on the catapult stroke. When I got to the ready room, many personnel, including those from the tower, told me they thought they had seen sparks coming out of a motor, as well as an afterburner blowout that had relit. In the end, I had run a FOD-damaged motor for more than 15 minutes. Fortunately, the GE 404-400 is a great engine, and this situation didn't end up with a catastrophic engine failure.
