Tankers, Ski

By Capt. Jason Arthaud

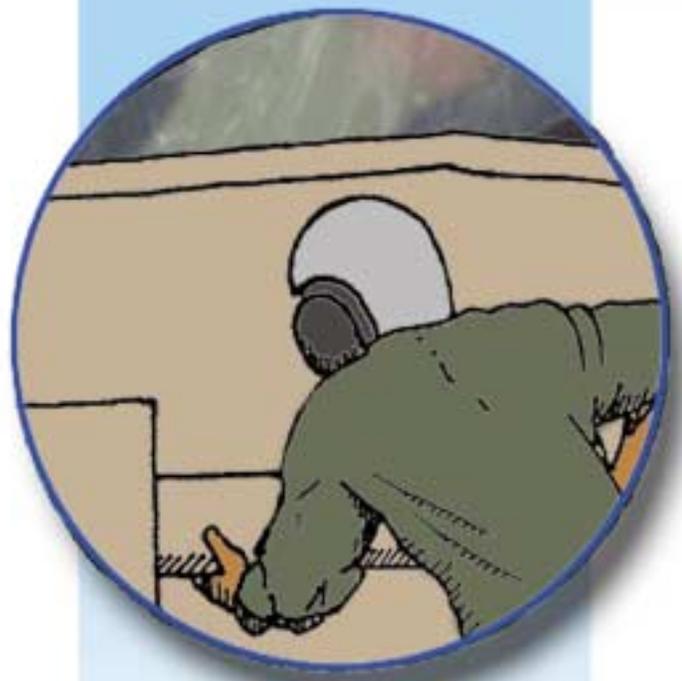
1. When the tank took off in reverse, the loader lost control of the round and it struck his chest and knocked him toward the breech.

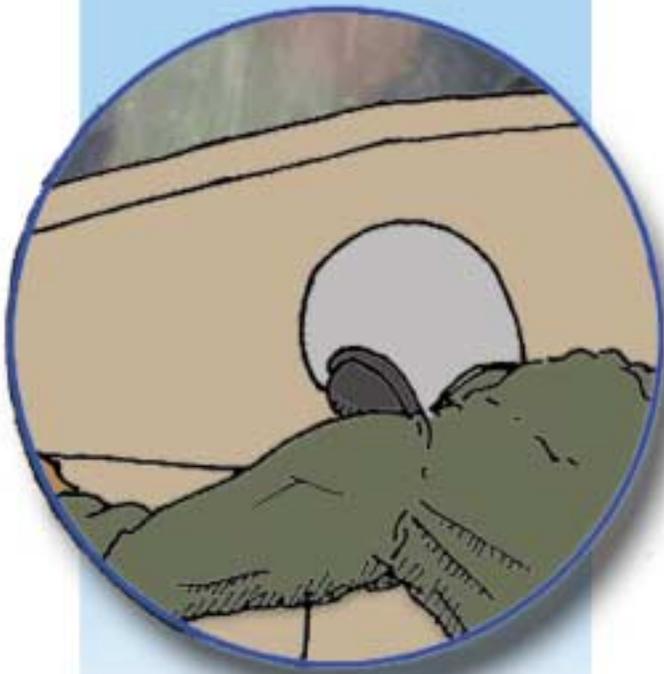
2. The loader missed the loader guard, fell over the breach, and attempted to shove the round home.

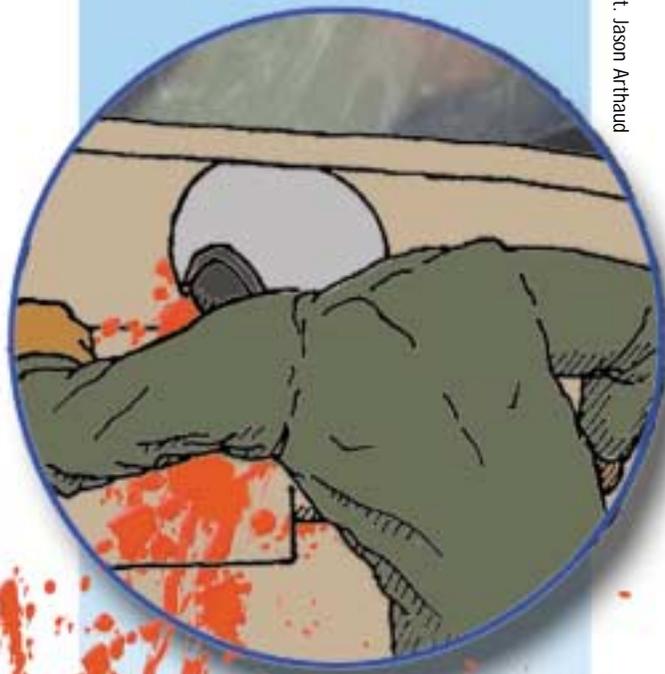
3. While over the breach, the tank crested a slight rise. The stabilized gun swung down to stay on target, and the breech-block swung up and crushed the loader's head.

Examination of the tank found that the gun-turret drive (GTD) switch was in the wrong position when the lance corporal tried to re-load. The GTD switch, operated solely by the loader, should have been set to EL UNCPL. This setting locks the gun and keeps the commander and gunner from moving it up or down. If the main-gun is locked at zero degree elevation, a loader can safely load and move about his station. Investigators found the loader skipped this step.

By not switching the GTD to the elevation-uncoupled position, the gun was still under the commander and gunner's control, a dangerous condition for loading while moving. When the tank backed over the rise in the rough terrain, the gunner was tracking a target. Since the main gun was stabilized, "slaved to the sight," it moved up and down as necessary to stay on target. The loader's head was over the breech when the tank crawled over the slight rise in the ground. When the tank crested the rise, the muzzle end of the gun depressed to stay on target, and the breech end swung up and crushed the loader's head.

The instructors at Fort Knox estimate that most tank crewmen, unless recent graduates of the armor school, are probably skipping this loading step. The Marine detachment and the master gunners branch at Fort Knox have included "ensure GTD is set to elevation-coupled," as a new step in the TCGST. The FM,

17-12, also has included, "To make sure the main gun can be loaded safely across all types of terrain, the GTD switch in the loader's position must remain in the EL UNCPL position."

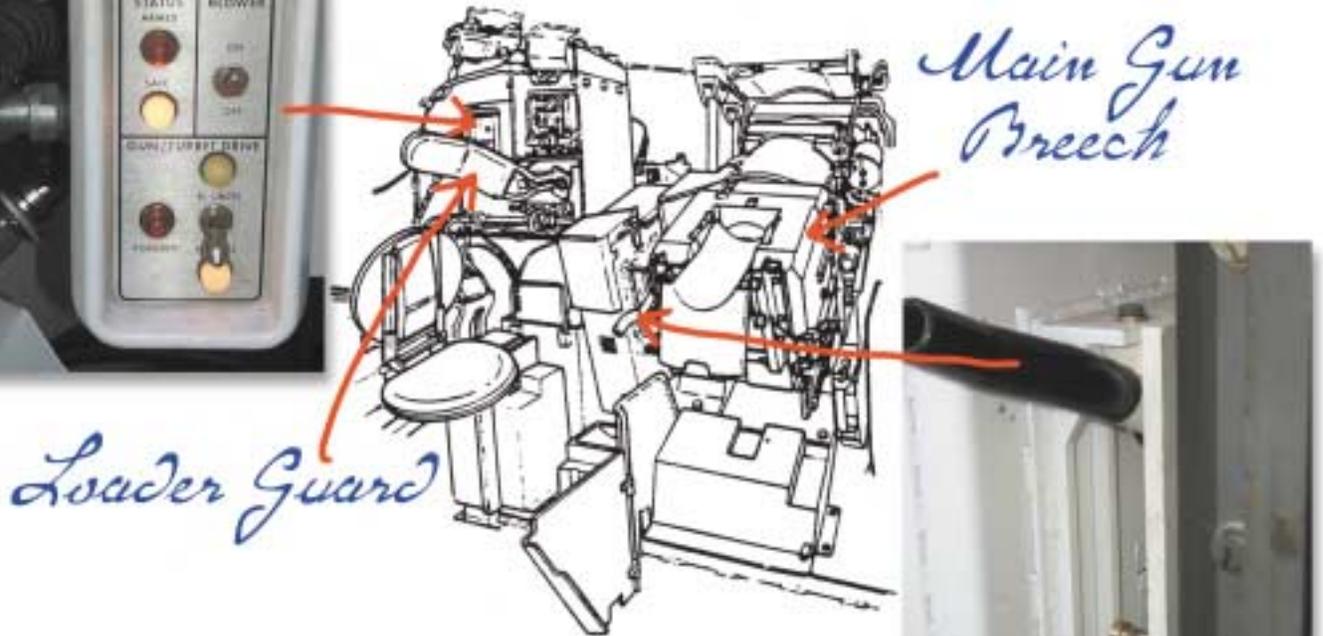
GTD panel

The GUN/TURRET DRIVE panel switch has three settings; EL UNCPL, POWERED and MANUAL. Once set to EL UNCPL, the gun automatically returns to POWERED and back to EL UNCPL as the arming lever is raised to the ARM position or lowered to SAFE.

In this case, the GTD switch was in POWER when the lance corporal attempted to re-load. When he moved the arming lever to SAFE, the gun stayed stabilized. If he had placed the GTD switch in EL UNCPL and left it there, the gun would have leveled itself and locked at zero degrees when he pushed the lever to SAFE. It would have automatically switched back to power when the loader flipped the arming lever to ARM. Once armed, the gun instantly realigns itself with the sight, and the commander and gunner are able to fire.

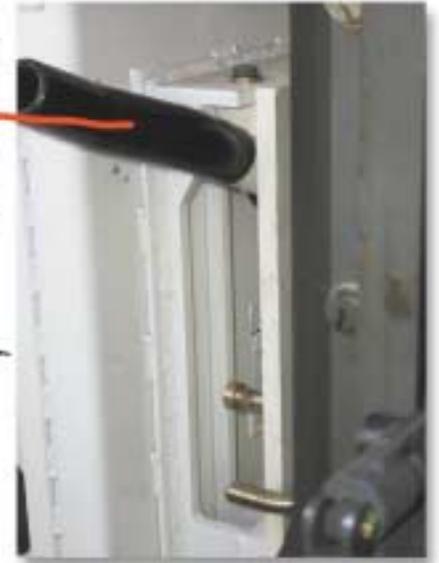
Arming Lever

The ARM/SAFE in the up, ARM, position. If the GUN/TURRET DRIVE switch is set to EL UNCPL, the gun automatically moves back to POWERED when the arming lever is raised to the ARM position.
