Our Massive Prop- Overspeed Flight

by Lt. Brendan Berry

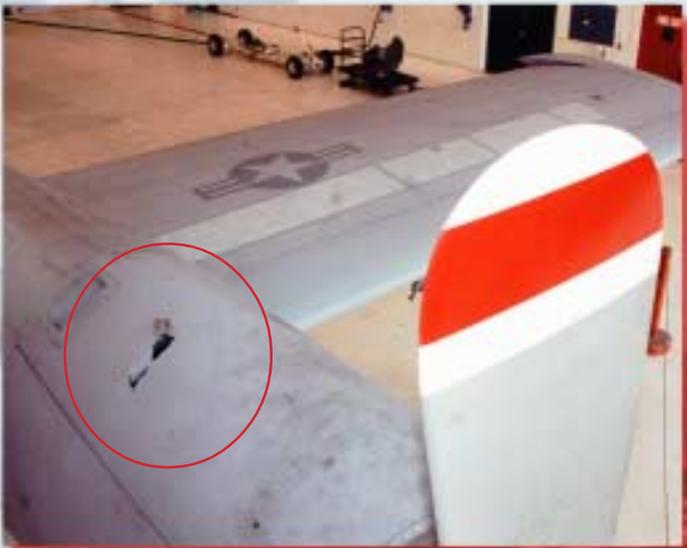
The IP in the right seat took the controls, and I took the comms. Turning to look out the window at No. 2, I was shocked to see that its prop-spinner cover was gone, as were parts of the propeller deicing cuffs and islands. There was a large gash in the top of the No. 1 engine nacelle, but all cockpit indications showed that engine was operating normally.

Postflight revealed the prop had oversped to 165 percent, although the gearbox is only guaranteed to 115 percent by the manufacturer. The spinner and much of the deicing cuffs and islands had separated and struck the fuselage at several points, causing dents and the popping noises we heard. The No. 2 EDC had had an uncontained failure, sending shrapnel throughout the inside of the No. 2 nacelle, puncturing the nacelle in several places, and also sending a large piece through the top of

the No. 1 nacelle, bouncing off the oil tank mounted on top of the engine.
