M16-A2 Exploded

By Capt. Jason D. Arthaud

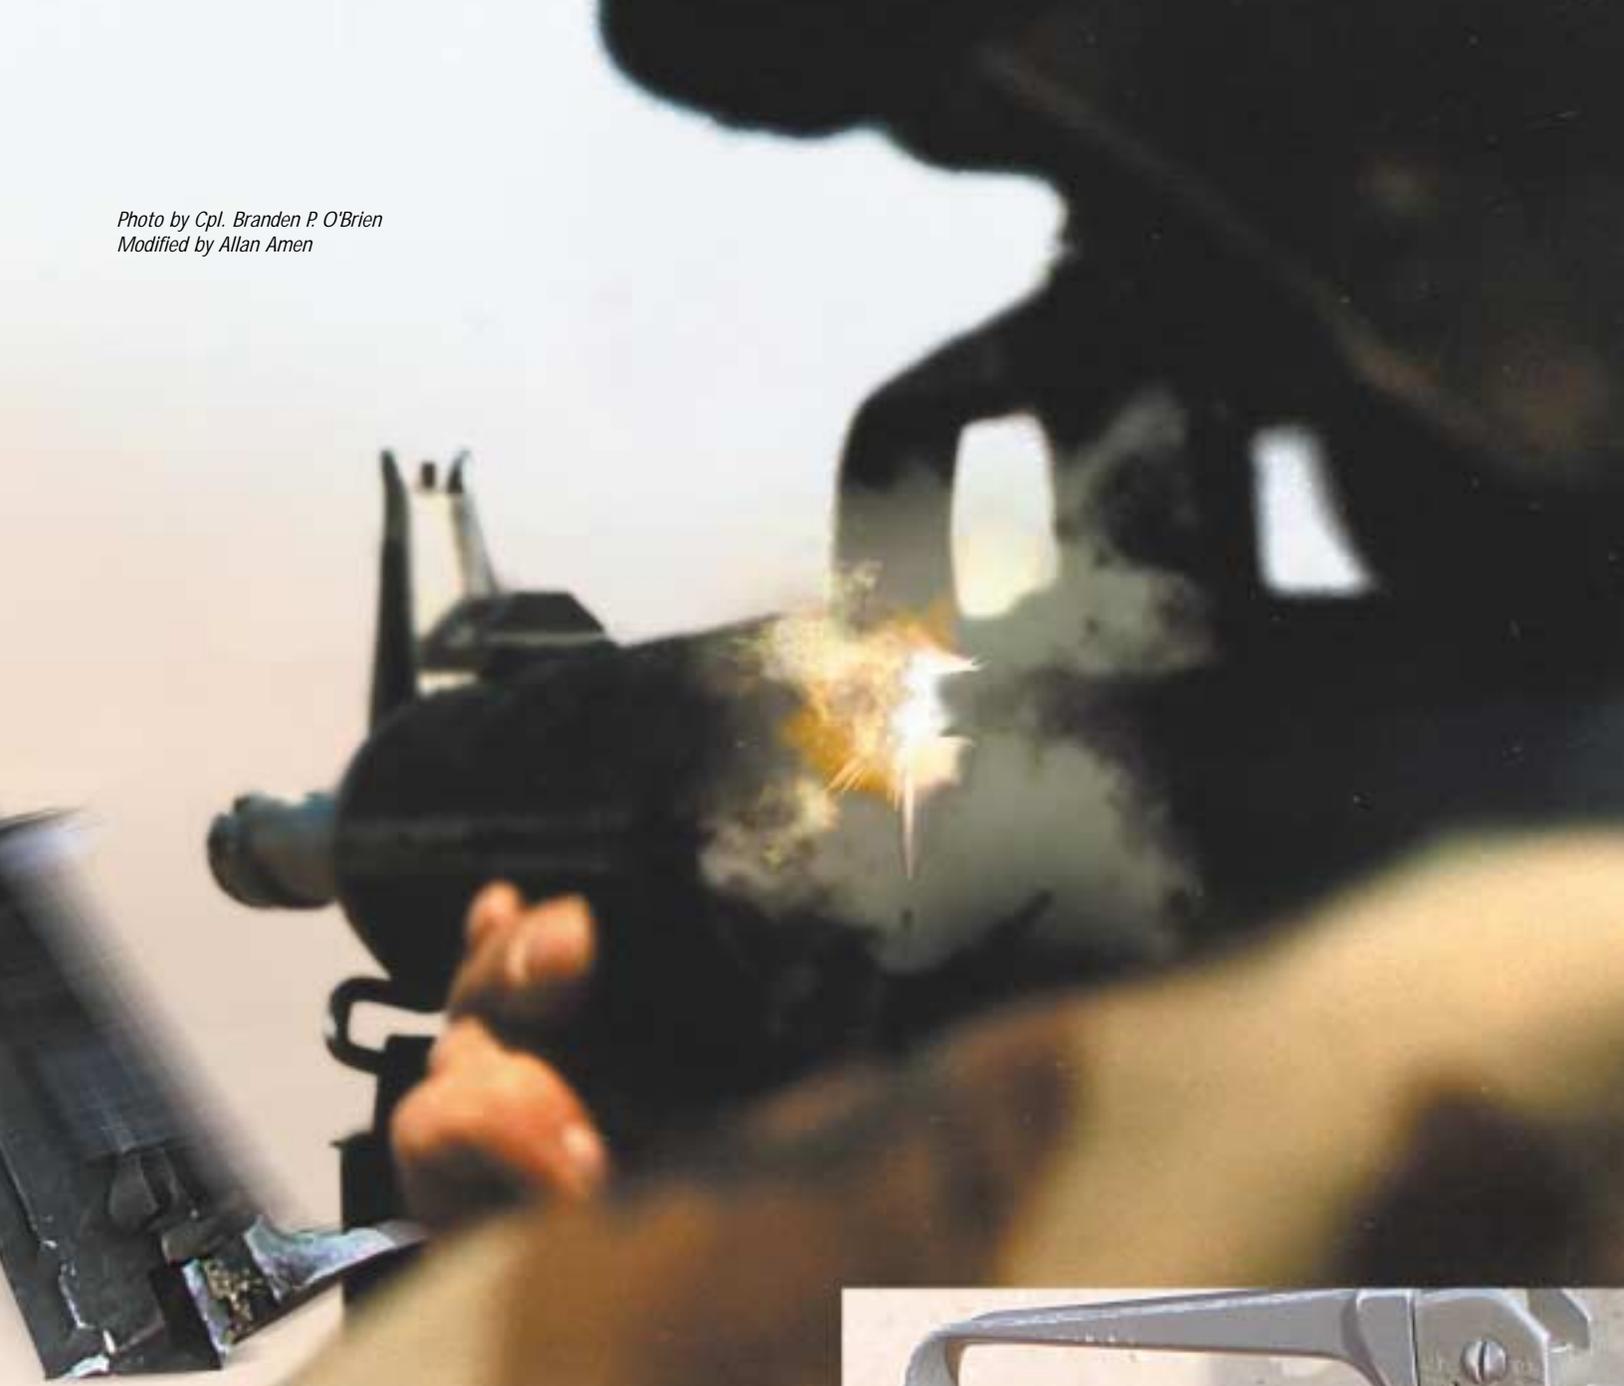
While riflemen suppressed targets from squad base-of-fire positions, another squad maneuvered within hand-grenade range. After tossing grenades, the Marines ducked behind berms for cover. After the grenades detonated, the squad resumed suppression. One corporal picked up his M16, and when he fired, it exploded. His receiver shattered, and a fragment blew off, cutting a lance corporal who was behind him, in the neck.

probably fired with sand in their bores. The mishap rifle had a bullet lodged in its barrel, and since the shrapnel from this weapon contributed to the injury, it was set aside for the investigation.

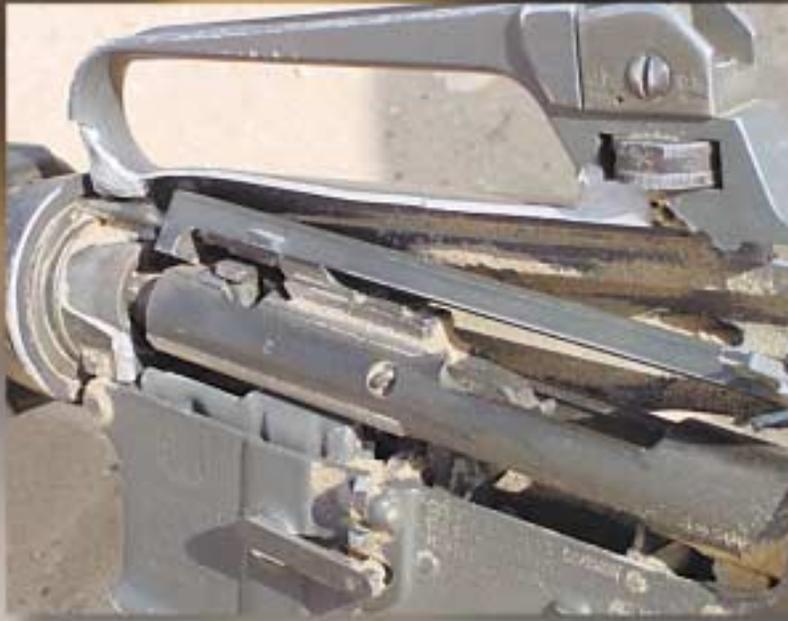
Figure 1.

The ammunition was tested, and nothing unusual was discovered. If a case had been overloaded or exposed to direct sunlight, the chamber pressure during firing wouldn't have exceeded 70,000 psi. The damaged rifles were exposed to pressures nearly three times the normal amount (fig. 1).

What Happens When M16 Barrel Pressures Are Too High?

PSI	Event	Results
55,000	Normal firing	no damage
70,000	Proof-test firing	no damage
90,000	Test	no damage visible
100,000	Partial-barrel obstruction	case bulged, primer flattened
110,000 to 140,000	Barrel obstruction located mid-barrel to muzzle	receiver cracked or bulged, extractor peeled back, rounds blown down and out of magazine.
160,000	Barrel obstruction near chamber	receiver ruptured, bolt carrier split, extractor peeled back, barrel extension cracked, rounds blown down and out of magazine, receiver pivot pin lugs sheared off.

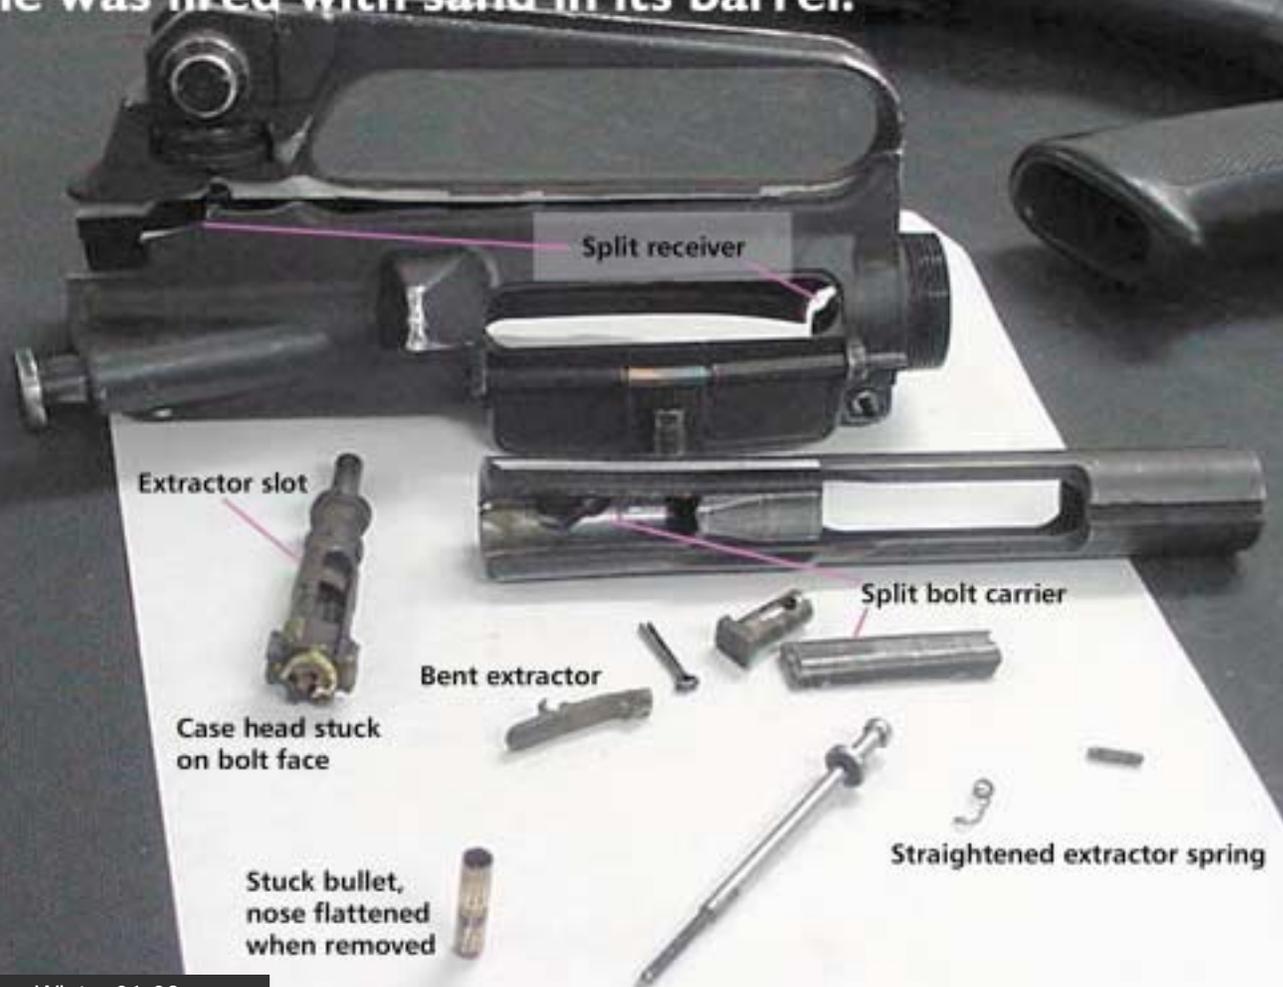
Figure 2.

The corporal was lying behind a berm with his weapon, while Marines from another squad threw grenades. When the last grenade went off, he picked up his rifle, unintentionally scooped up sand with his muzzle, and fired. The round went off and sent the bullet down the barrel—plowing sand as it went. The sand wedged between the bullet and the bore, creating so much friction the bullet skidded to a stop. The powder behind it, however, continued to burn, and the chamber pressure rose above 100,000 psi. With the barrel blocked, the path of least resistance was now through the cartridge-case head.

The intense heat and extreme pressure forced its way through the unsupported base of the brass case into the receiver through the extractor slot (fig. 2). Since the M16's extractor isn't fully supported by barrel-locking recesses, the extractor peeled back, and the bolt carrier and upper receiver split (fig. 3). Gas vented down through the magazine and out the right side of the rifle through the ejection port. The left side of the receiver provided no escape for the gas, and the left side ruptured, blew off, and hit the lance corporal. The limited technical inspection (LTI) following the mishap didn't list the lower receiver as damaged; but often the lower receiver bulges, and the front pivot-pin lugs are sheared off.

A number of parts were destroyed when this rifle was fired with sand in its barrel.

Use the issue, shoot-through, plastic muzzle caps to keep sand and dirt out of weapon barrels. The \$2,000 spent to replace five rifles could have bought 40,000 5-cent muzzle caps.
