Almost Killed by a Practice Bomb

Humpty Dumpty Had a Great Fall

Another Wheel Bearing Incident

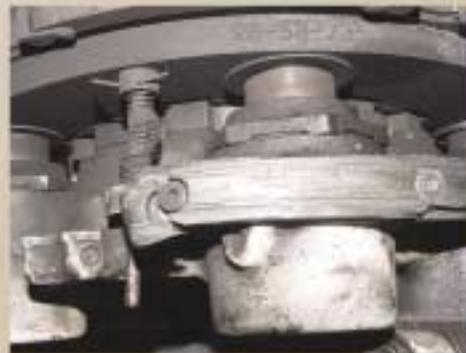
I don't want to overdo it, but these photos are from LCdr. Robert "Mighty" Quinn of VFA-83. He said no photos exist of the bearings because they were "dissolved to mush." Every maintainer must do their utmost to prevent this repeat problem. Check the bearing part numbers before you build a wheel assembly.

The wrong bearing caused this brake damage...

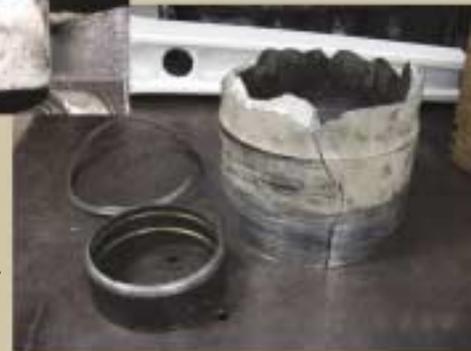
and this axle damage.

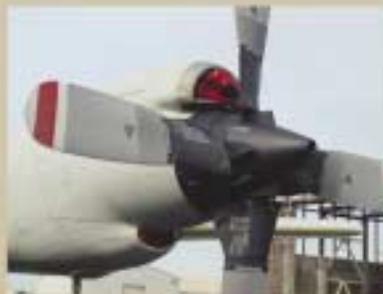
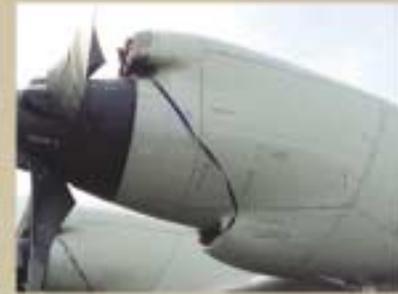
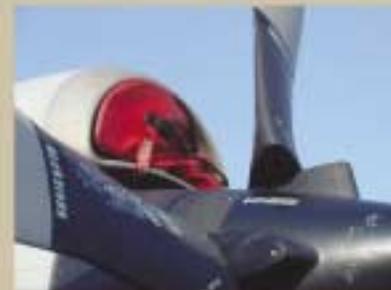
I read this story with interest. I'm the maintenance manager for a P-3 site at Corpus Christi, Texas. OSHA recently has been looking at the aviation community, and they have been hitting us hard, especially in the fall-protection area. OSHA was concerned with the way we install and remove intake covers and various plugs, which mirrored the method described in Chief Roblyer's story.

Using the items in the accompanying photos, we solved our problems. They can be installed from a lower height, can be removed by pulling on a lanyard, and are made from reinforced vinyl and replaceable foam inserts. They're built by Bruce's Custom Covers—the company website is www.aircraftcovers.com and phone numbers are (408)738-3959 and 1-800-777-6405. The intake plug is part number LP3-100 (\$296.80 for four) and oil cooler plug is LP3-110 (\$207.00 for four).
