Basket Case

By AD1(AW) Glenn Kildare

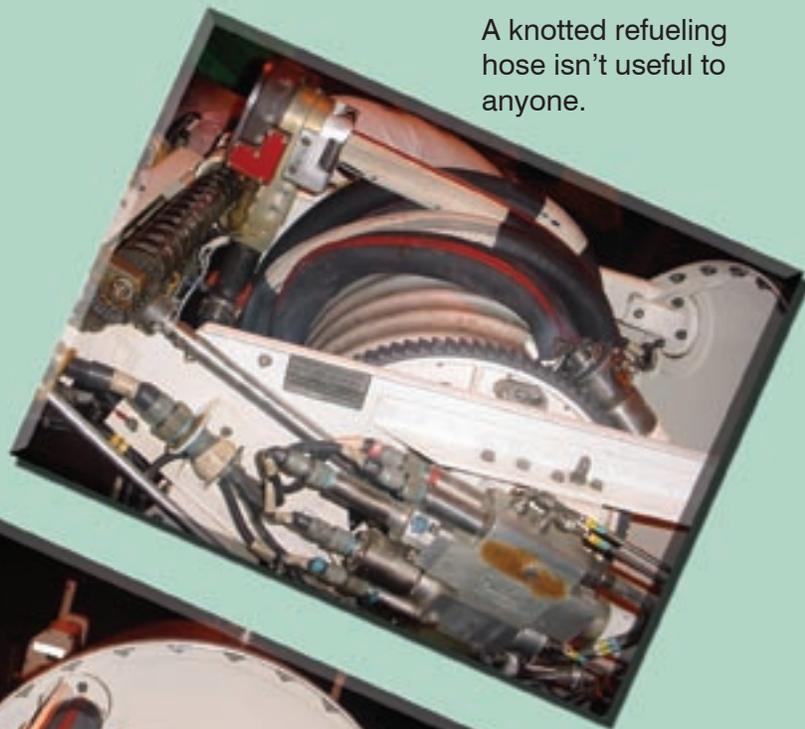
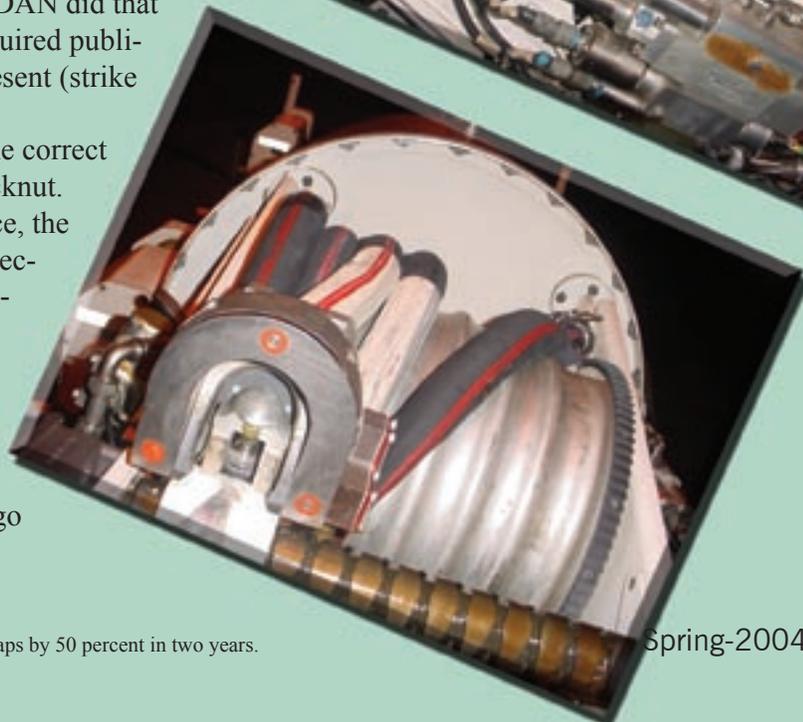
Once 106 was on deck, we downloaded the ARS pod and began our investigation. After removing the pod's tail section, we noticed 8 feet of the hose was jammed and tangled around the drum, preventing the hose from streaming or retracting completely. We checked for correct synchronization of the drum-and-reel guide and found it was aligned correctly. We then found the hose guide would not move through its full path of travel. Upon closer inspection, we noticed a bolt and nut were installed incorrectly in the hose-guide track. The locknut was protruding along the track and prevented the full travel of the hose guide, causing the hose guide to shear and to jam the hose.

A flathead, counter-sunk screw with a locking nut should have been installed in the track with the head flush to the surface of the guide. In its place, however, was a three-eighths-inch, hex-head bolt and castellated nut. When maintenance had been done two days earlier, the CVW-11

The ARS team should have extended and retracted the hose assembly completely, which would have highlighted the bad maintenance. When the aircrew extended the hose on the first flight, the hose guide traveled along the guide until it hit the protruding nut and sheared the connection between the drum and guide—this function worked as designed. The hose eventually wrapped over itself and fouled the pod, causing the crew to jettison it.

A knotted refueling hose isn't useful to anyone.

Maintainers need to use the book and do a thorough CDI inspection. It is the only sure way to get the job done right the first time, and those steps will help make the 50-percent reduction goal a reality.
