E-2C WIRING SYSTEM AWARENESS

PREVENTING WIRING SYSTEM FAILURE SAVES
TIME, MONEY...

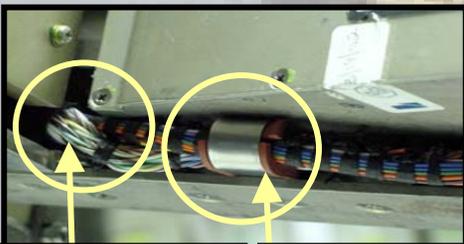
Bottom left bundle chafing against power supply.

Cushion clamp rubber misaligned.

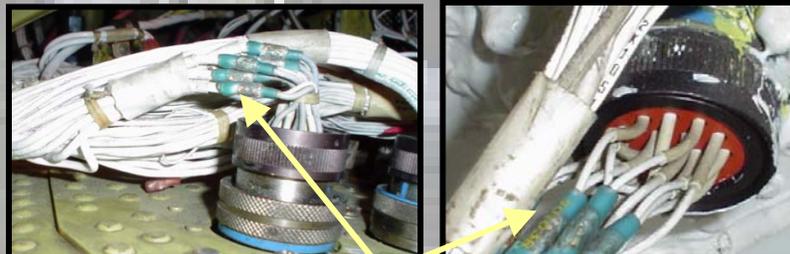
Solder ferrules too close to connector. This will not allow for any repairs and requires cannon plug/harness replacement.

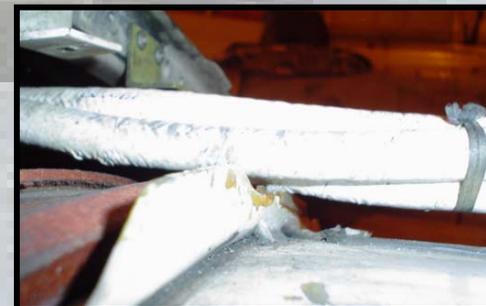
Missing clamp allowing wiring to chafe against structure.
