Saved by the Net

By DC2 Scott Hoffman,
USS *Harry S. Truman* (CVN-75)

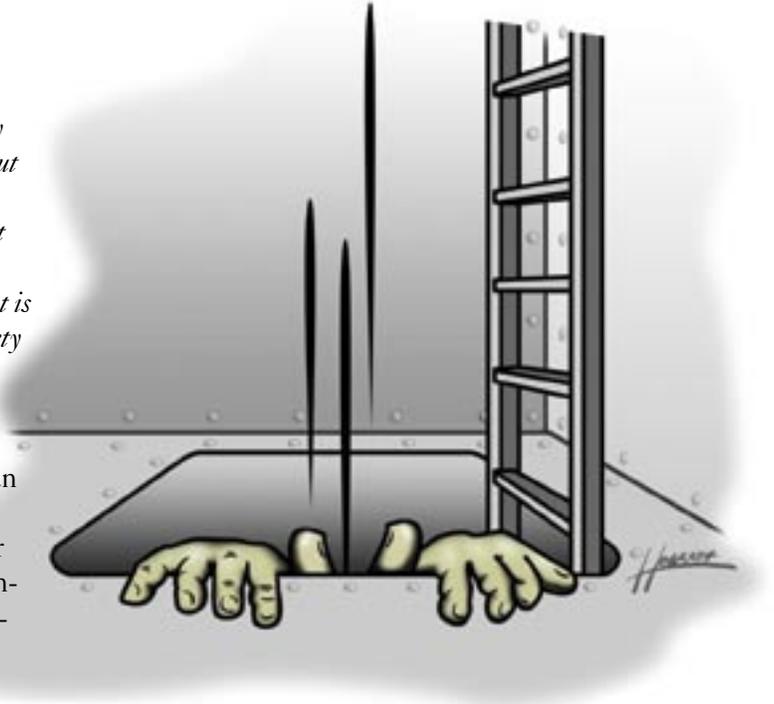
About halfway down, she lost her footing and fell approximately 15 feet—from the fourth to the fifth deck—landing partway in the safety netting. She sustained head trauma and broke some teeth when she hit the steel deck plate and knife-edge. But, her ordeal didn't end there. She was hanging with most of her weight dangling over the edge of the net. Any wrong move could have sent her down to the next level.

Within minutes, the rapid-response team was rigging rescue equipment for the deep rescue, while corpsmen assessed the DC3's injuries. She was evacuated from the space on an elevator and was taken to medical for evaluation and treatment. Inspection of the spaces leading from the second deck to the seventh deck revealed all ladders were normal and in good condition. The safety nets worked as advertised and truly saved the life of the DC3.

As noted by Master Chief Dingmann in his *SSB* article, the reference for trunk-safety nets is section 612e of General Specifications for Overhaul of Surface Ships. It says that, for every ladder extending through three or more decks, safety nets must be installed, beginning at the topmost deck. One also then must be installed at every other deck all the way to the bottom. ■
