Let's Take Care of Our People and Equipment

By BMCS(SWIAW) Danny Tidwell, Naval Safety Center

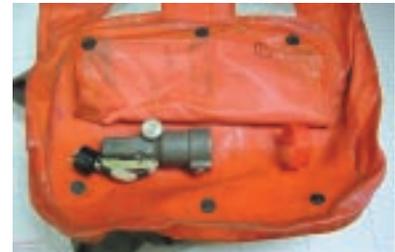
This life vest is missing its CO₂ cartridge.

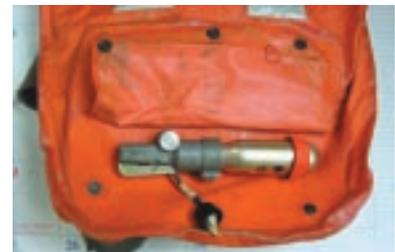
The anti-sabotage compound is missing from this life preserver.

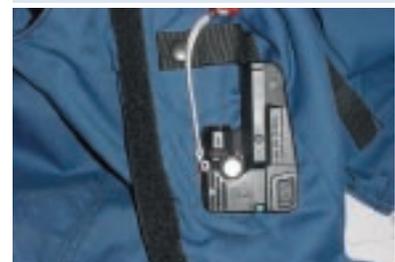
Here's a different life preserver from the one at the top of the page, but with the same problem: no CO₂ cartridge.

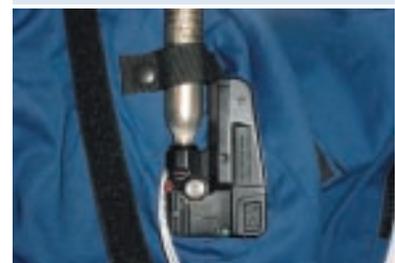
The CO₂ cartridge in this preserver indicates red at the bottom, meaning it is not screwed in tightly. When screwed in properly, the cartridge's bottom shows green.
