The Simple Things . . .Part II

What Was Routine Became a Disaster

By Steven R. Southard,
Naval Sea Systems Command Deep
Submergence Branch

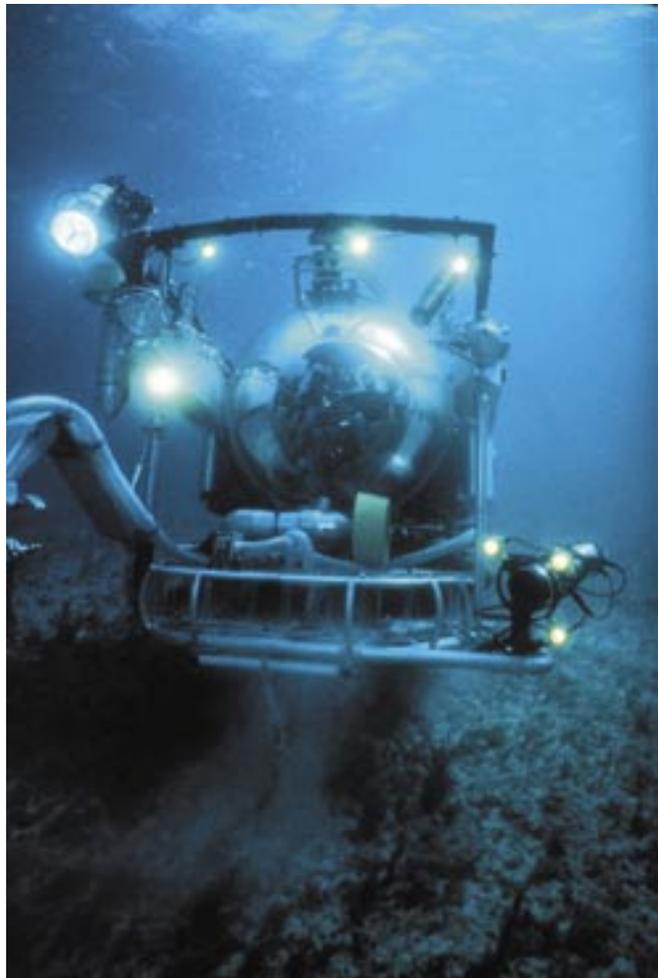
The *Johnson Sea Link* is shown submerged with the pilot and observer barely visible as one looks through the vessel’s forward sphere, which is six inches thick and made of acrylic material.

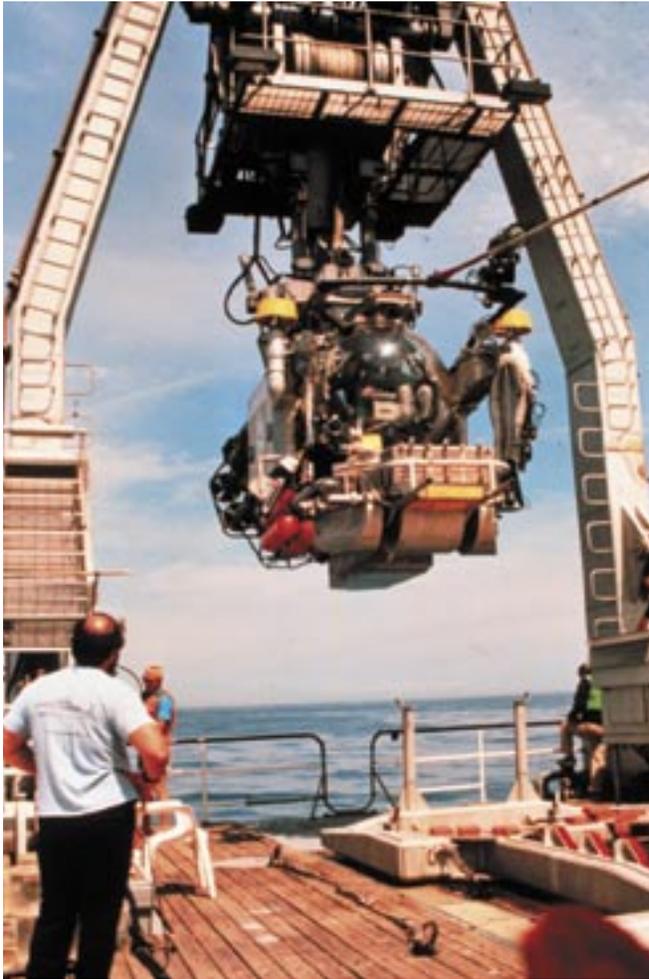
The *Johnson Sea Link* is prepared for being lowered into the ocean from its support vessel. The June 1973, mishap claimed the life of the submersible designer's son, who was a diver aboard the *Johnson Sea Link*.

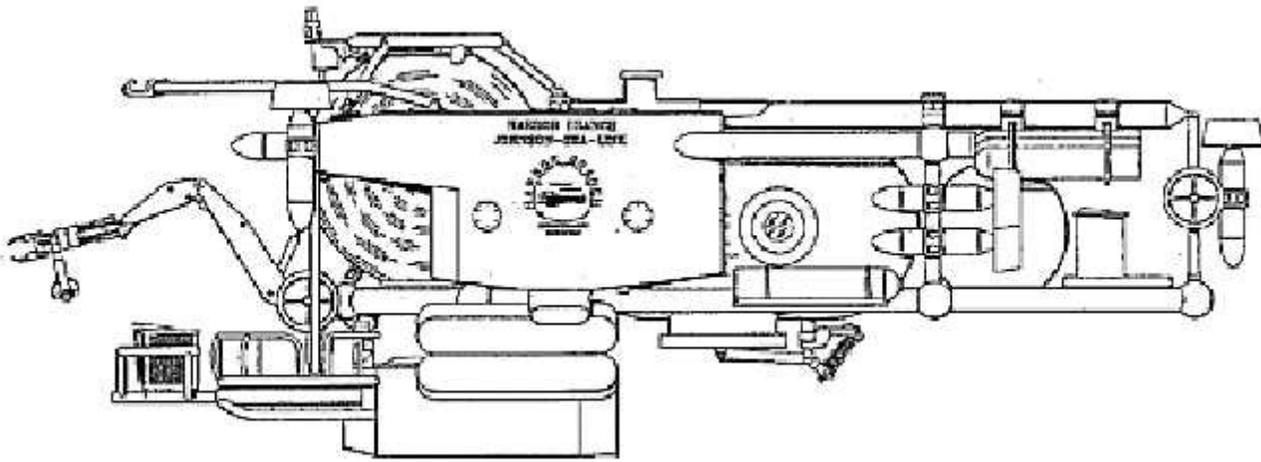
The *Johnson Sea Link* side-view drawing shows the many appendages and protruding equipment that could easily become entangled in the environment such as that of the sunken Navy ship with its marker flagpoles and their supporting cables.

- ✓ Pilot error in failing to keep the submersible clear of obstructions,
- ✓ Rescue force inadequacy due to technology limitations,
- ✓ Poor design of the *Johnson Sea Link* in view of its projections, appendages, and irregular shapes,
- ✓ Casual preparations by the crew (acceptance of the failed scrubber motor, belief in ability to sense CO₂ and failing to dress for cold temperatures).

Though the *Johnson Sea Link* was not a Navy deep submergence system, the Naval Sea Systems Command learned the lessons of this disaster. The System Certification Procedures and Criteria Manual for Deep Submergence Systems prohibits projecting appendages, requires component performance to be analyzed over the full range of expected temperatures and pressures, requires operating procedures for avoiding entanglement, and mandates rigorous safety and hazard analyses.
