# We'll Give It a Stab!

By AM3 Joshua Schoelen

# BRAVO ZULU

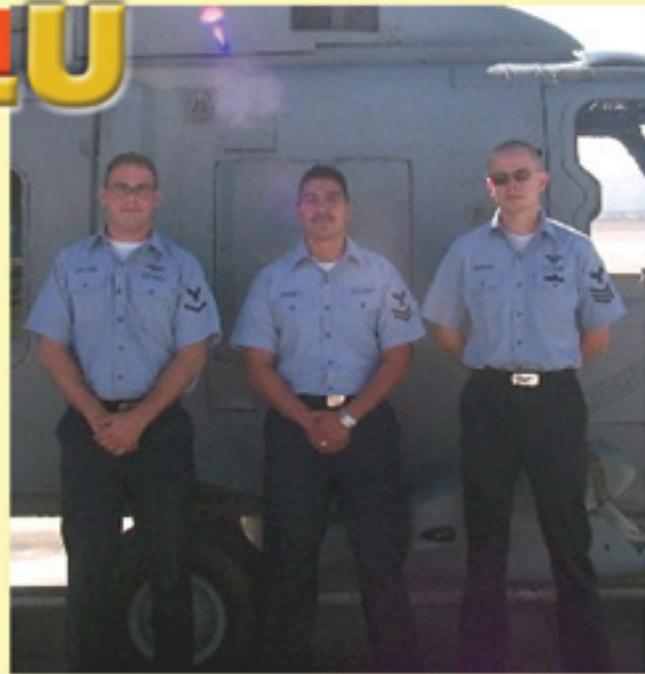
**AT3 Daniel Collins, AD2 Alex Cardenas, and AO1 Zebbie Perkins**

During the launch of Saberhawk 72 for fleet-battle-experiment Juliet, Petty Officers Cardenas and Collins shared fireguard responsibilities. They noticed smoke coming from the No. 2 engine of the SH-60B and quickly notified the plane captain, Petty Officer Perkins, who immediately signaled the pilots to shut down the aircraft.

A closer look at the No. 2 engine revealed a loose B-sump check valve. That valve was replaced in time for Saberhawk 72 to meet operational requirements for the experiment. These maintainers acted quickly and decisively, averting a potential engine fire.

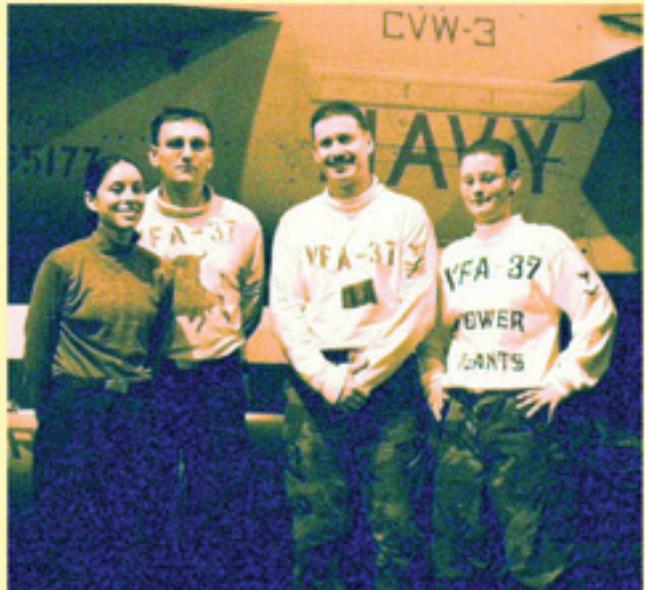
**AEAN Laura Nelson, AD1 Gerald Laclair, AD1 David Cragun, and AD3 Tammy Bookout**

AEAN Nelson noticed a metallic piece of FOD on the flight line. She called over AD1 Laclair, AD1 Cragun, and AD3 Bookout, and they all searched the area around the aircraft, finding more pieces. Petty Officer Laclair and Cragun immediately recognized the metallic pieces as parts from a turbine blade on the GE F404-402 jet engine.

They immediately notified maintenance control and tried to determine the origin of the FOD. They quickly narrowed the search to two aircraft, and both were downed. After a thorough look at both aircraft, they found Ragin' 304 had suffered an internal FOD of the starboard engine. The third-stage turbine blades had suffered catastrophic damage.

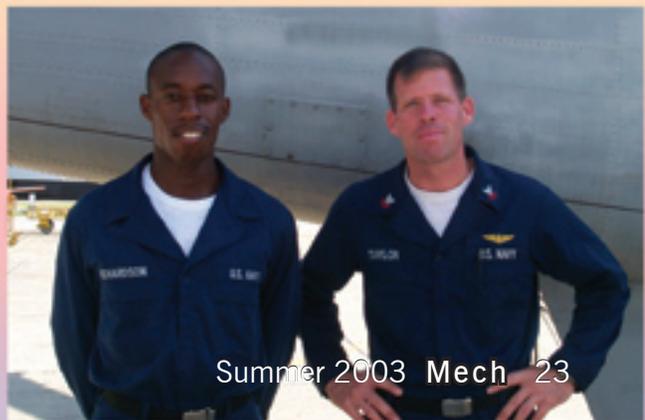
**AD2(NAC) Carl Taylor**

While washing Redtail 213, a wash team had on protective gear: splash-proof goggles, gloves, and cranials with cinched chinstraps. ADAN Richardson had climbed up a 15-foot ladder to pass a bucket of aircraft soap mixed with water to a shipmate. He unexpectedly hit the horizontal stabilizer, and the potent mix spilled onto his forehead. Some of the soap seeped under his goggle's foam seal, blinding him.

Petty Officer Taylor witnessed the accident, immediately helped Airman Richardson down from the ladder, and escorted him to an eyewash station. That eyewash quickly eased ADAN Richardson's discomfort, and, after 15 minutes of flushing, he was ready for transport to medical.
