# H-53 WIRING SYSTEM AWARENESS

## PREVENTING WIRING SYSTEM FAILURE

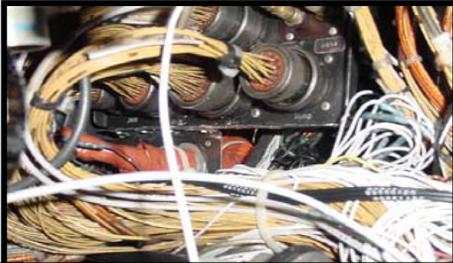
Misrouted wiring.

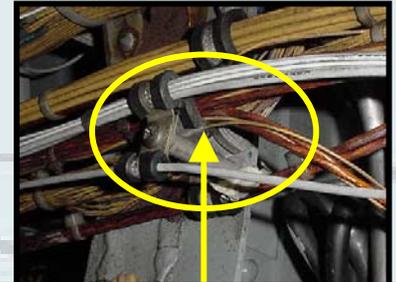
Wiring outside of clamp wedge.

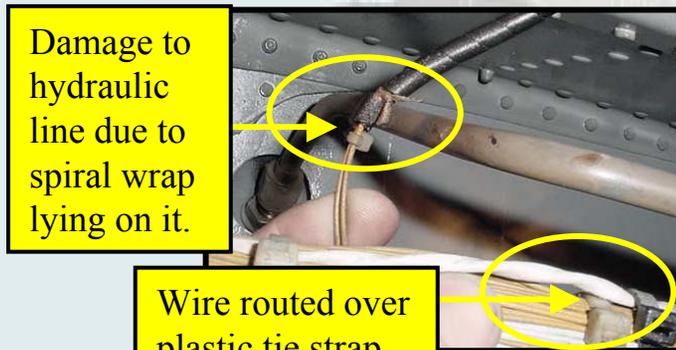
Damage to hydraulic line due to spiral wrap lying on it.

Wire routed over plastic tie strap.

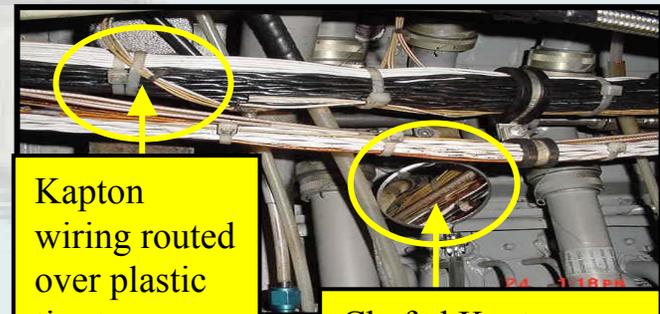
Kapton wiring routed over plastic tie straps.

Chafed Kapton.
