# E-2C WIRING SYSTEM AWARENESS

## PREVENTING WIRING SYSTEM FAILURE

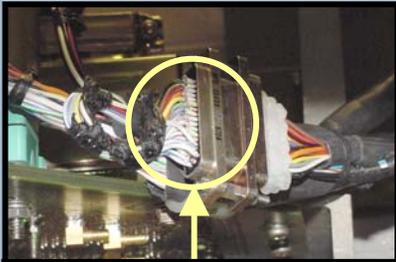
Cut wires left attached.

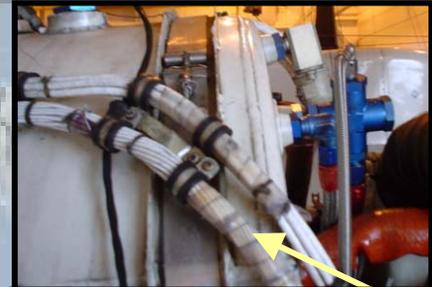
Prop de-icing harness chafing corner of oil tank.

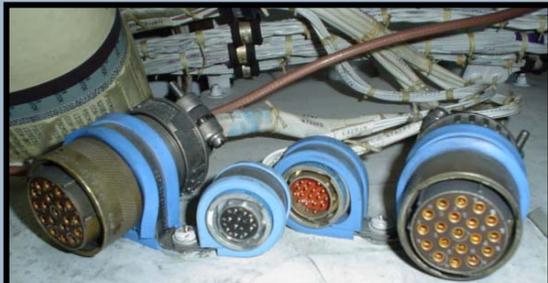
Properly stowed connectors, but need environmental protection (silicon tape) to prevent corrosion.

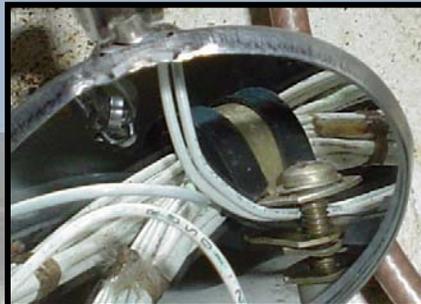
C-clamp loose. Misrouted "Battle Repair" wiring.

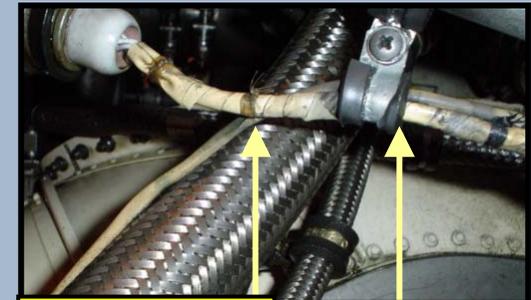
Chafing condition.

Worn clamp.
