BRAVO ZULU

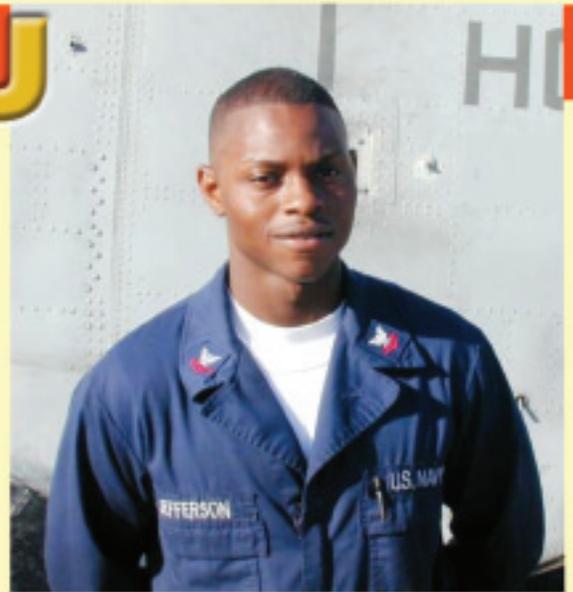
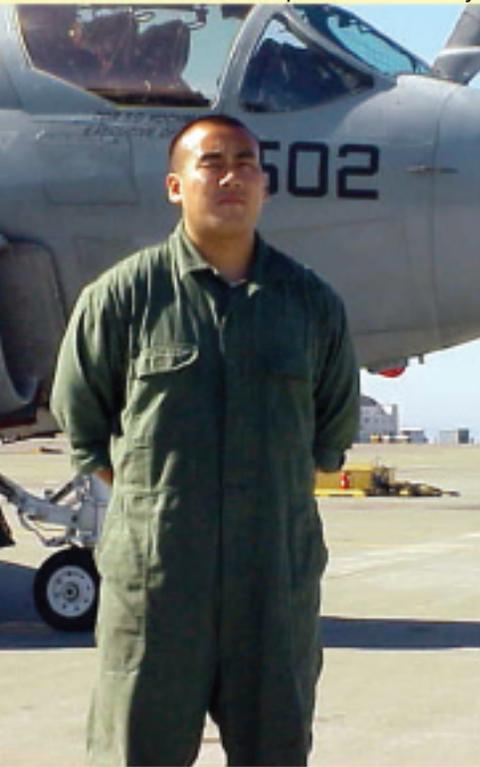
While doing the zonal portion of a phase-A inspection, Petty Officer Jefferson saw something unusual on the No. 1 engine firewall. Working in a tight space, he saw an odd-looking spot and cleaned it, finding a crack. Continuing to wipe that area, he found the crack was much longer than he first believed. He discovered a 12-inch crack that had radiated in several directions, causing multiple rivets and hi-lock fasteners to fall out. His efforts found a critical problem that lay hidden.

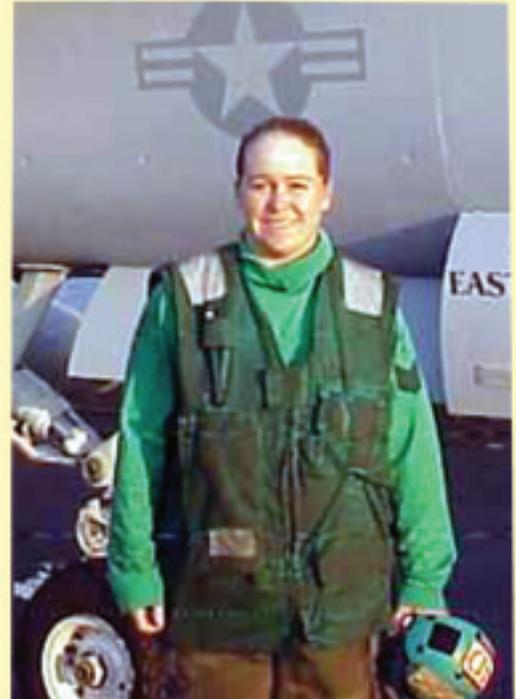
Petty Officer Huyett found a sheared bolt with an attached piece of safety wire lying on the deck near War Party 414. She did a thorough inspection and found the bolt was part of the planing-link system for the main-landing gear. Had this discrepancy gone undetected, it could have resulted in failure of the planing link, improper operation of the landing-gear components, or, worst case, a gear collapse on landing.

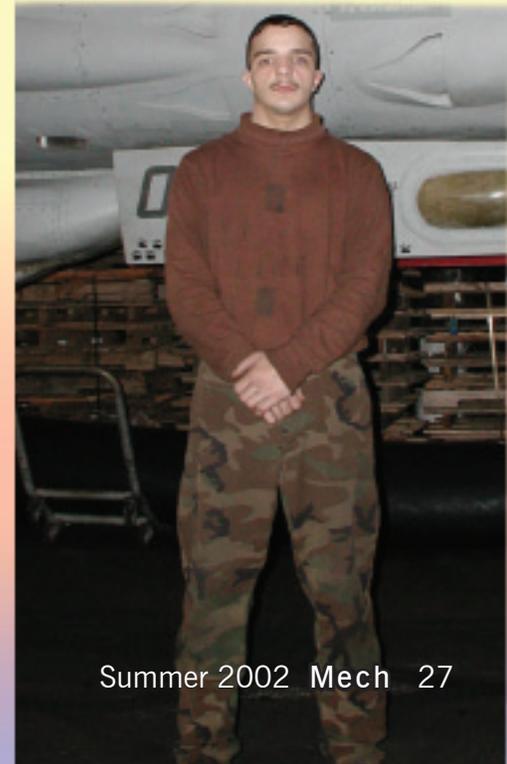
In the early night hours during combat operations on board USS *Carl Vinson*, Airman Justin Roach rode brakes for Blacklion 111. A recovery was in progress when he spotted an object in the landing area near the centerline. He got out of the aircraft, ran to the LSO platform, and told them something was in the landing area. CAG Paddles waved off the next Hornet, and Airman Roach ran out to retrieve the object, a tie-down chain.
