Illegal Outlets Found on Submarines

By LCdr. Parker Swan,
Naval Safety Center

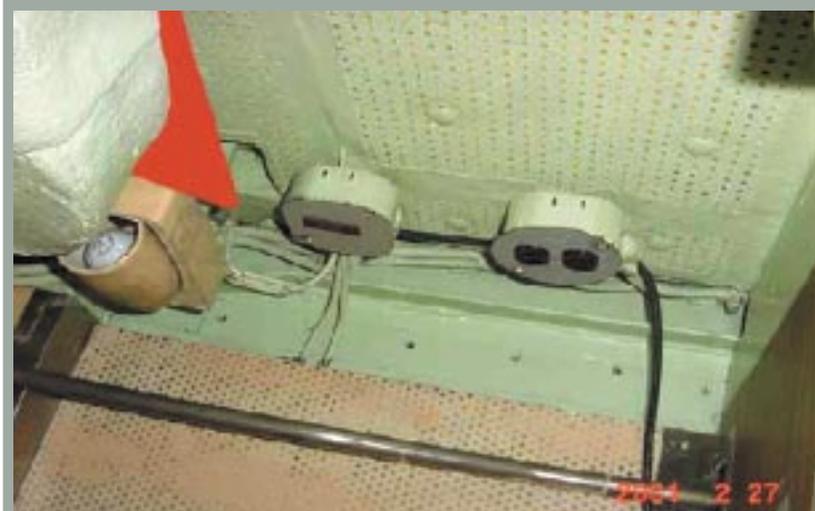
The junction box on the right has been illegally modified: For one thing, it has an extension cord hard-wired into it. Both junction boxes should appear like the one on the left.

If the command determines a need for more outlets, they must submit documentation to the appropriate planning yard for approval and schedule work for the next restricted availability or overhaul period. The submarine's squadron can provide help with this planning.

Meanwhile, all hands should remember it is against regulations—and *dangerous*—to make unauthorized modifications to any Navy ship. ☺
