THE DANGERS *of* GETTING UNDERWAY

By Cdr. Ron Keim,
Naval Safety Center

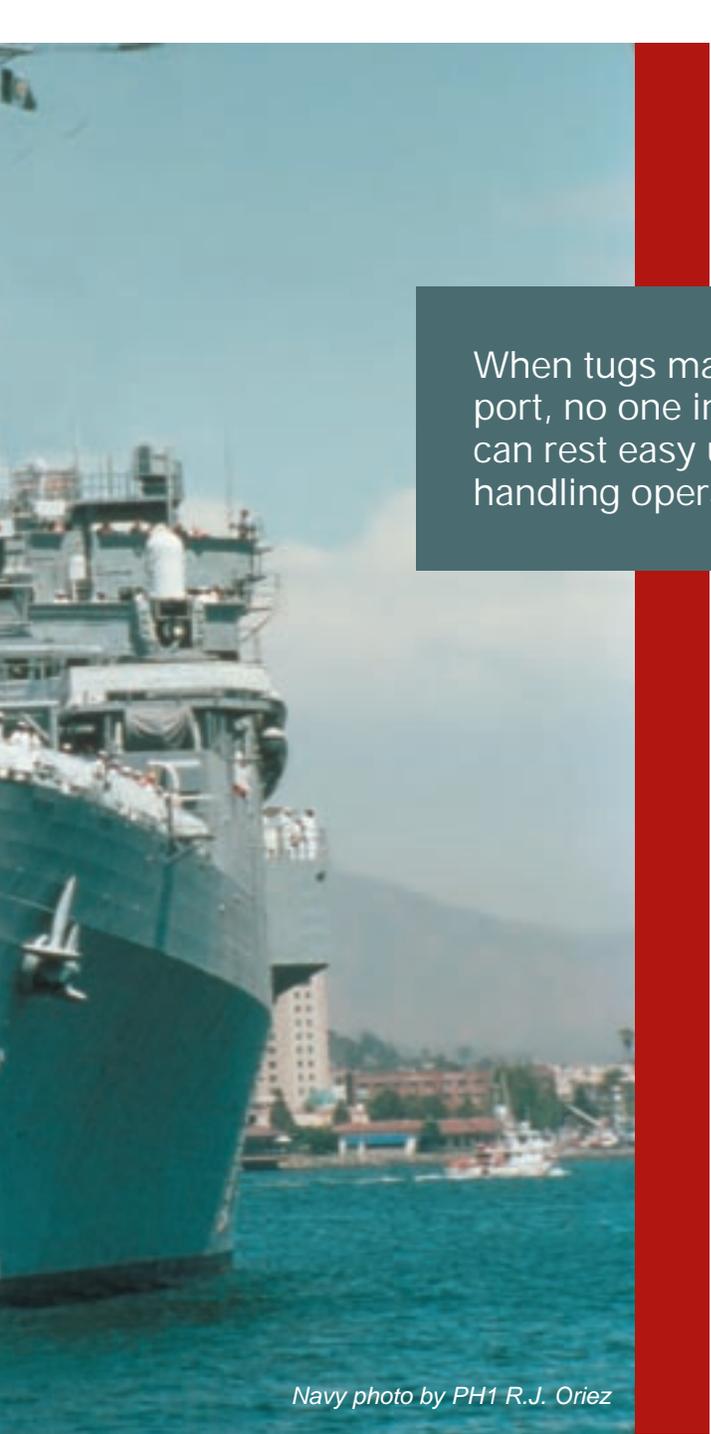
Navy photo by PH1 R.J. Oriez

When tugs maneuver a ship out of port, no one in the ship's deck force can rest easy until all the line-handling operations are secured.

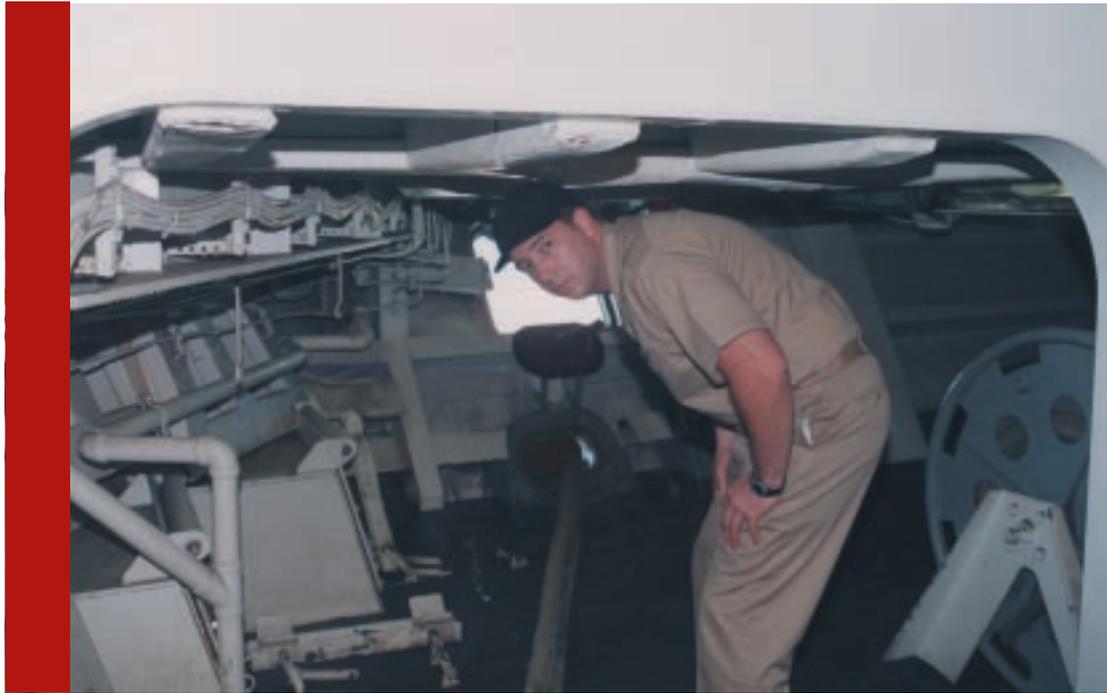
Last, the ship's after line-handling station, where one of the tugs was made up, had numerous design flaws that factored into the mishap. To start with, a low 5-foot overhead forced line handlers to stoop over in an unbalanced position. The cramped configuration of the space also made it impossible to fake out the 80-to-100-foot messenger lines and provided no safe haven in case of a mishap. The station's enclosed design restricted visibility between line handlers and tugs.

A 5-foot overhead in a ship's after line-handling station has this effect on someone who stands more than 6 feet tall. The ensign in this story stands 6 feet 4 inches.
