# Tailhook Trounces Toes

By AM3 Brian Moore

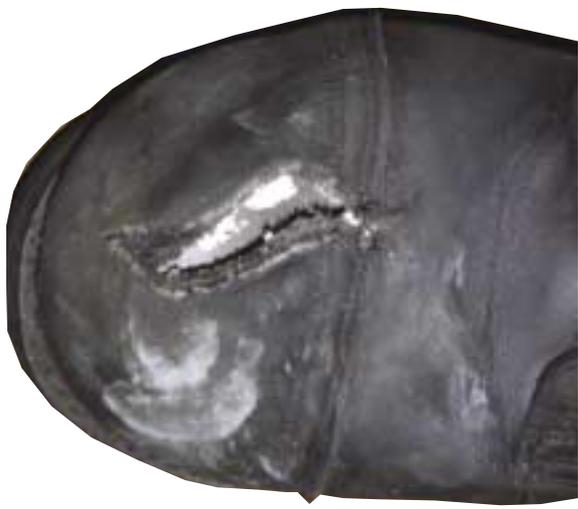
This foot wasn’t a match for a 70-pound tailhook under 800 pounds of pressure.

What did I learn from this experience? I should have followed procedures. The safety chain would not have been broken had I done the steps in the right order. Always be cautious around moving aircraft parts, even if you’re the person working on those items. A momentary lapse in judgment quickly can lead to trouble. Finally, always wear your personal protective equipment. At the very least, it’ll save your toes.
