Just a Scrape

By AM2(AW) John Franklin

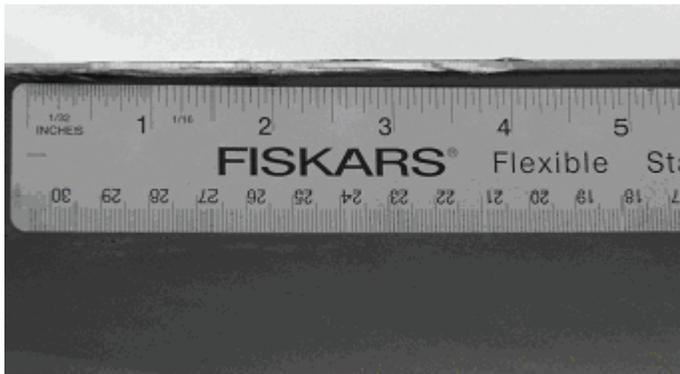
Gouge on the leading edge of the stab. Notice the bare metal, length and depth of the gouge.

The scratch turned out to be a gouge in the aluminum section on the leading edge of the stab. Once the damage was inspected, we found it was not within limits, meaning the stab should have been repaired or replaced. This type of damage has very small limitations (< .0030-inch on the leading edge). A quick visual inspection wouldn't have told me that the damage wasn't within limits, but it would have forced me to question the damage and look up the limitations in the structural-repair manual. Damage to the leading edge of the stab, a primary flight-control surface, could lead to abnormal

I also could have asked how the stab was "scratched." As it turns out, the stab was damaged when the aft section of the FLIR pod dislodged in flight and hit the leading edge of the stab. Had I investigated the report of a scratch and examined the surrounding area, I would have noticed this section missing and realized where the damage had come from.

The stab was removed and repaired after only one flight. It's unfortunate that it took an incident like this one to open my eyes, but it shows how one person not taking each situation seriously could lead to an aircraft mishap. I have learned a great deal from this event. I now investigate the problem 100 percent of the time and determine what to do. I also have rebuilt the confidence of leadership in my abilities. 🦋
