Secure for Sea

By Lt. Paul Will

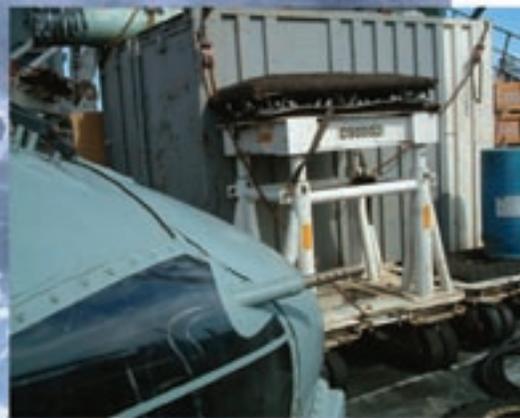
Now that multi-million-dollar components and sensors are installed on naval aircraft, the need to secure for sea never has been more important. Look what happened to Saberhawk 75, an SH-60B, when an improperly chained wing dolly broke free on the flight deck. The aircraft's chin bubble was scratched, the radar altimeter antenna was damaged, and the AAR-47 plume detector was destroyed.

The damage to this aircraft was avoidable.

The damage totaled only \$8,500 but would have been a Class A mishap had the \$1.3 million FLIR not been removed for repair just a few days earlier. Do not wait until you feel the rolls to make sure aircraft and support equipment are chained down properly. By then, it already may be too late!

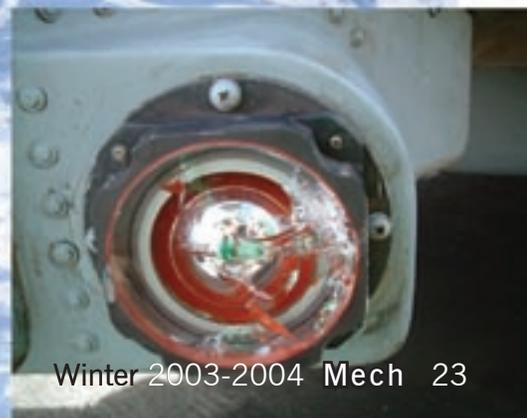
This damaged detector is a small example of how bad the damage could have been.
