Troubleshooting Aircraft Systems With Infrared Thermography

By Jed Figg

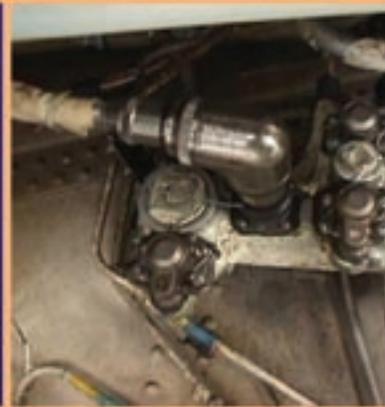
Electro-hydraulic FCISOV tested under identical flight operations.

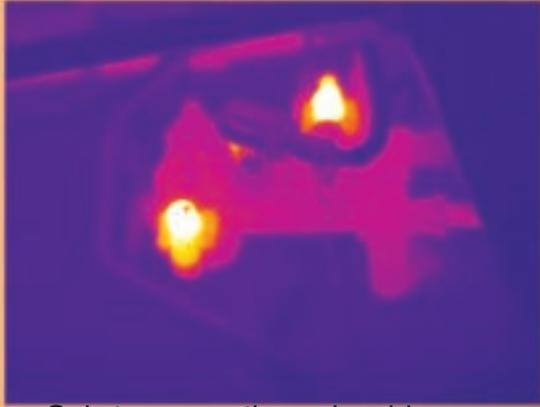
Only two operating solenoids are seen here.
