# Mech

**Vol. 45, No. 2 Spring 2006**

## Back in the Editor's Chair...Full Time

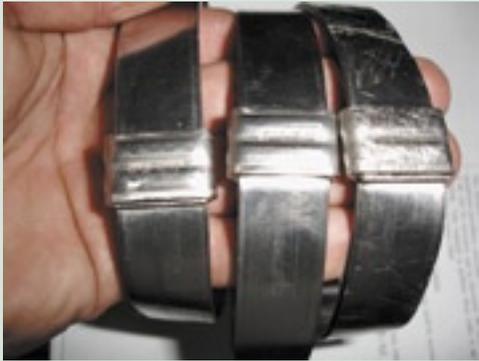
These bands hold the hose to the coupler and often become damaged or aren't connected properly.

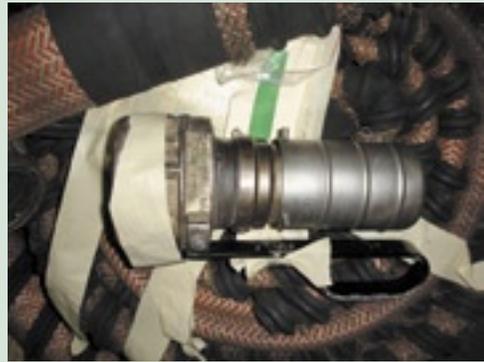
It's critical to attach the hose securely to a coupler like this one.

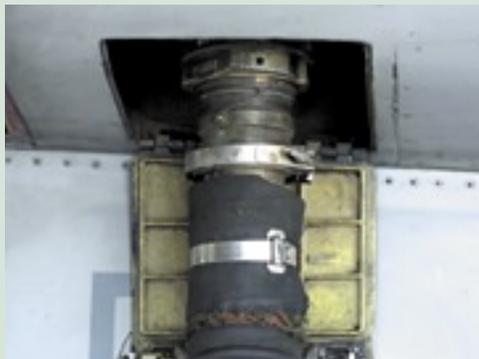
Take a look at the hose and bands for wear and security.

On board ship or station, squadron ground crews and hangar or flight-deck personnel inspect assigned support equipment (SE) daily. The NAVAIR 19-600-306-6-1 checklist specifies, "Visually inspect pneumatic duct for evidence of damage (chafing and tears), connectors for integrity of banding material, air-hose coupling (aircraft side) for integrity of safety wire, and quick-disconnect coupling-retaining mechanism for corrosion and for presence of retaining balls." In this

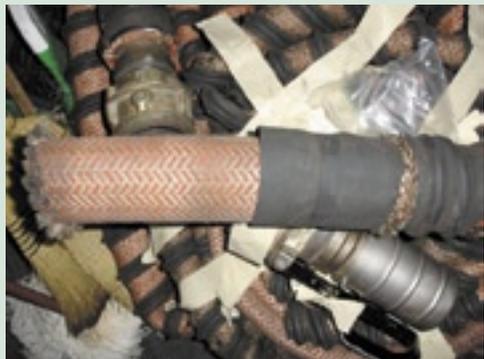
A hose can flail around once it separates from a coupler.

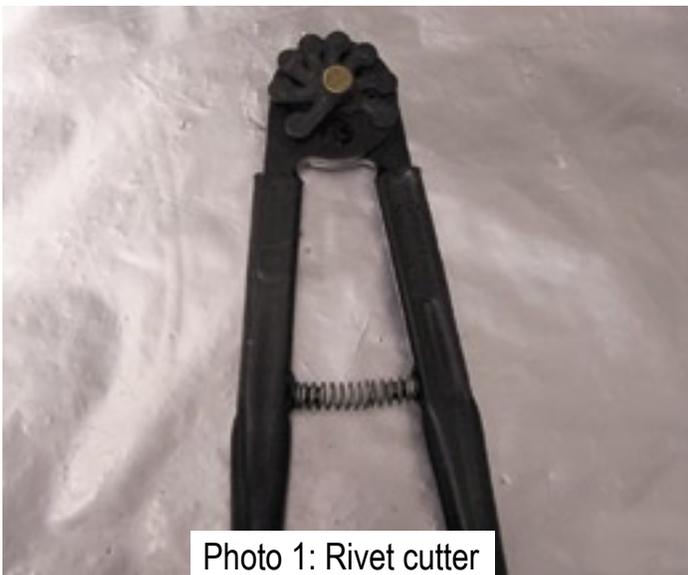
Photo 1: Rivet cutter

The rivet cutter has the following count: two handles secured with a locknut (count as one), a spring, retaining stud and eight leaves (see photos No. 1 and No. 2) for 11 pieces. But a review of inventory sheets will list this as one piece. In one command, our team found three leaves missing.

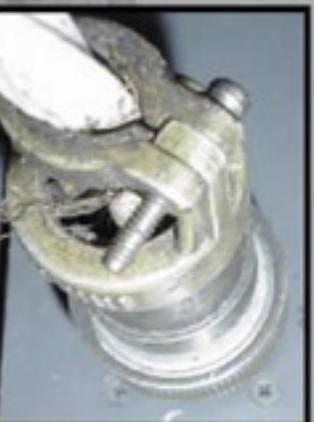
Shielding deteriorated, no longer provides EMI protection to system.
