A Rag With a Mind

By AM3 Edgar Crook

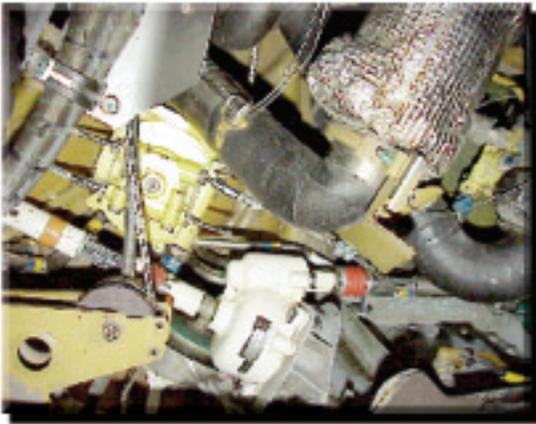
This area in a Hornet's wing contains the mechanisms that drive the leading-edge flaps.

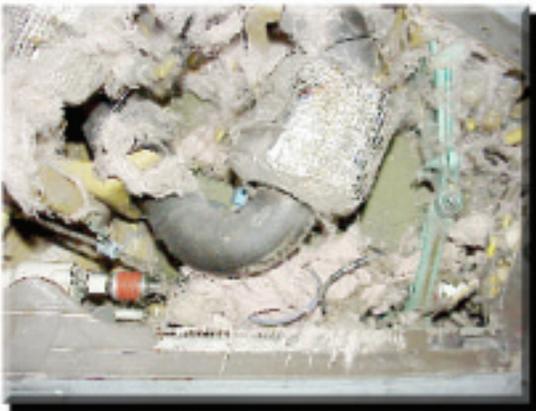
Here's what that area looks like after you leave a rag in it.

One night, though, a pilot reported to the flight-deck controller that the "beer cans" (wingfold-lock indicators) were stuck, indicating the wings would not spread and lock. The airframes night-check crew removed panel 34 (right) to investigate the problem. They were shocked to find a rag wrapped around the

short shaft that drives the leading-edge flaps. The rag had wrapped around the wingfold-control cable and had snapped it in half. They removed the cable and installed a new one, which required a rig check.

This entire mess could have been avoided if we had taken our time and thought about what we had to do. It was very hot in the hangar, and we had rushed to get the panels back on for the phase and 42-day inspections. We must have kicked that rag into the wingfold-lock area before reinstalling the panels and after the CDI had completed his check.

Since this incident, we now require a QAR and CDI to inspect the inside of all panel areas, and then we install the panels while they watch. We also are required to look inside any panel that contains hydraulic lines or a flight-control servo. Our squadron now has made rags a part of our tool-checkout procedures. If we check out three rags for a job, we have to bring three rags back to the shop. We show them to the supervisor or CDI and then sign the log's return block.

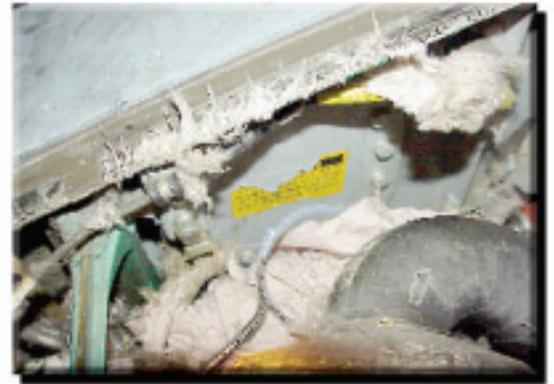
We had to pull out pieces of the rag out of the panel area where air pressure flows over the panel's surface.

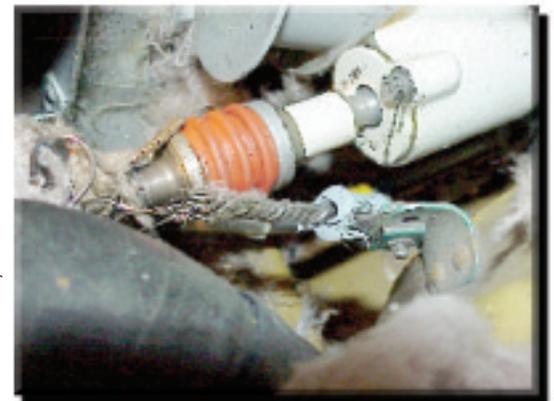
It may seem hard to believe, but a rag snapped the wingfold-control cable.
