Christmas in

By GySgt. Andrew Gates

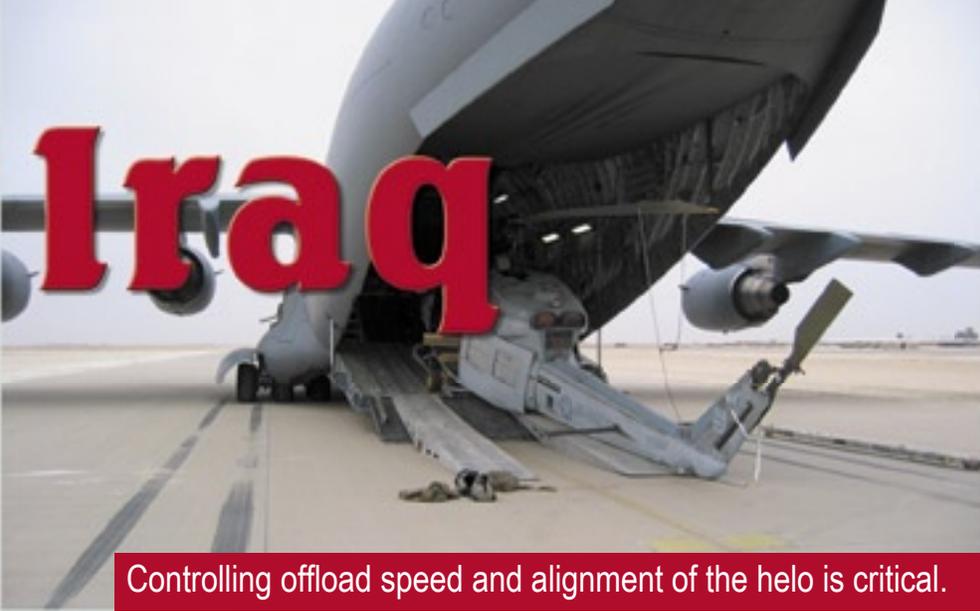
Controlling offload speed and alignment of the helo is critical.

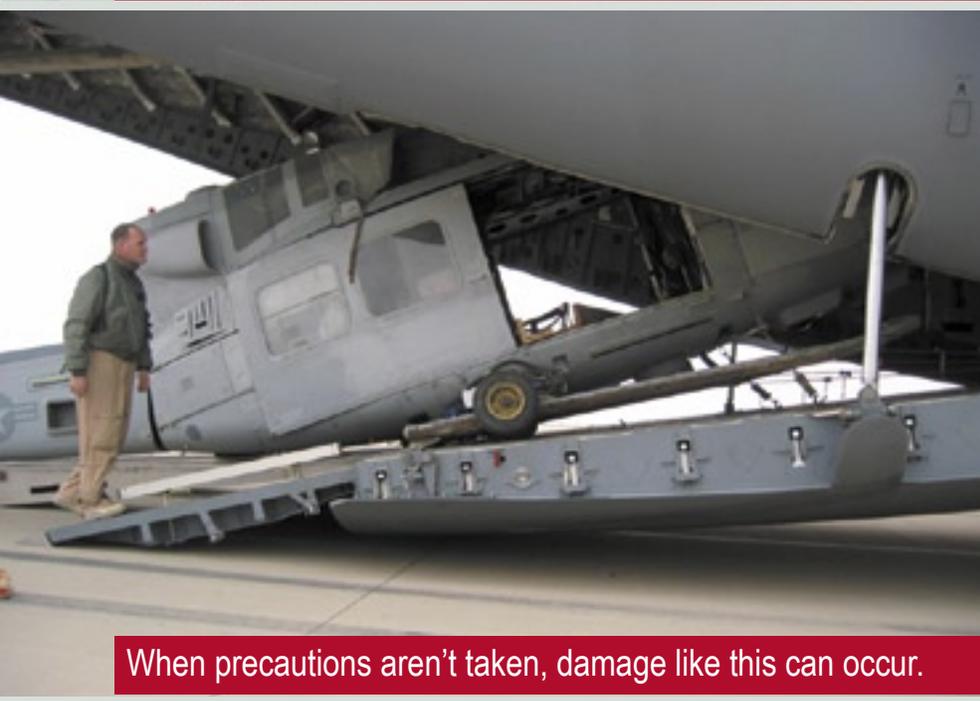
During the offload, a winch was used to control the speed of the aircraft being rolled down the ramp. It freewheeled, and the aircraft sped at an uncontrollable rate toward the end of the ramp, slamming into the deck. The ensuing impact caused the skids to collapse, separating the tail boom at the mounting lugs. The aircraft still was partly inside the C-17. It would remain

When precautions aren't taken, damage like this can occur.

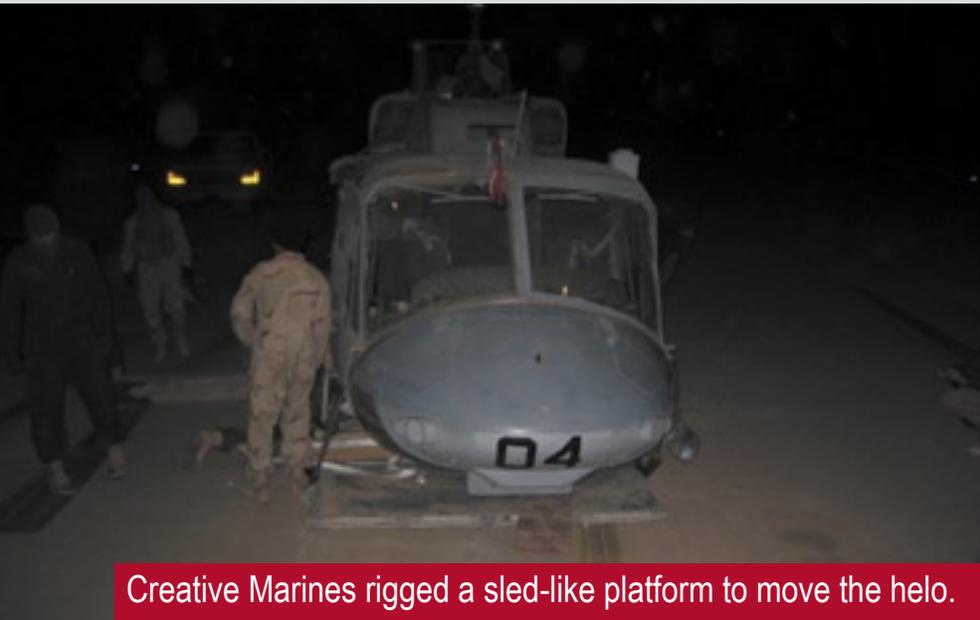
Creative Marines rigged a sled-like platform to move the helo.

The aircraft was positioned in such a way that we couldn't lift it with a crane or tow it. The tail boom was crushed upward, and the aircraft was at such an odd angle that we were afraid to move it. First, we chained down the Huey from the front to prevent it from falling out of the aircraft and then secured it with more tie downs, preparing to remove the tail boom. Since there was no manual for removal of stuck aircraft, we had to get creative and do this job safely. The best course of action we came up with included a forklift, railroad ties, Air Force pallets, cargo straps, and a little luck. Essentially, we built a sleigh for the aircraft body with the above items, placing these items in key weight- and load-bearing areas. Three hours later, we had wrestled the aircraft off of the C-17 with no further damage to either airframe.
