# Unpinned Seat Could Be an Unplanned Ride

By AD1(AW) Derek Holbrook

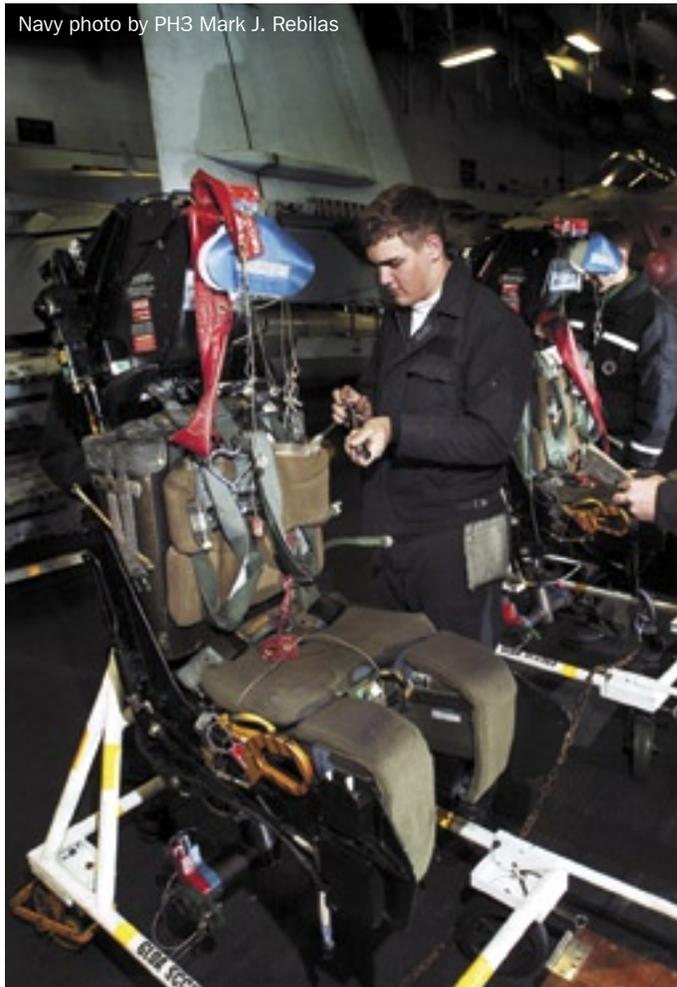
An armed seat is like a rocket ready to go off.
