Best Practice

Preflight Your Flight Deck

By LCdr. Jeff Rogers

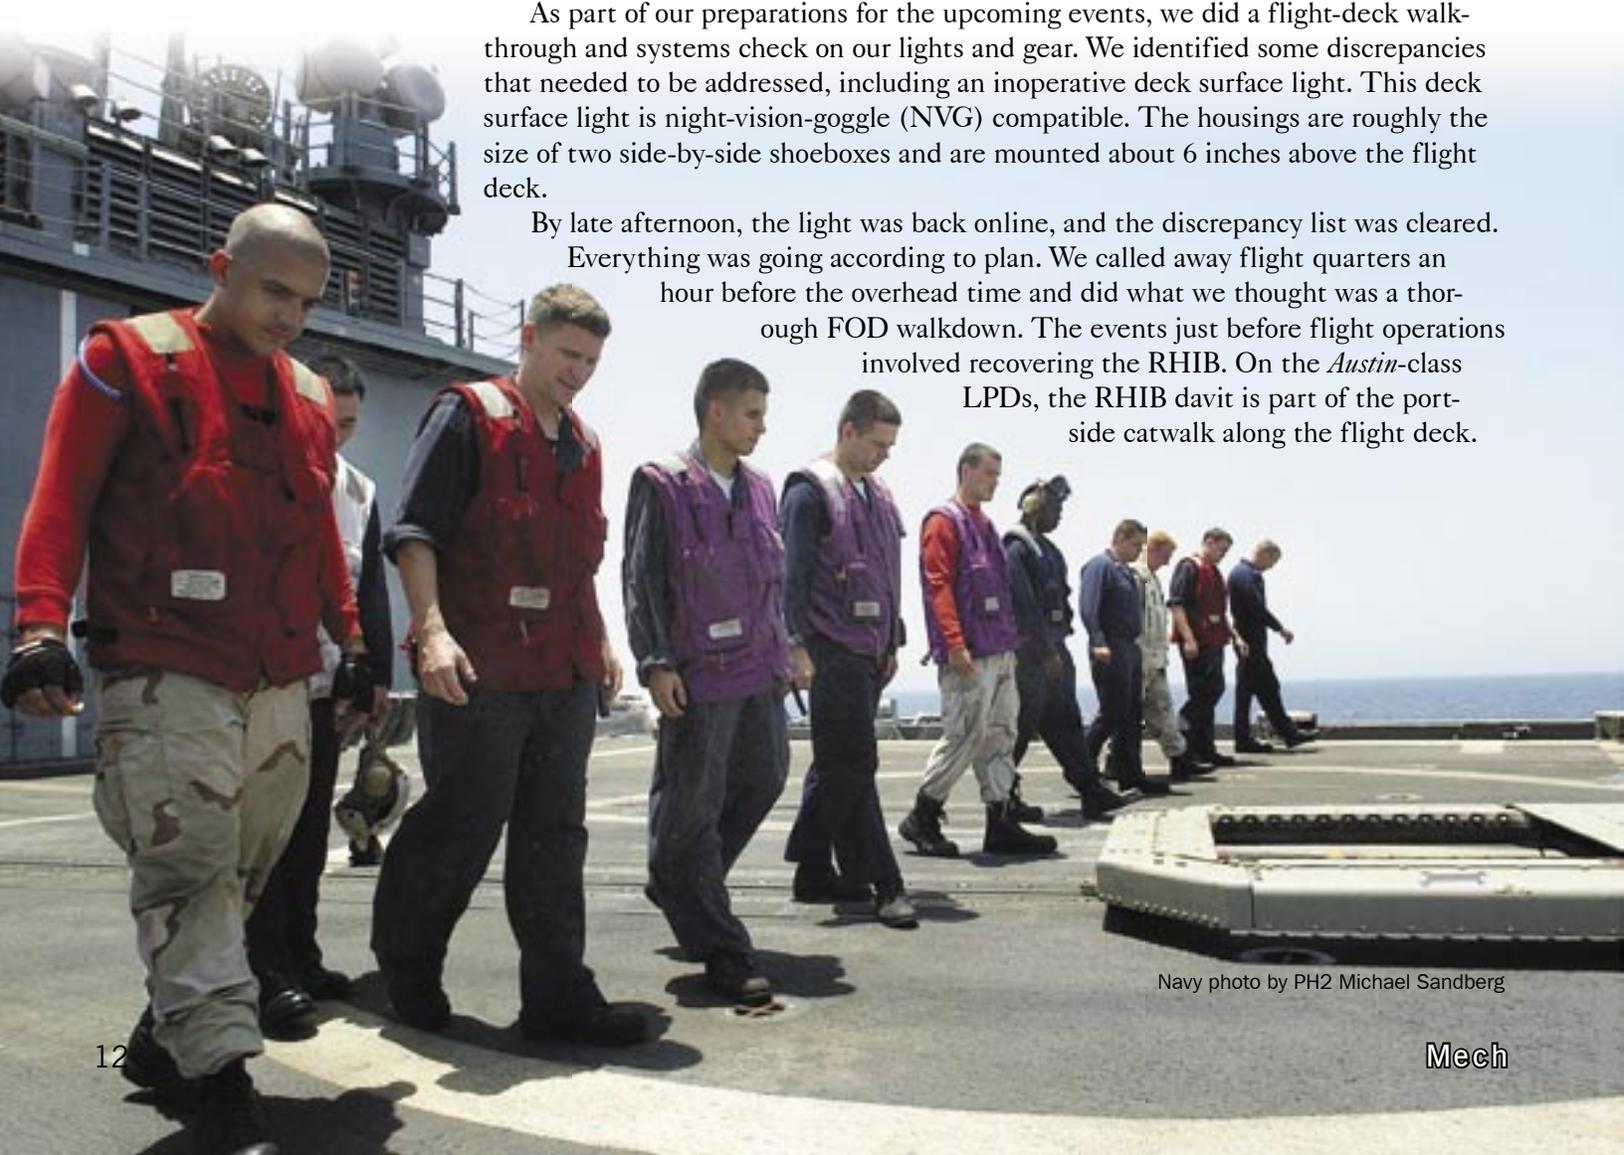
A FOD check should include security of gear on and around the deck. A close look shows the latch on this light housing can be critical.

I held off the two helicopters into the Delta holding pattern until my deck crew could investigate. They found that the unsecured light cover had been blown off by the H-47's rotor downwash during the initial landings. The missing cover allowed light to escape the housing and reflect off the deck coaming. Once the deck crew

We learned a cheap lesson that night because nobody was hurt and nothing was damaged. We since have added a security "pull" on these light covers as part of our FOD walkdown. This security step was adopted because the latches on the light covers may appear to be secured when they merely are resting in the down position. Therefore, a visual inspection is not enough, especially if the check is done in low-light conditions. Finally, I have
