3,000 PSI Is Unforgiving

By AM2 (AW) Shawn Hayes

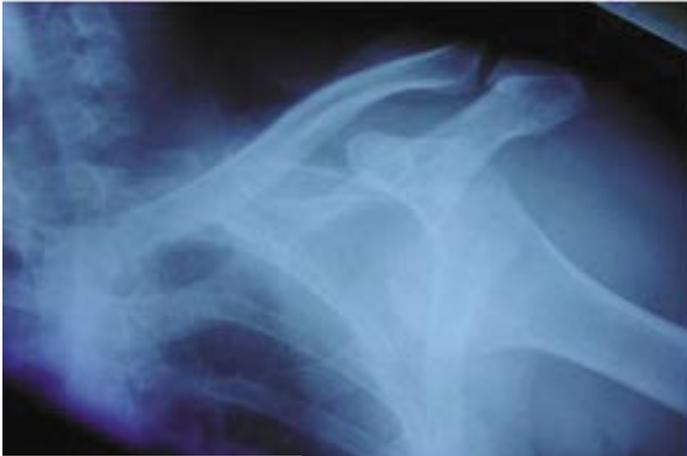
Separated shoulder

routine maintenance evolution. I should have waited for both engines to come online and then requested a “hands off” signal from the PC before going near any flight-control surface with hydraulic power applied. We also violated the squadron’s maintenance SOP; we didn’t do a brief of the evolution with all involved persons. We all were so familiar with our duties that we went right to work. We only briefed the turn with the maintenance-desk chief, FDC, and turn-qualified guy.

Had we done a simple brief of the job, we could have discussed roles and responsibilities, answered any questions, and highlighted this hazard. A periodic review of squadron maintenance SOPs would be a good step to

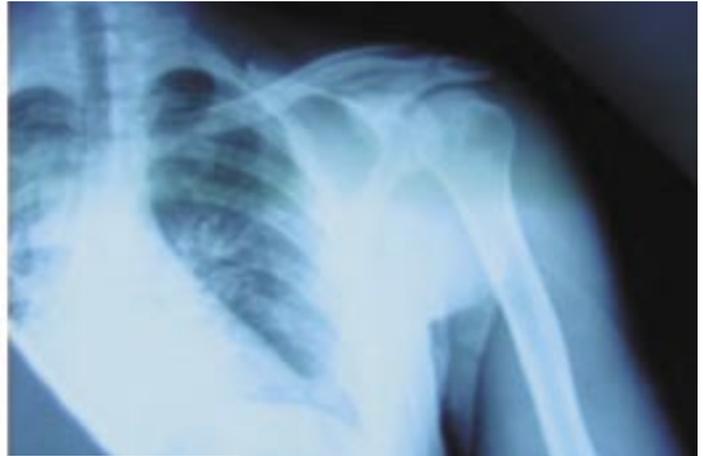
I spent the next three days in medical and more than 70 days on light and limited duty, nursing a dislocated shoulder. My X-rays clearly showed the dislocated shoulder before and after it was popped back in place—quite an experience.
