Unknown Danger

By Lt. Gary Horsey, USS Theodore Roosevelt (CVN-71)

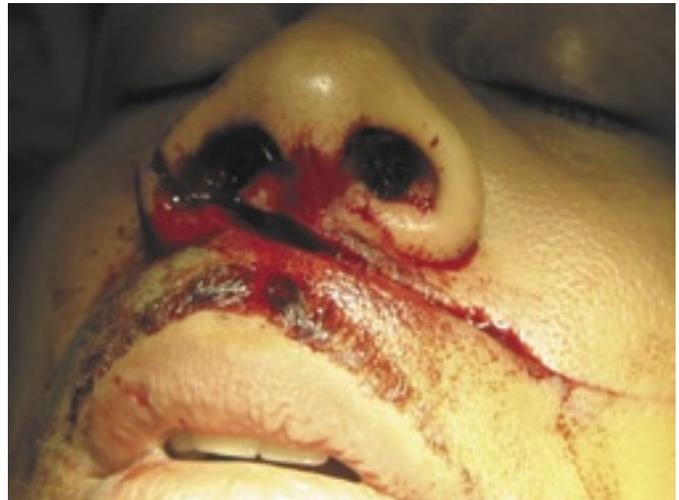
Before the AS2 had completed the last few turns to remove one bolt, the lid exploded off the LCFU with a loud pop. The lid hit the AS2 in the face. He immediately grabbed his mouth and doubled over. That was the last position I recalled seeing him in before he was rushed to medical. He received more than 40 stitches (covering 6 inches of his face), had three hours of

Investigators found none of the regular ingredients for mishaps; the AS2 had received adequate training, and pre-operational checks of equipment had been done. Complacency, lack of communication, and the day-to-day operational environment did not lead to this disaster. The investigation team did find an obstructed bleed valve that prevented the complete release of pressure.

The AS2’s overall situational awareness was lower than it should have been. Without considering the possibility that there could be more than the normal 9 to 12 psi in the cylinder, he loosened the retaining ring clamp, while leaning directly over the LCFU, which placed his face over the lid. The resulting situation could have been fatal.

- Wear PPE whenever working with any pressurized equipment, regardless of the unit’s psi rating.
- Always stand to the side of a pressurized opening when performing maintenance on any pressurized equipment.
