Use Those Deck Pla

By GSCS(SW) John Davis,
Naval Safety Center

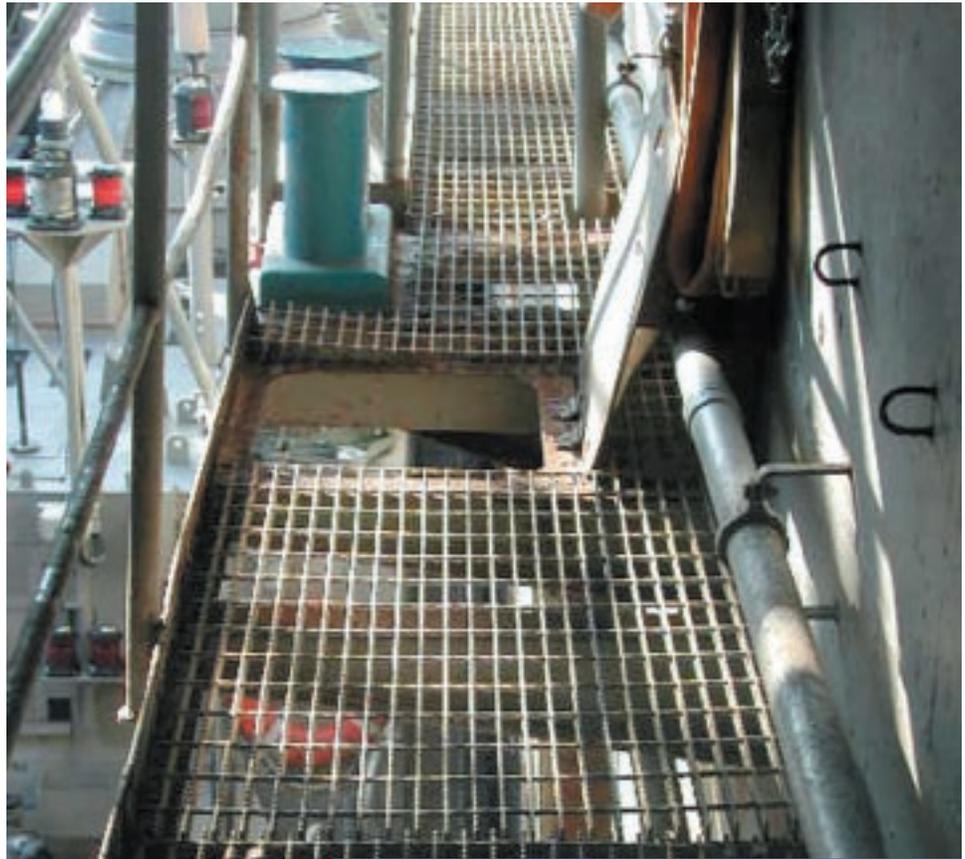
Meanwhile, a Sailor had climbed to the catwalk via an amidships vertical ladder. He began hauling the hose aft, but he did not close the ladder's access hatch. He assumed that another Sailor (who was also helping with the refueling operation) was going to follow him up the ladder. However, this second Sailor got distracted below and didn't.

The Marine—coming from forward—didn't notice the open deck in the catwalk. He fell through the catwalk's amidships opening. He hit his head on a vehicle 20 feet below, and died from his injuries.

A closeup shows the opening where the Marine fell to his death. A distracted Sailor didn't climb through the opening and close it when he was supposed to, resulting in an unaware Marine falling through the opening to the well deck below, sustaining fatal injuries.

ings, or to clearly rope off as out-of-bounds any areas where plates or grates have been removed. Go out and regularly check your spaces to make sure all deck plates, grates, and coverings are in place. Also be sure associated safety chains are installed and in the required material condition if they're used to block an opening in the deck.
