E-2C WIRING SYSTEM AWARENESS

PREVENTING WIRING SYSTEM FAILURE SAVES
TIME, MONEY...

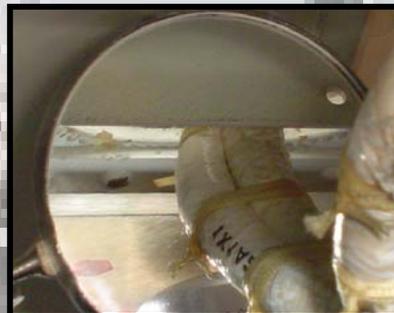
Plastic clamp incorrectly installed and chafing.

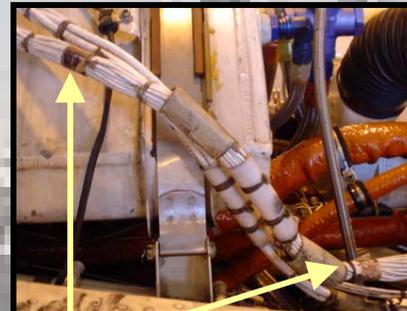
Power wiring transitioning through armpit chafing structure.

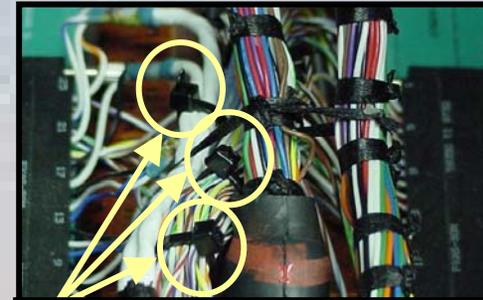
Harnesses missing clamps at critical clamp marker point. Purple tape signifies critical clamp point.
